# Appendix A

## Las Vegas, NM Urban Forest Project

### Candidate Trees for Removal

# Appendix B

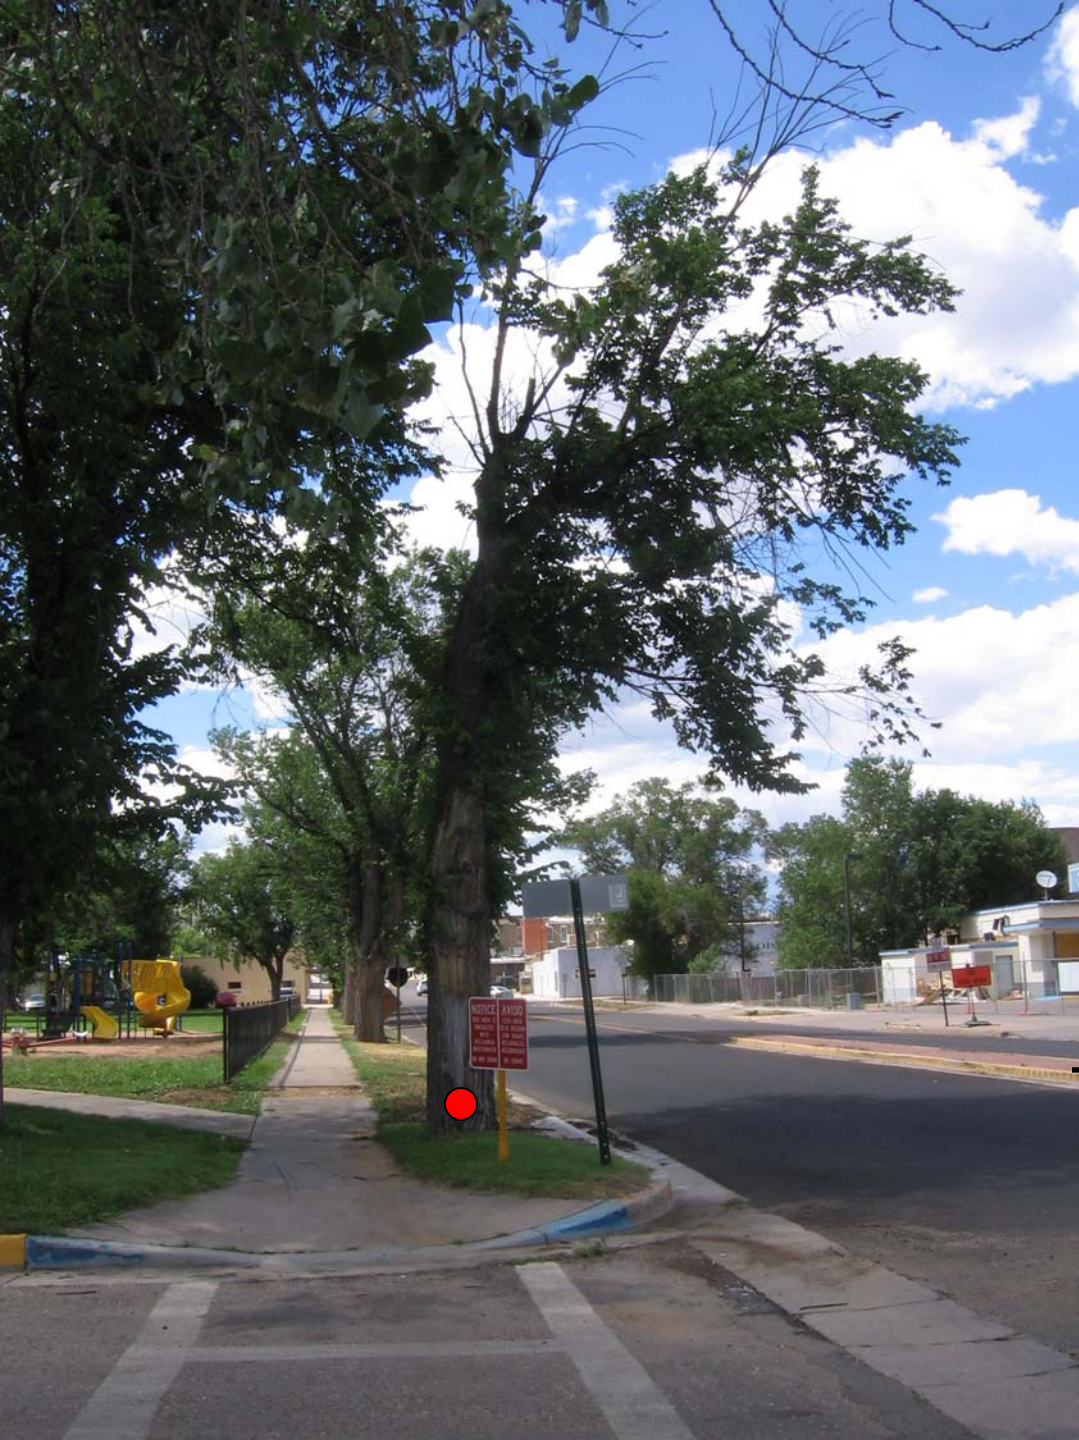
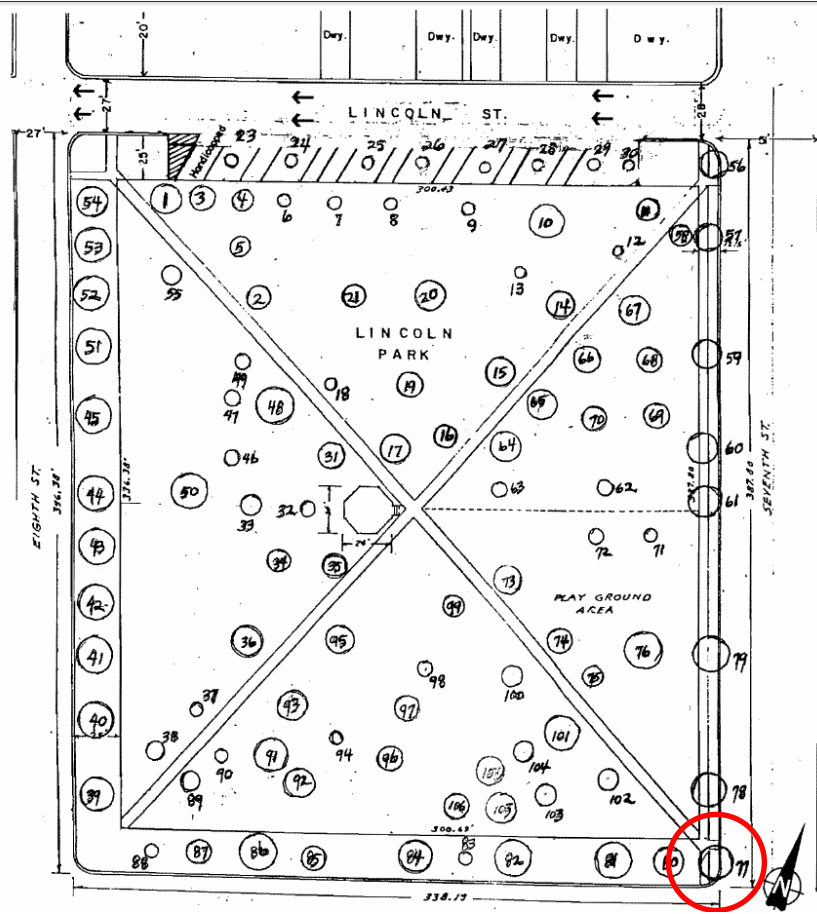
**Removal Tree # 1**  
**Lincoln Park - #77 on diagram**  
 (red dot paint on trunk)

- Elm, ~30' tall.
- Extreme injury and die back.
- Street tree.

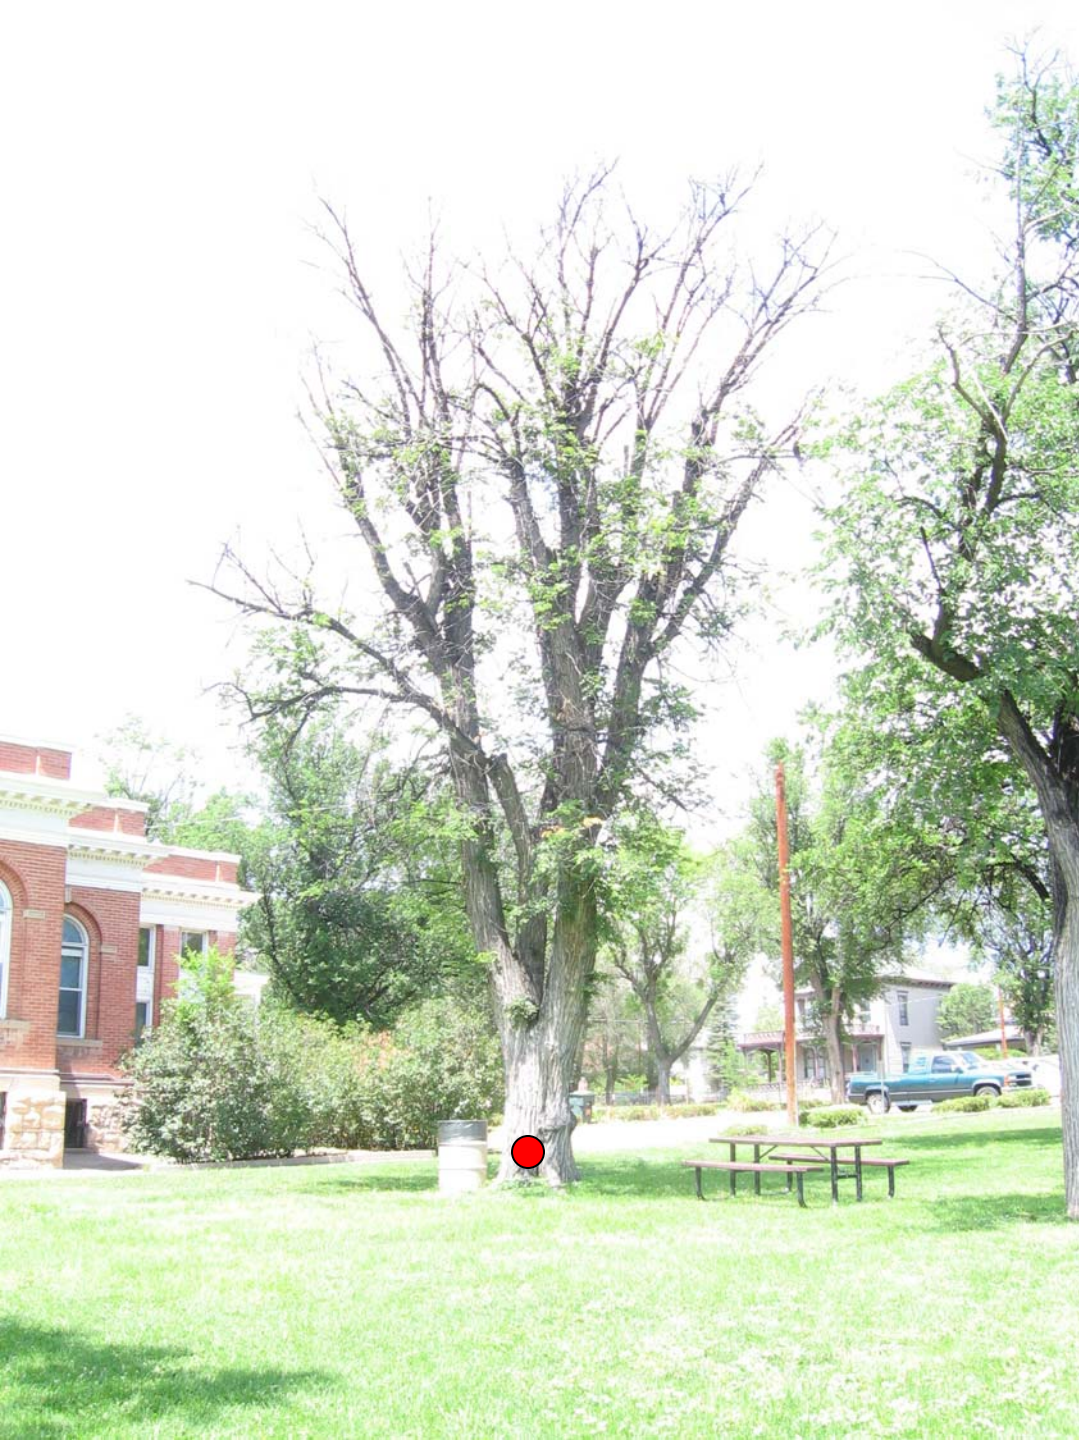
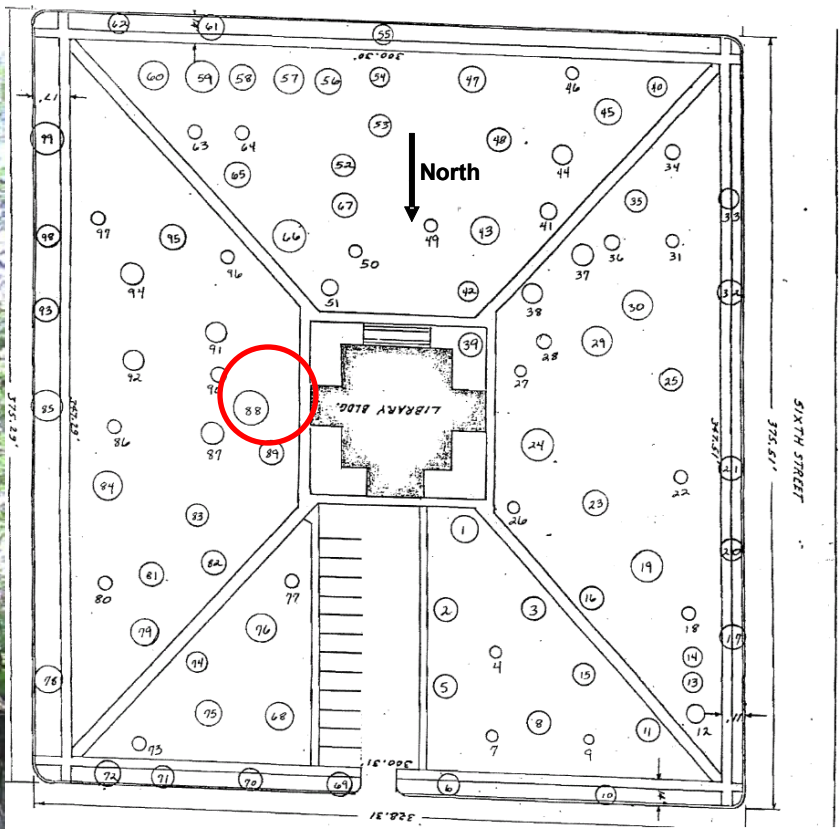
Removal Tree # 2  
Carnegie Park - #88 on diagram  
(red dot paint on trunk)

- Elm, ~35' tall.
- ~ 95% deadwood, remainder is epicormic shoots.

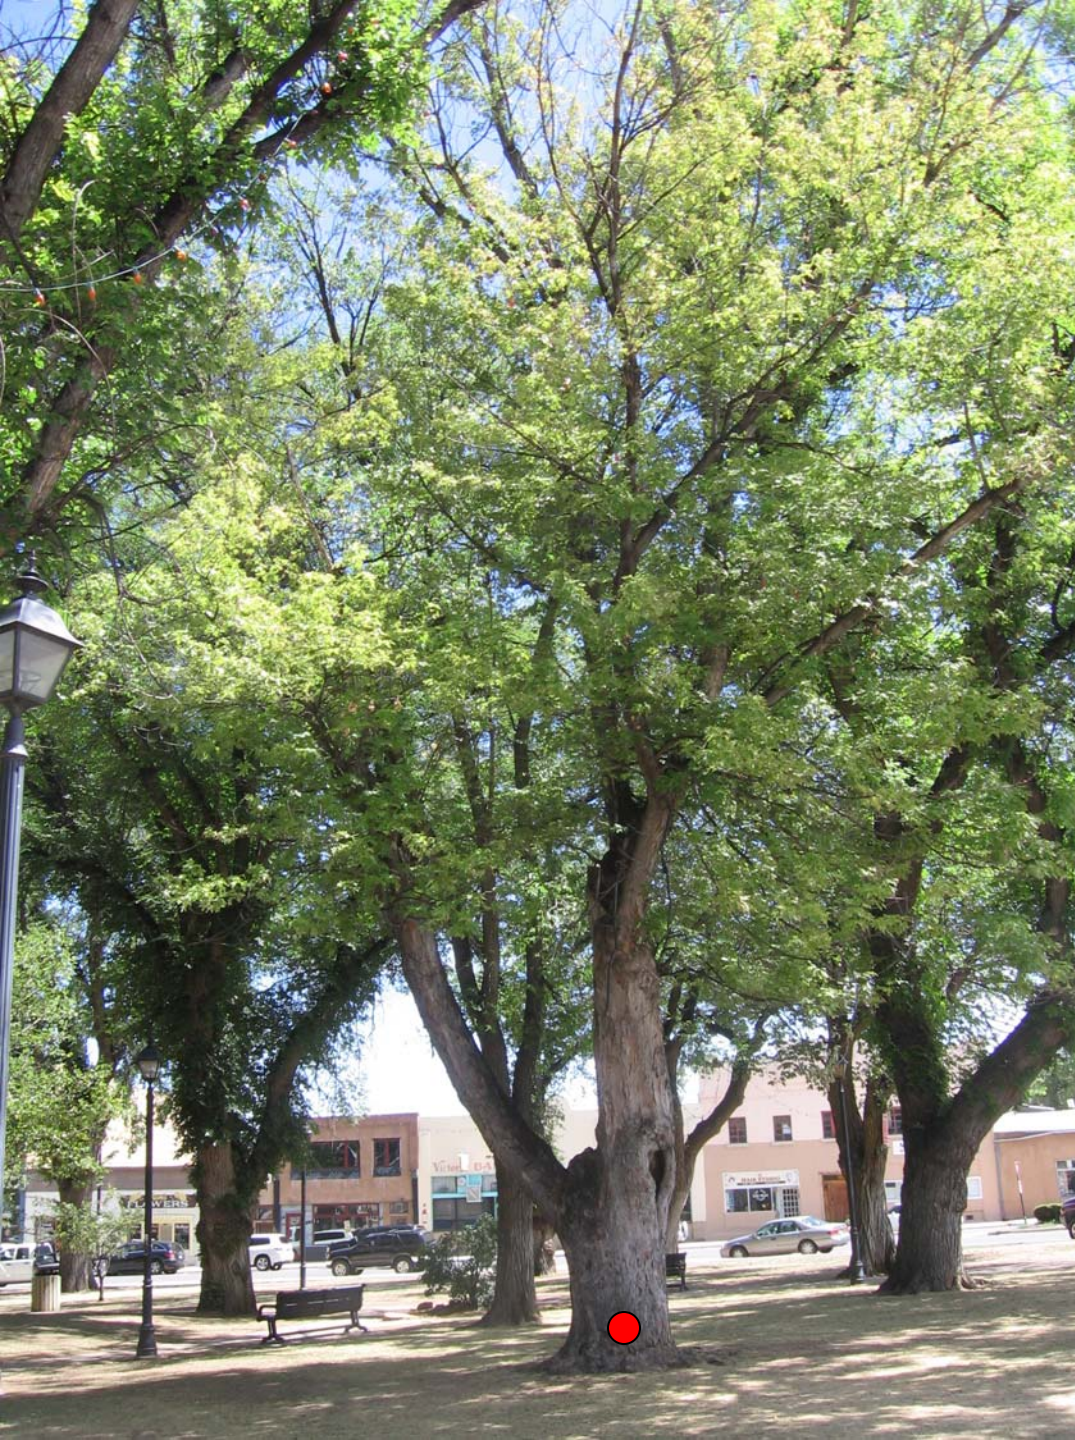
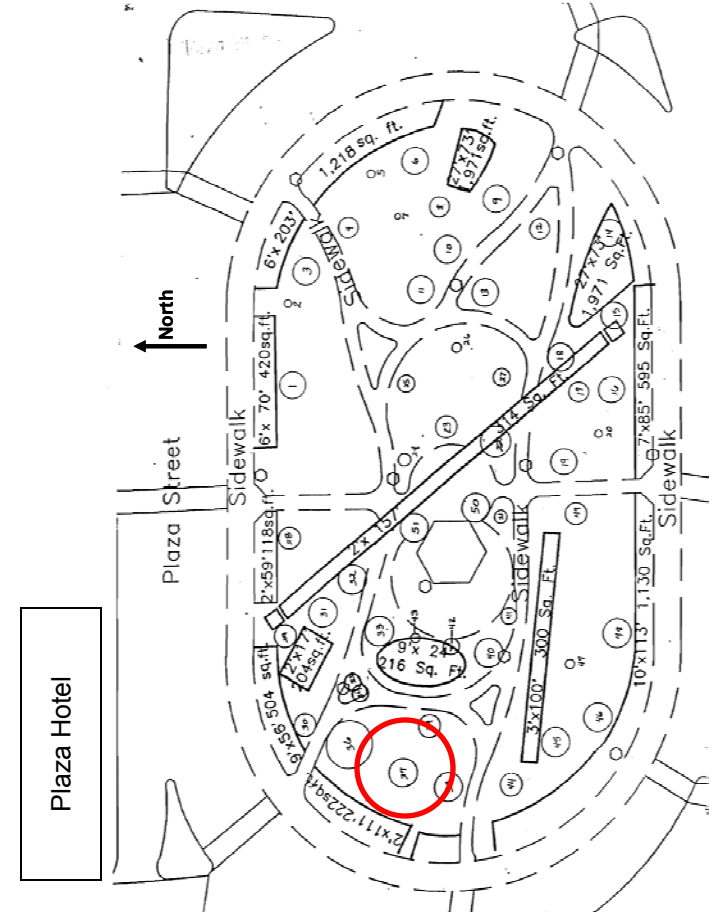
Removal Tree # 3  
 Plaza Park - #37 on diagram  
 (red dot paint on trunk)

- Maple, 50-55' tall.
- Extensive decay in stem and all major limbs
- Extremely poor canopy color indicating lack of vigor.

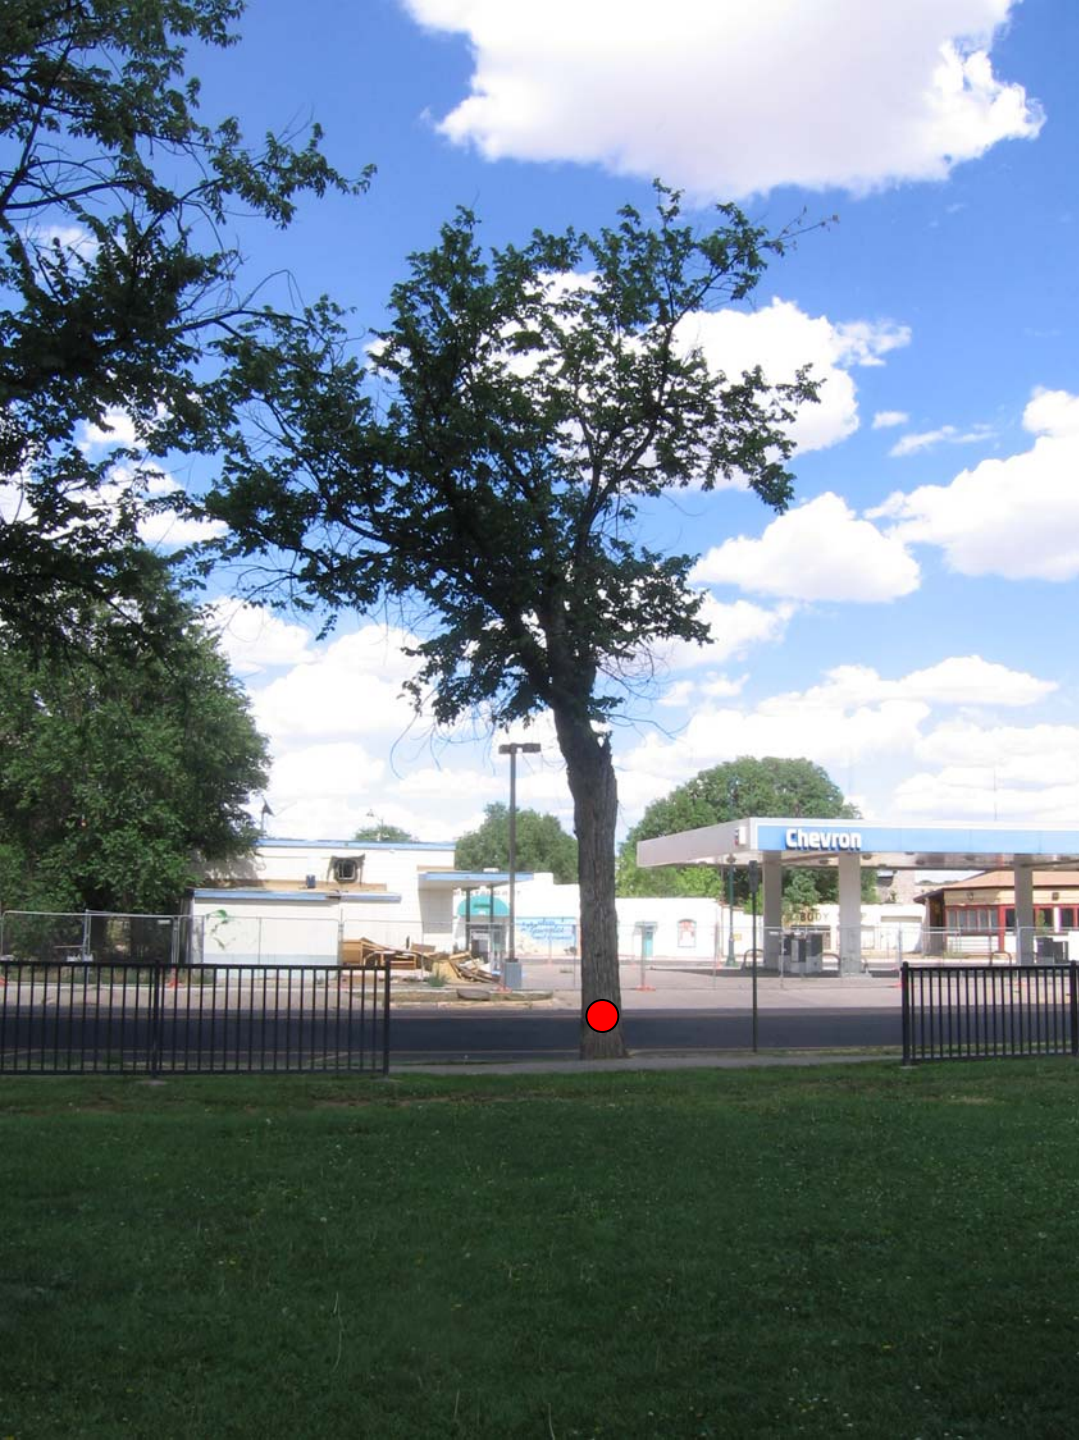
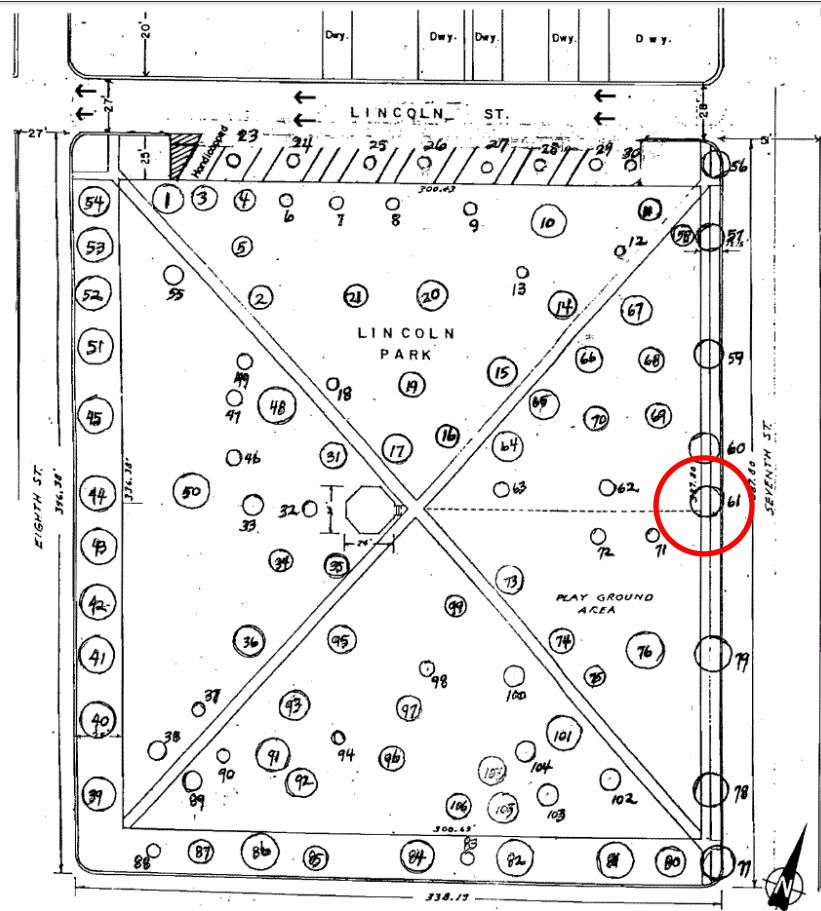
Removal Tree # 4  
Lincoln Park - #61 on diagram  
(red dot paint on trunk)

- Elm, ~30' tall.
- Street tree.
- Storm damage and/or topped.
- Decay in main stem at ~10'.

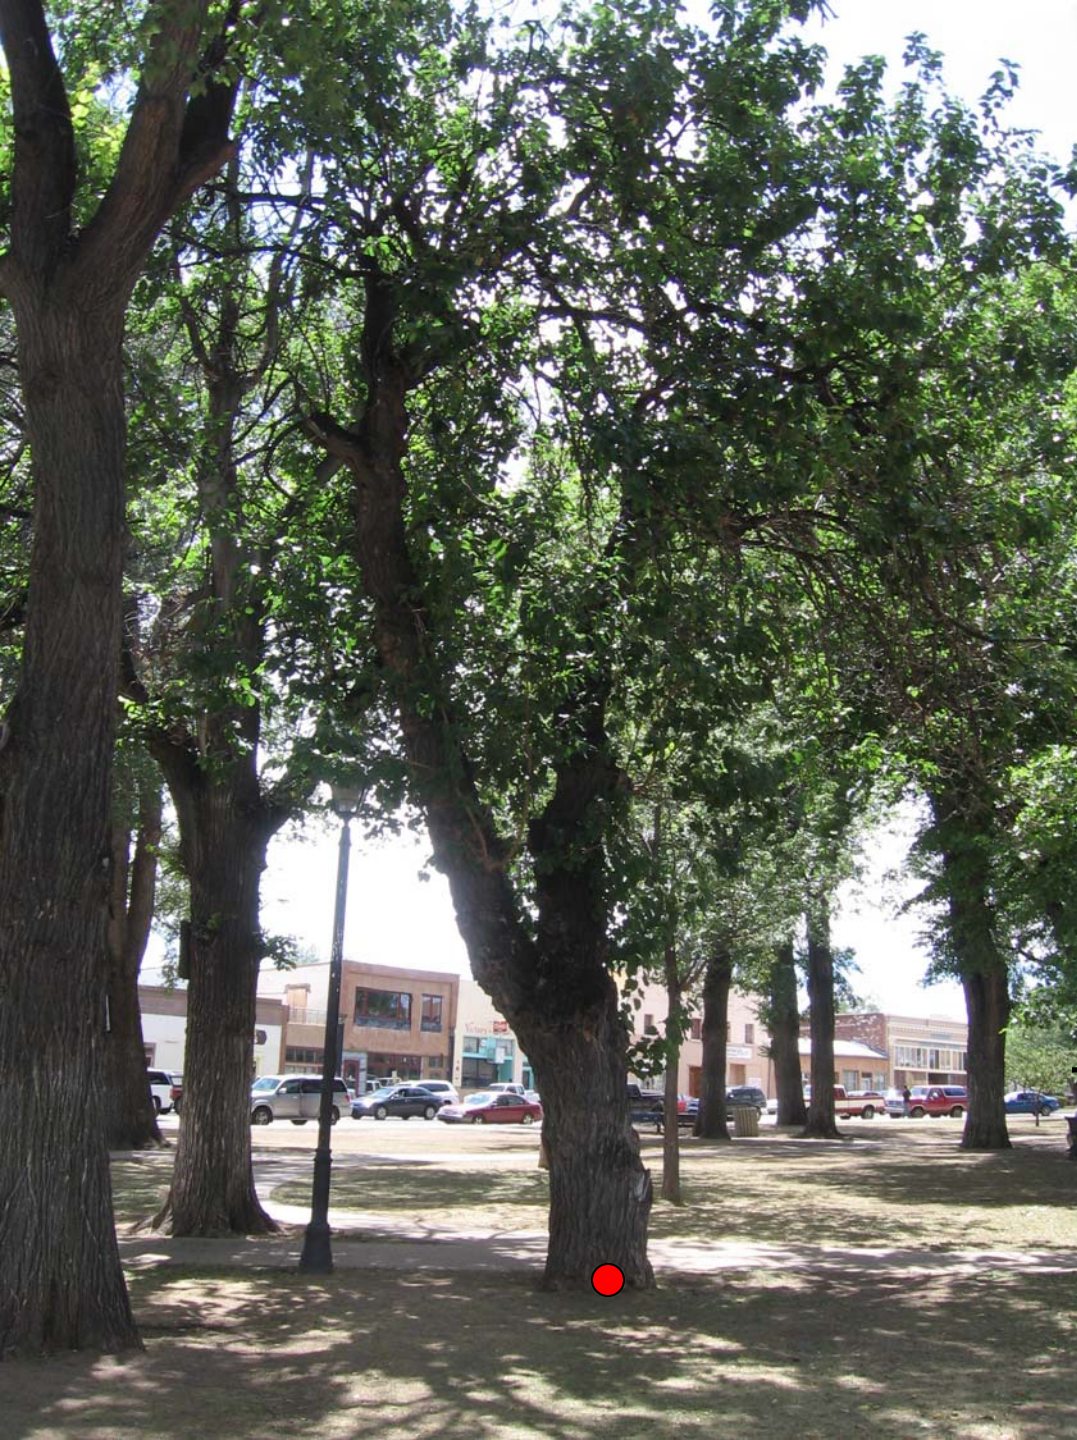
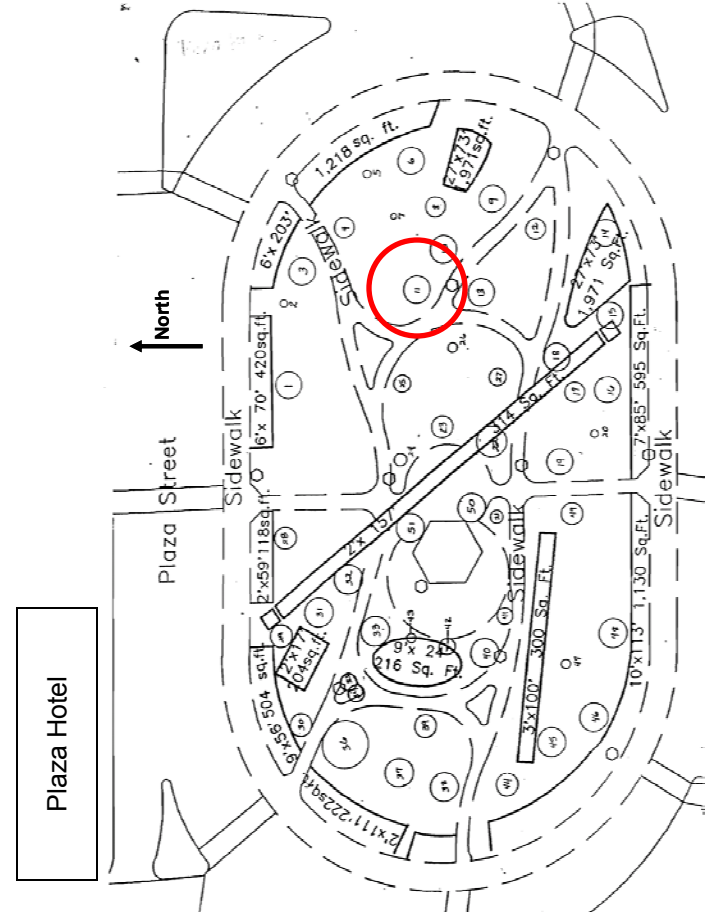
Removal Tree # 5  
Plaza Park - #11 on diagram  
(red dot paint on trunk)

- Elm, ~30' tall.
- Extensive decay and decline.
- Heavy limbs unsupported by corresponding tree vigor.

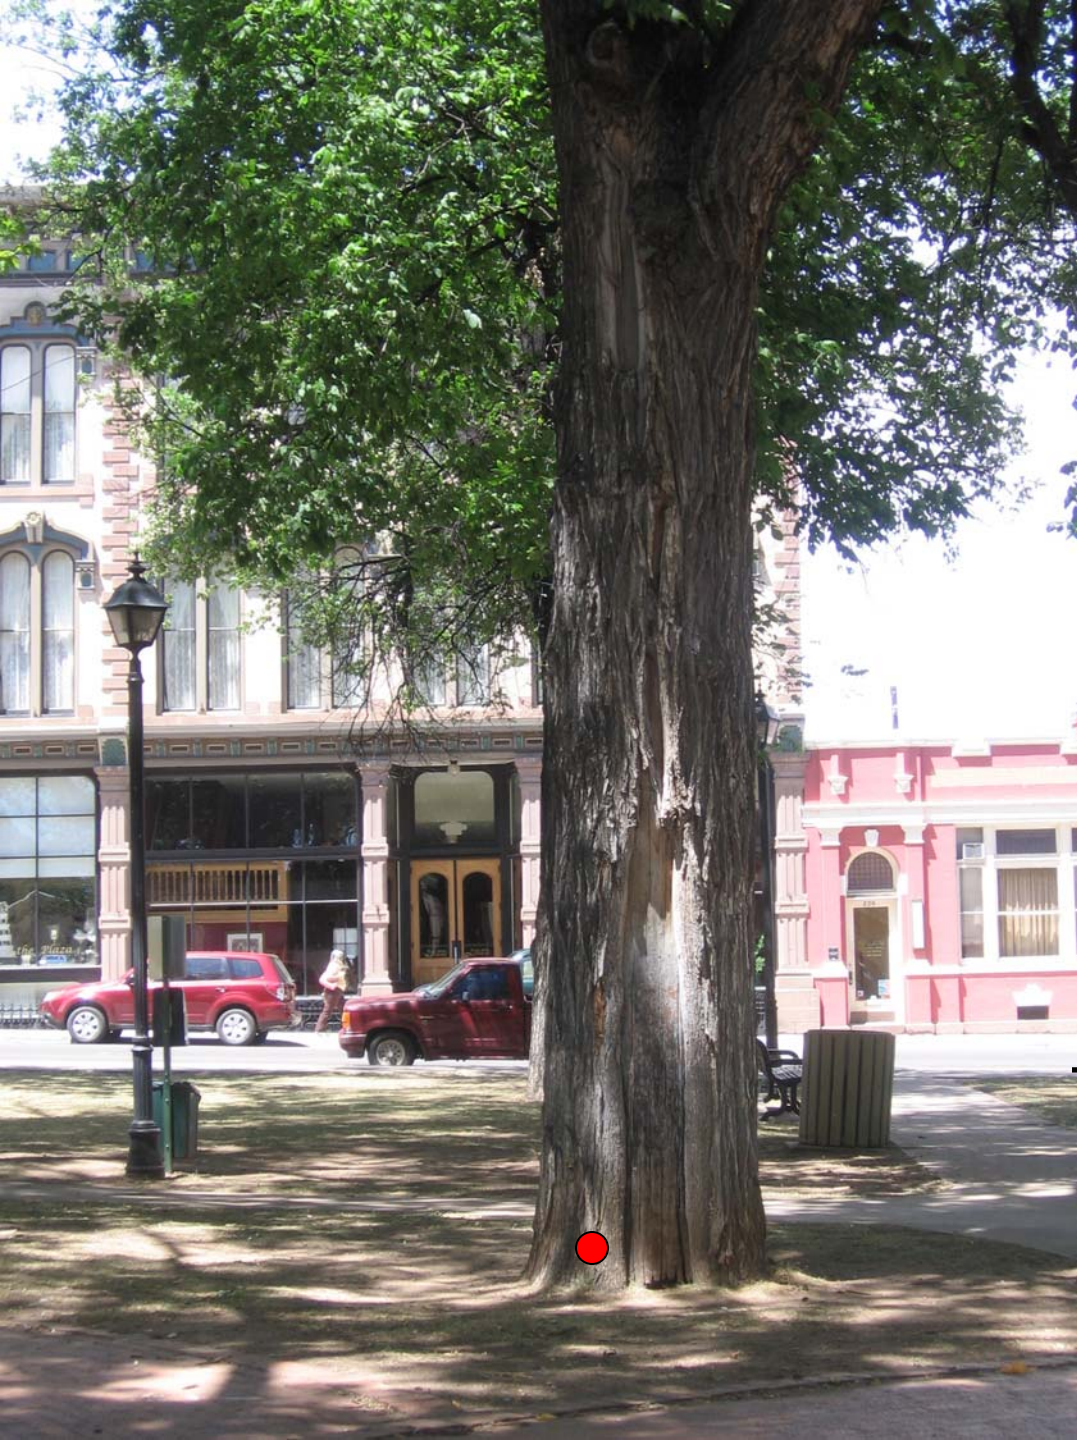
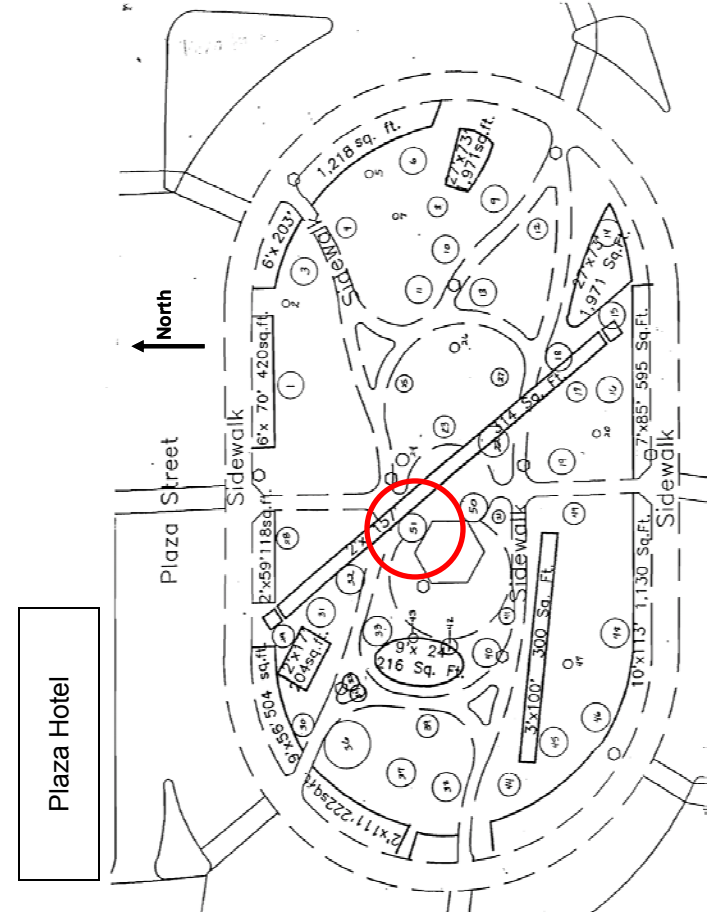
Removal Tree # 6  
Plaza Park - #51 on diagram  
(red dot paint on trunk)

- Elm, ~ 40''tall.
- Extensive wound, extending 10' up stem.
- Major limb girdled with wire.

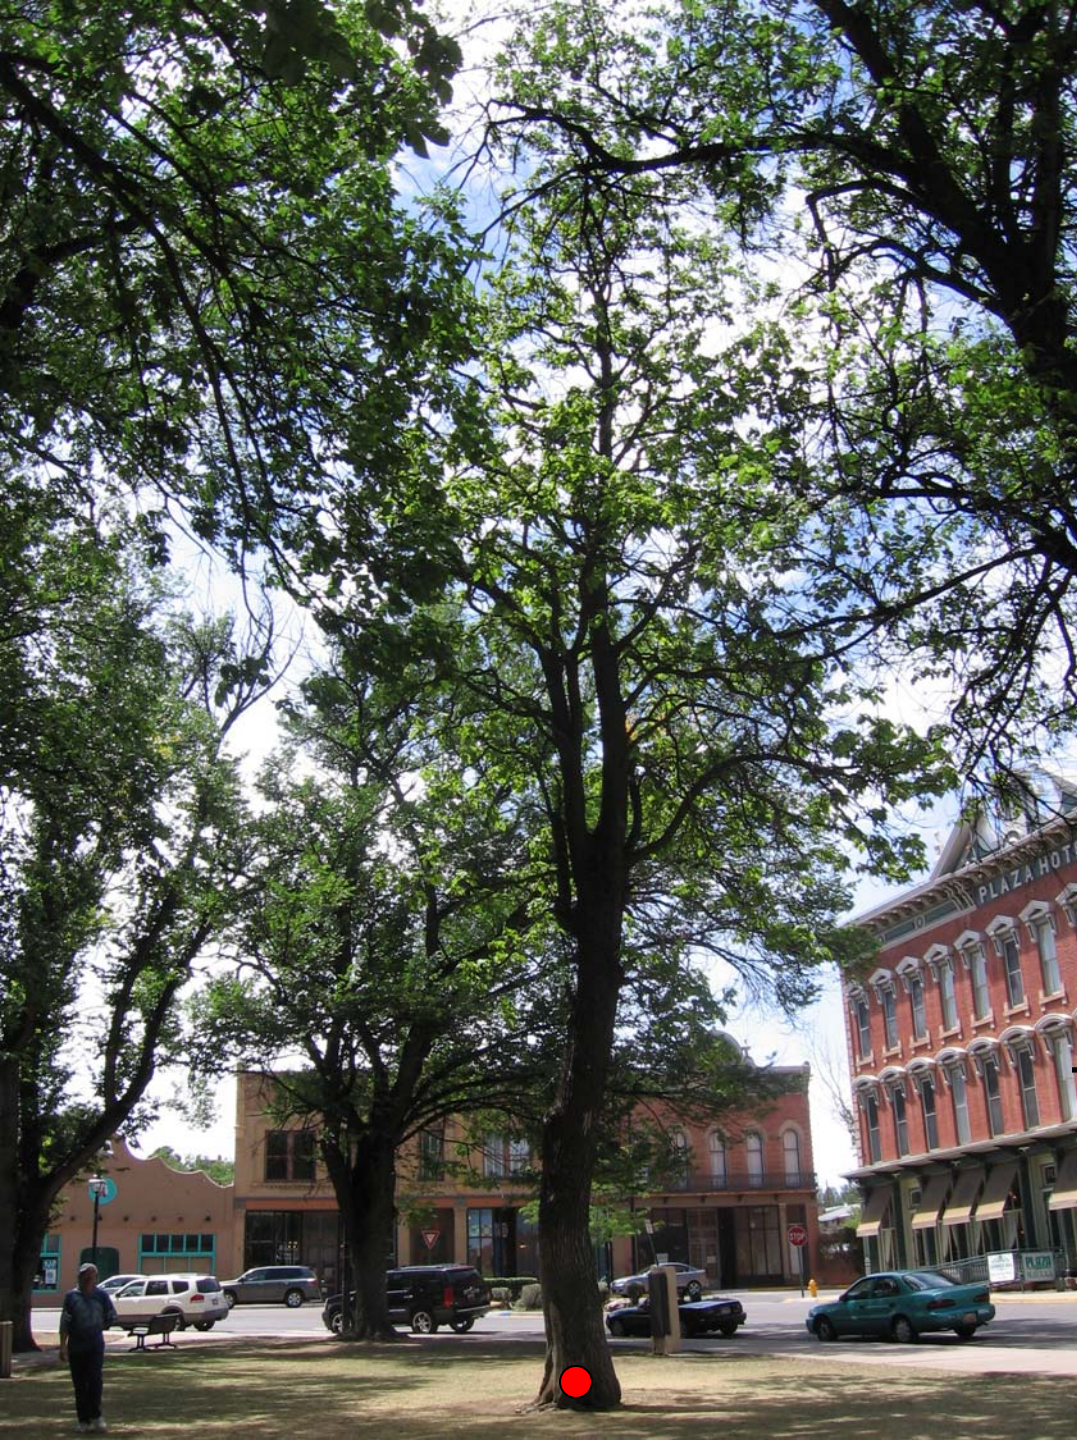
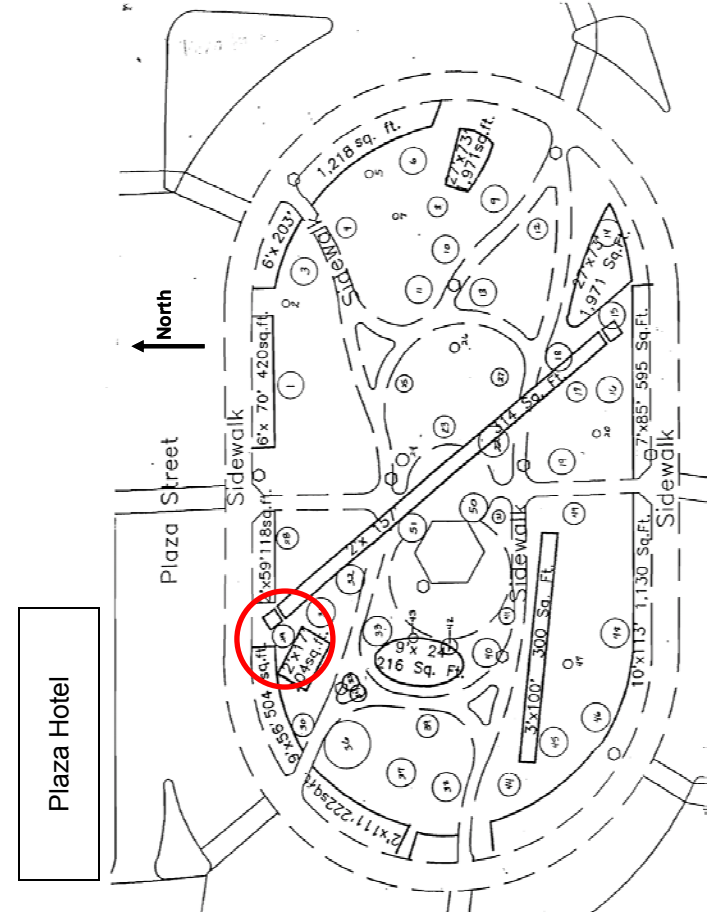
Removal Tree # 7  
Plaza Park - #29 on diagram  
(red dot paint on trunk)

- Elm, ~ 40 – 45' tall.
- Significant wound with associated decay in stem (as indicated by lean and by core sample taken).
- Significant lack of vigor.

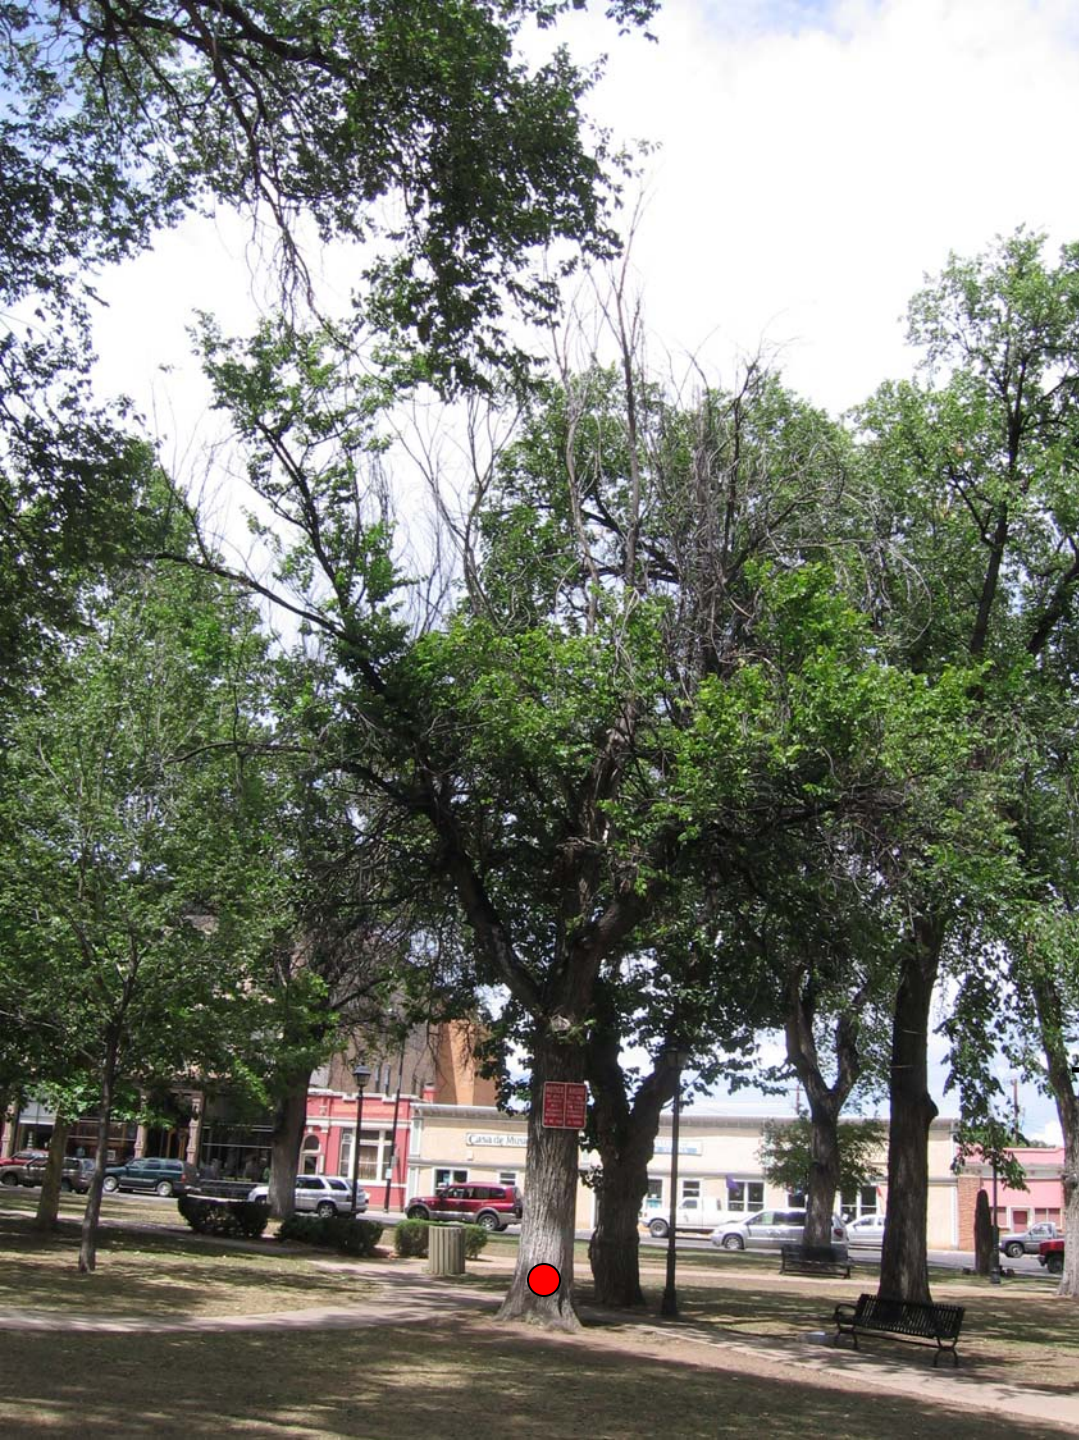
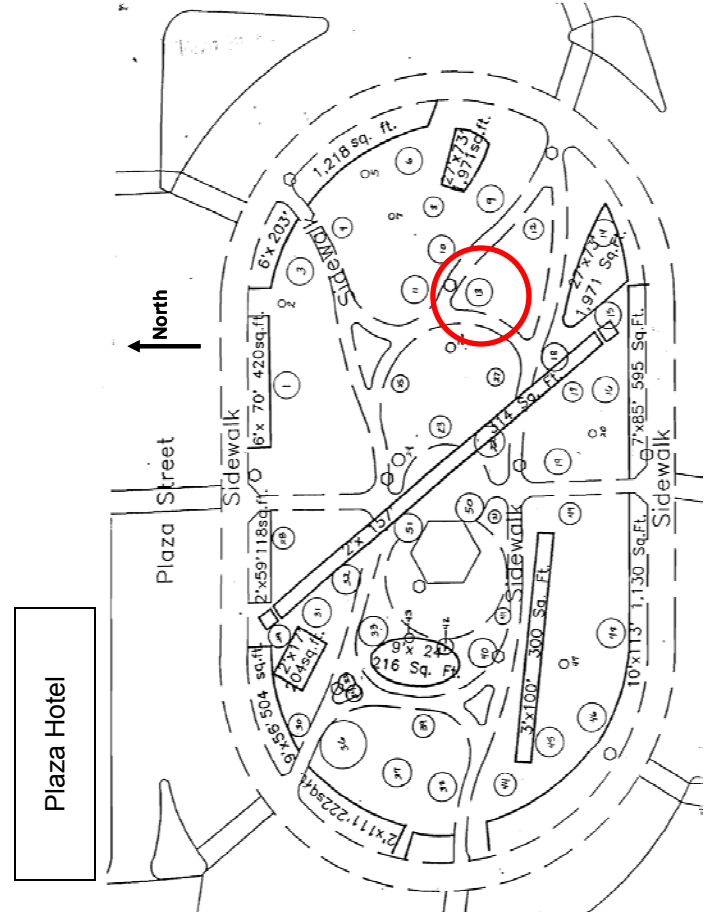
Removal Tree # 8  
Plaza Park - #13 on diagram  
(red dot paint on trunk)

- Elm, ~ 25 tall'.
- Mostly dead with epicormic shoots as main source of green.

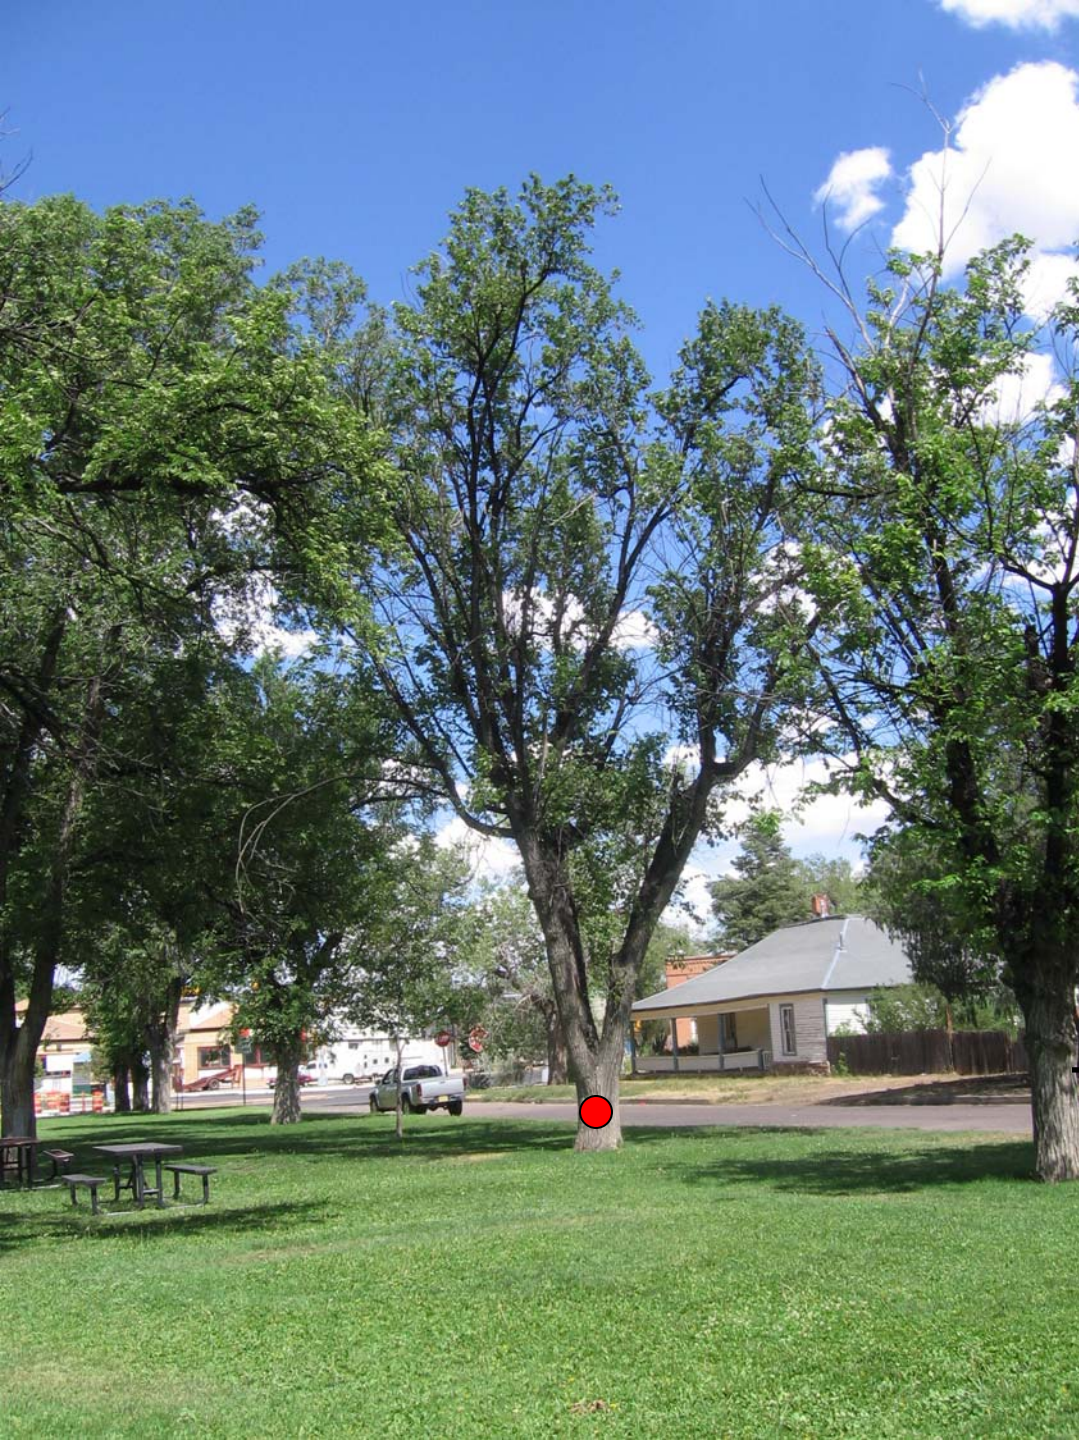
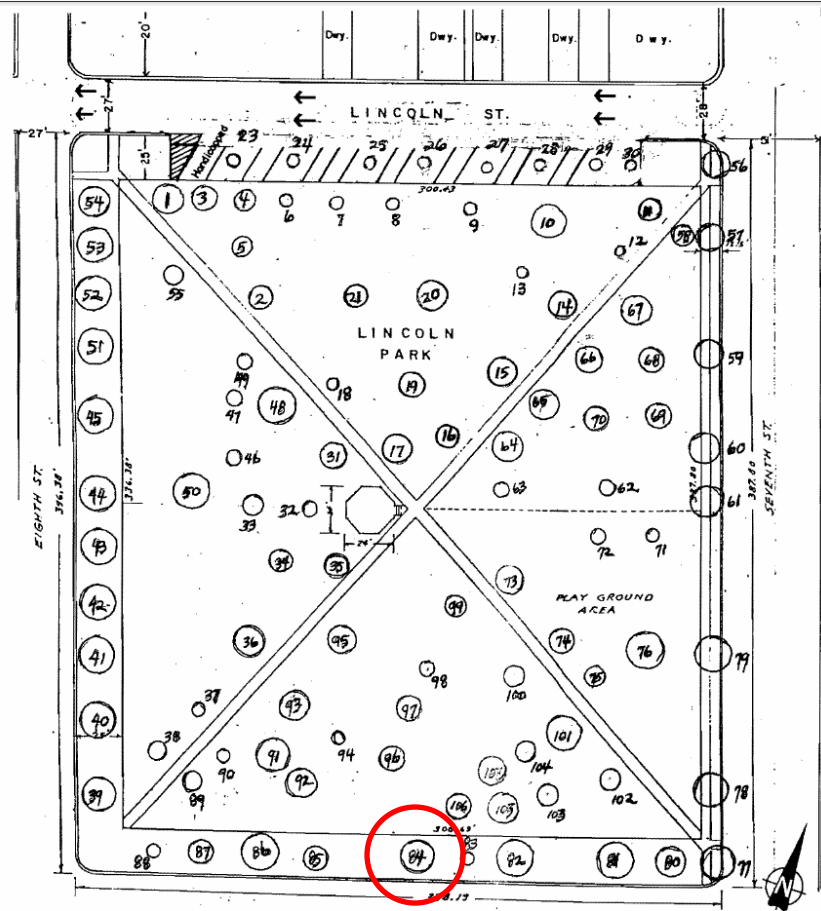
Removal Tree # 9  
 Lincoln Park - #84 on diagram  
 (red dot paint on trunk)

- Elm, ~ 25' tall.
- Poor structure – insufficient trunk, all major limbs coming out of the same area, one of which is injured/dying.
- Insufficient canopy indicating lack of vigor.

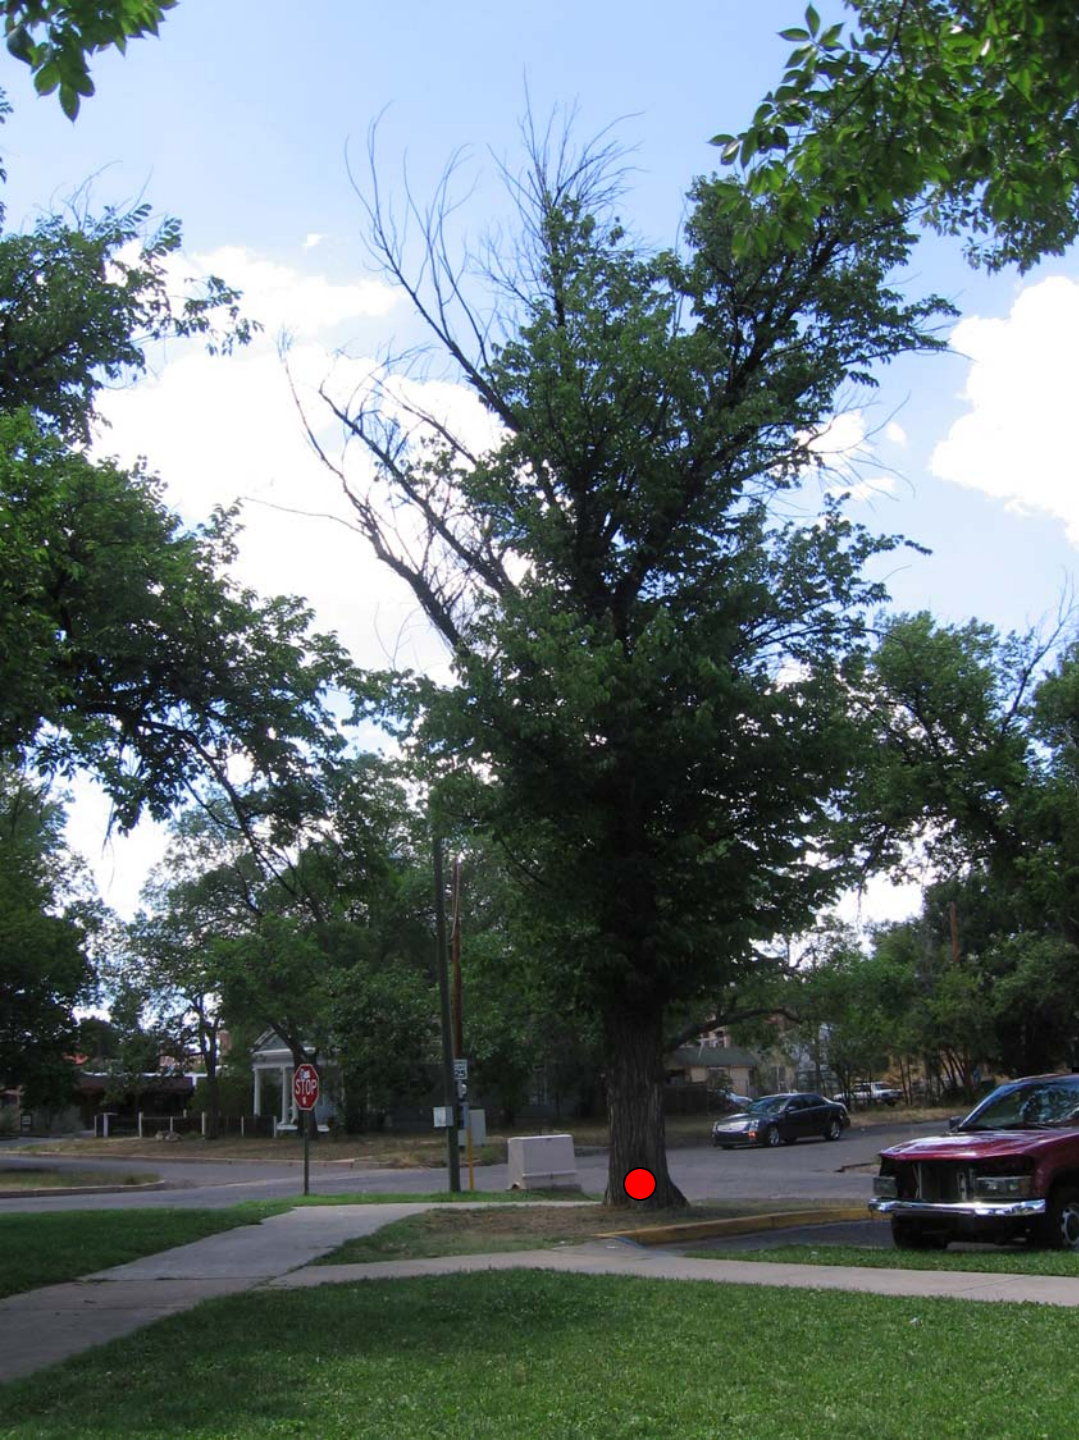
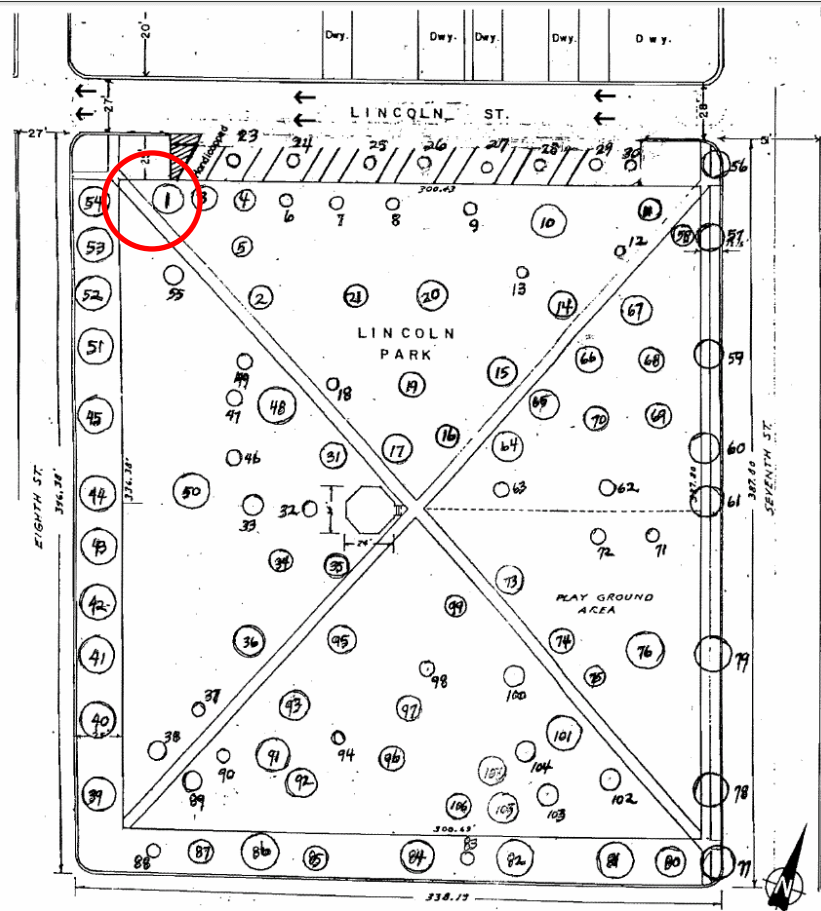
Removal Tree # 10  
 Lincoln Park - #1 on diagram  
 (red dot paint on trunk)

- Elm, ~ 30' tall.
- Too much deadwood and too few laterals to sustain its size.
- Target-rich area (car park, street, pedestrian walkway).
