# Appendix A

## Las Vegas, NM Urban Forest Project

### Candidate Trees for Removal

# Appendix B

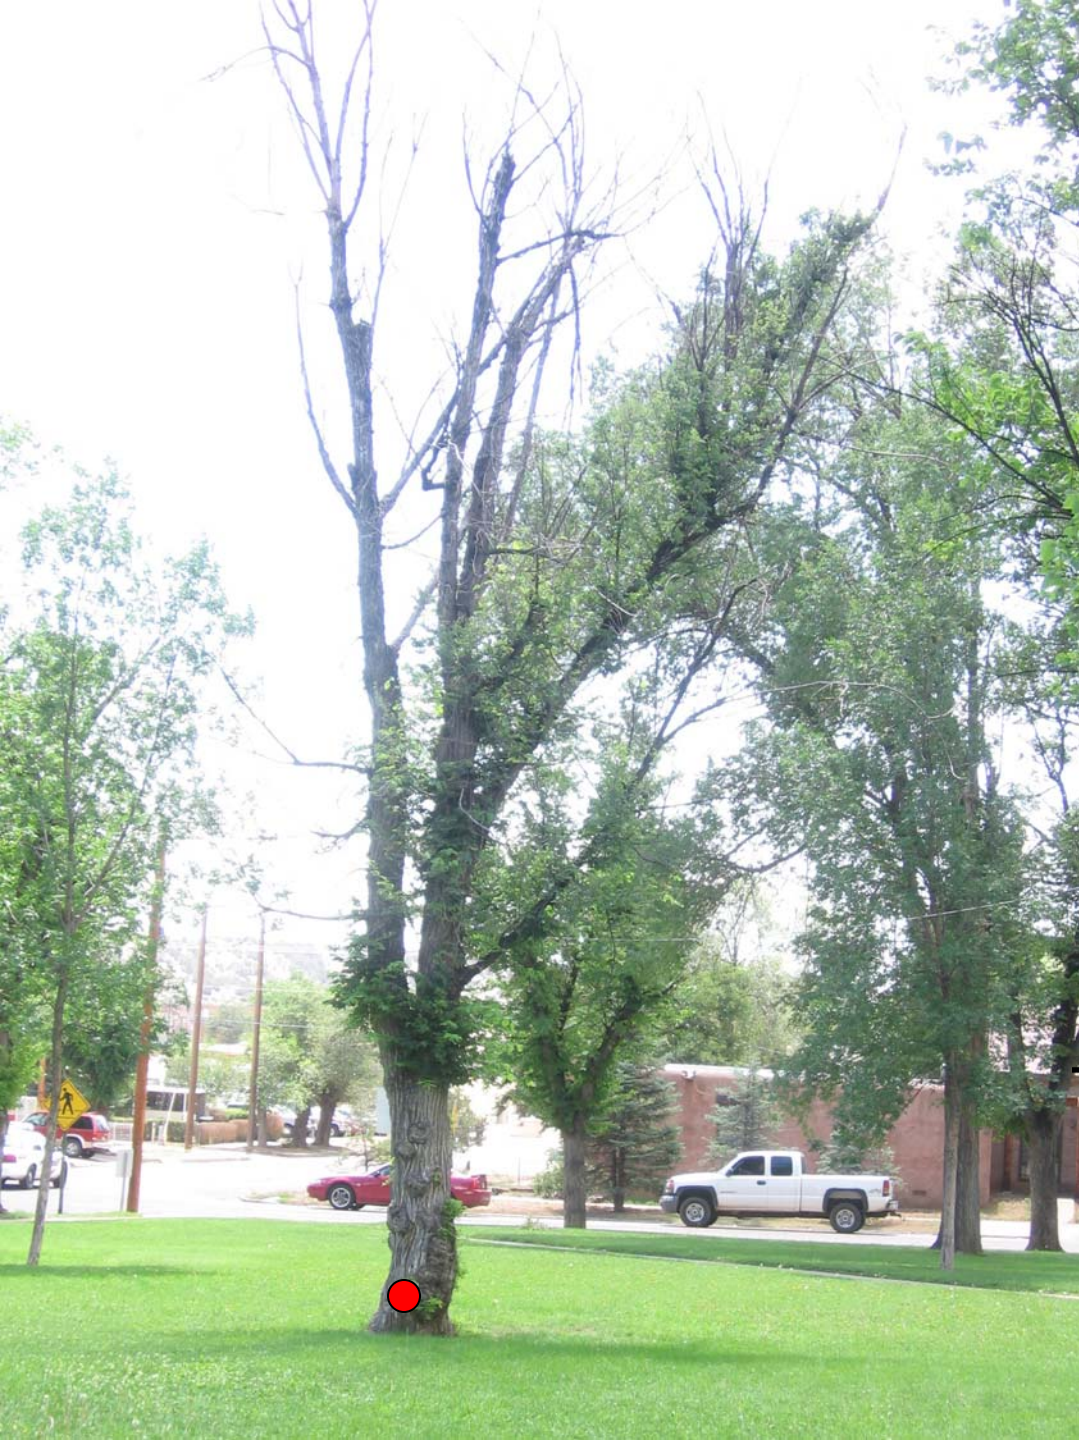
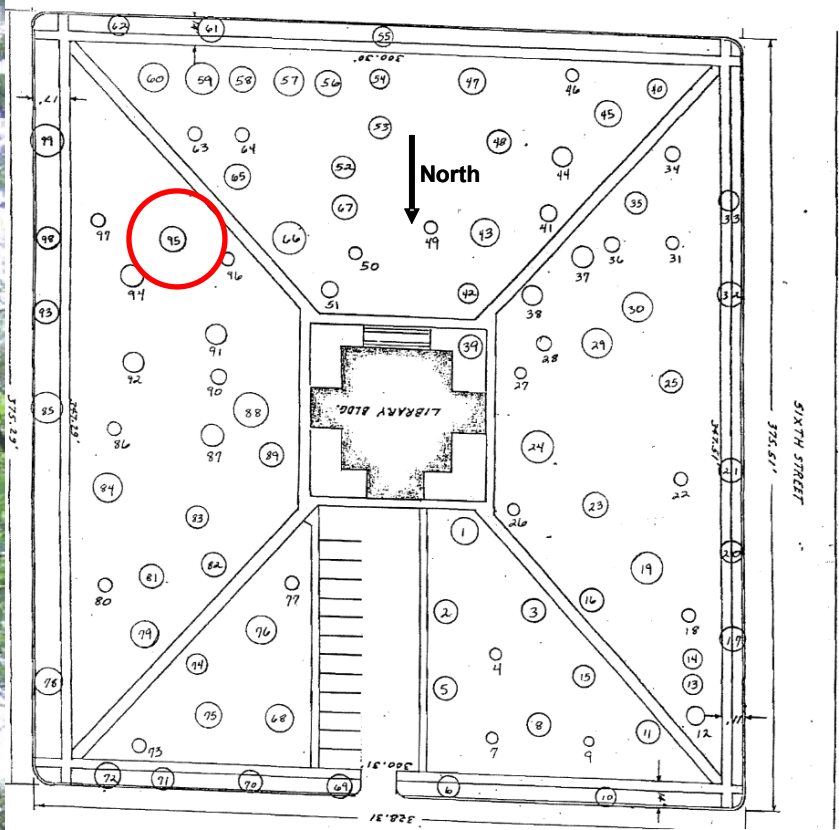
Removal Tree # 11  
Carnegie Park - #95 on diagram  
(red dot paint on trunk)

- Elm, ~ 30'tall.
- 95% dead, galls, epicormic shoots, and trunk anomaly at grade.

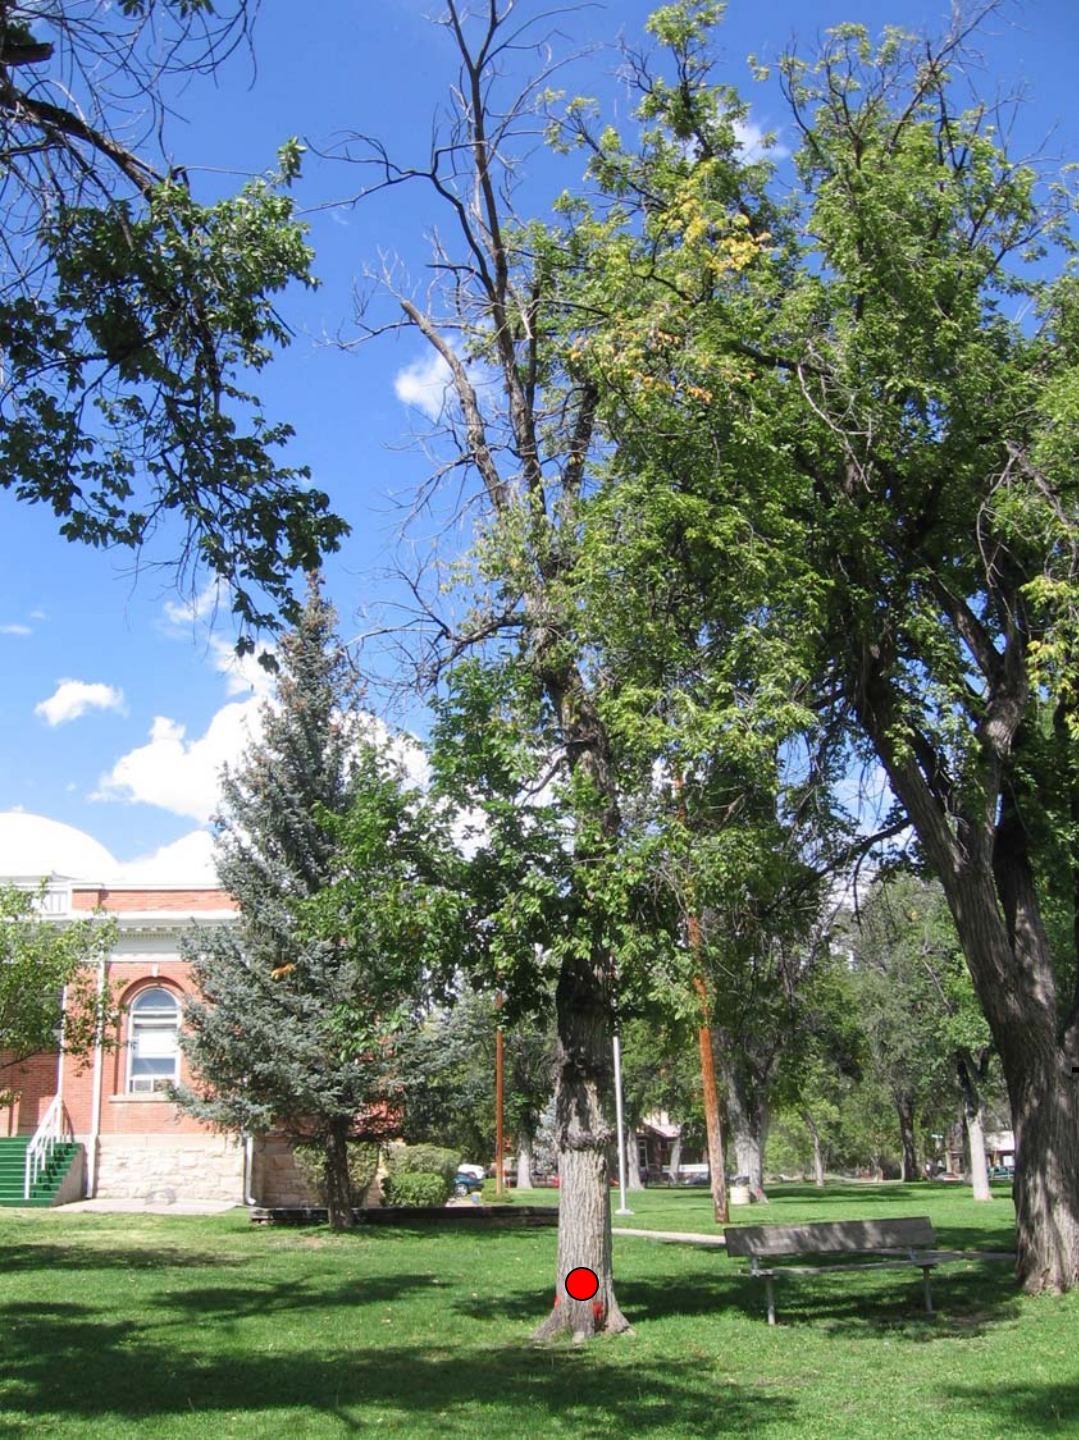
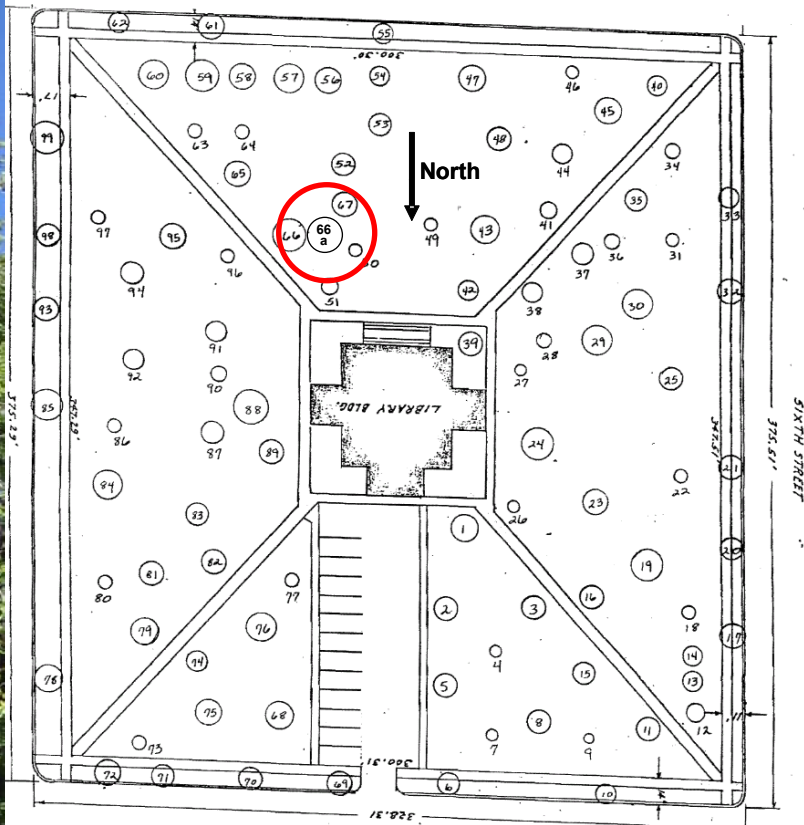
Removal Tree # 12  
Carnegie Park - #66a on diagram  
(red dot paint on trunk)

- Elm, ~ 35' tall
- Significant deadwood, stem encircled by galls at ~ 5'.
- Permanent bench as target.

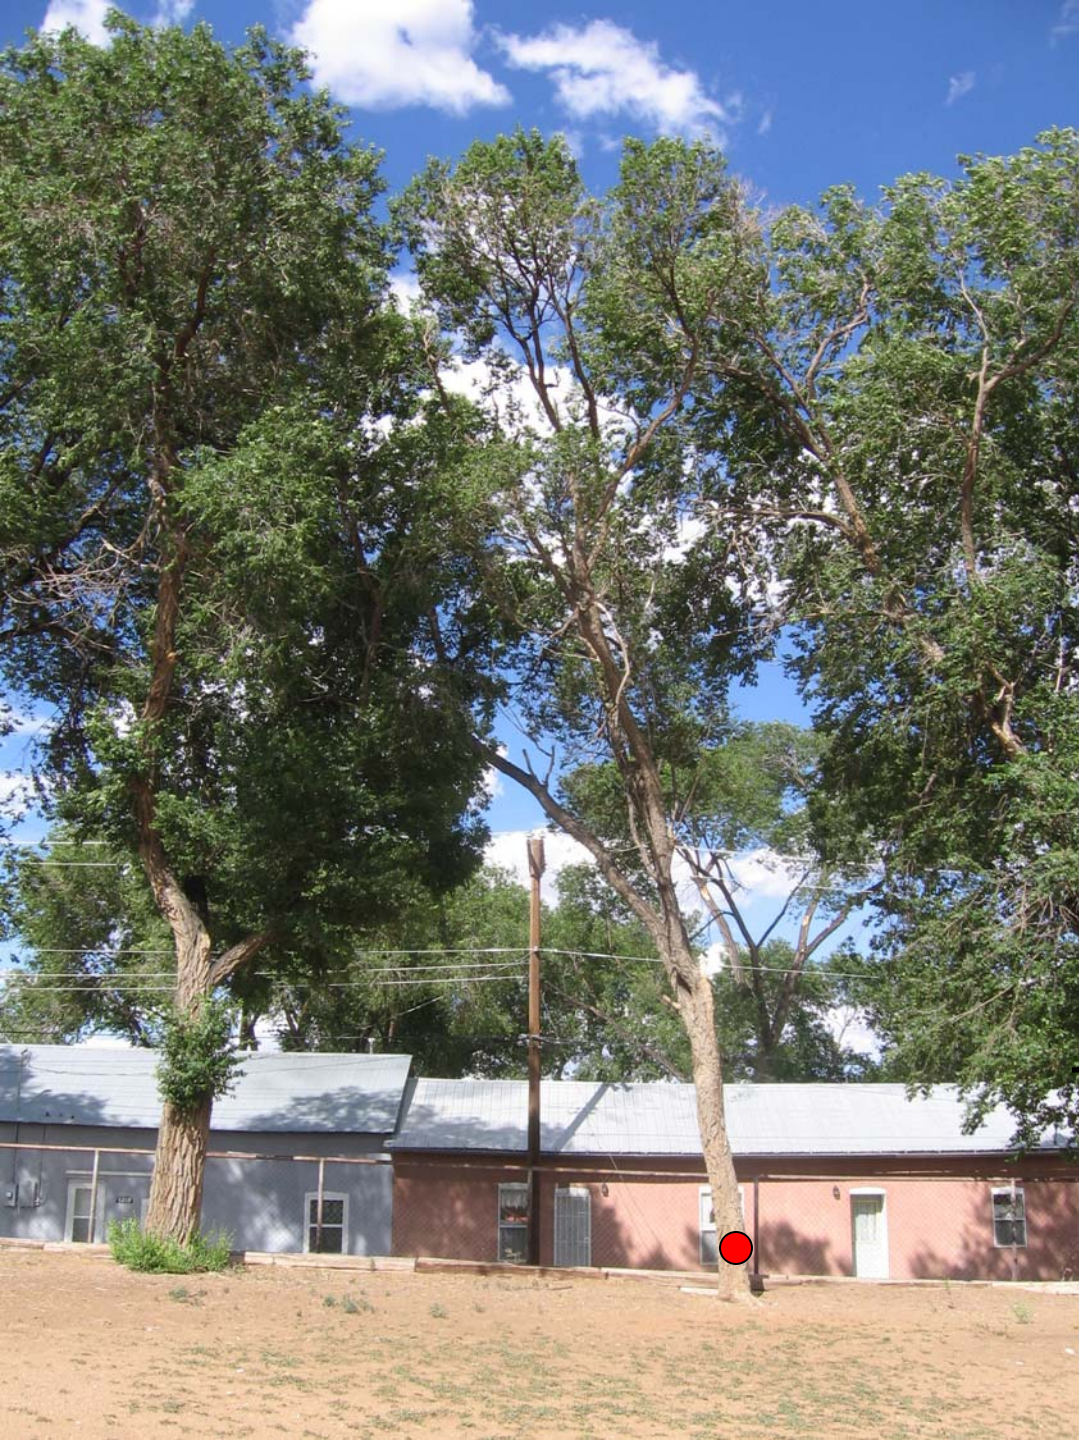
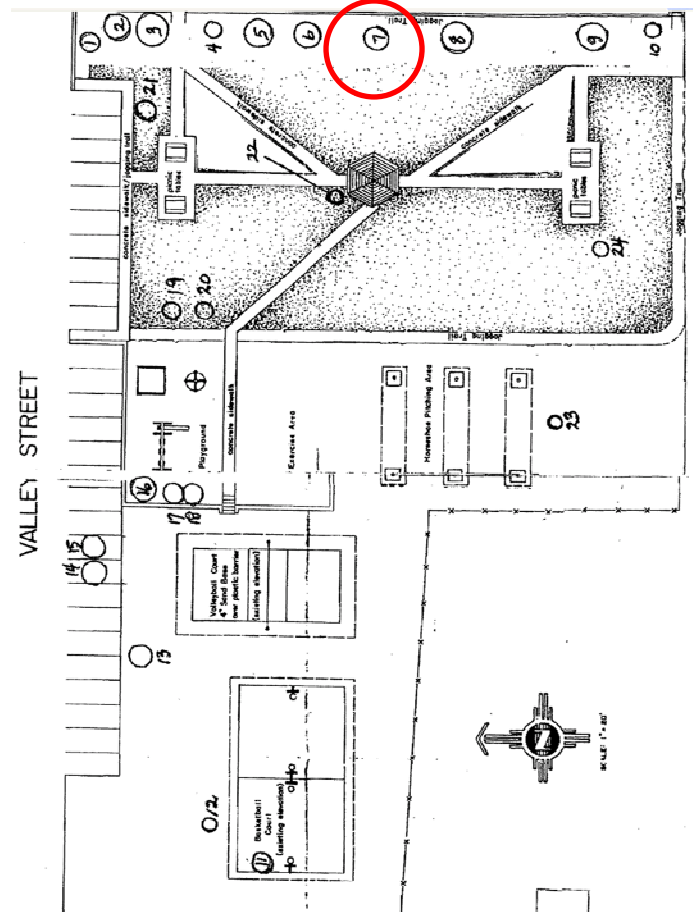
Removal Tree # 13  
S. Pacific Park - #7 on diagram  
(red dot paint on trunk)

- Elm, ~ 40'tall. Overhangs South Pacific St.
- Poor trunk taper (indicates lack of good anchor).
- Small leaves and pronounced lack of vigor.

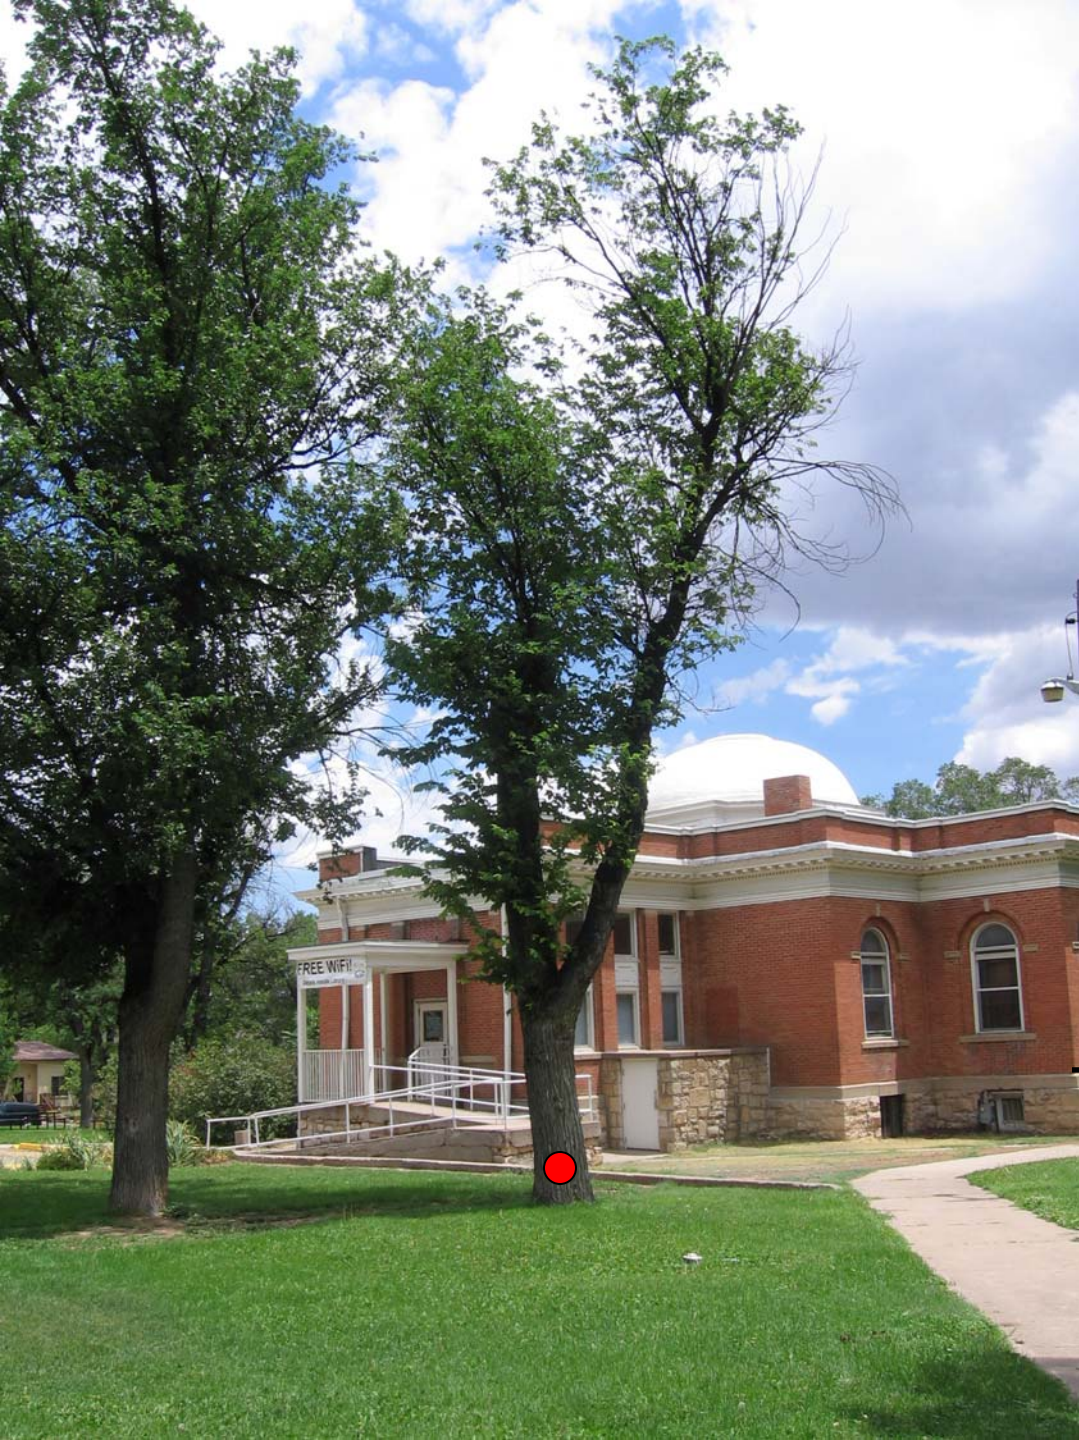
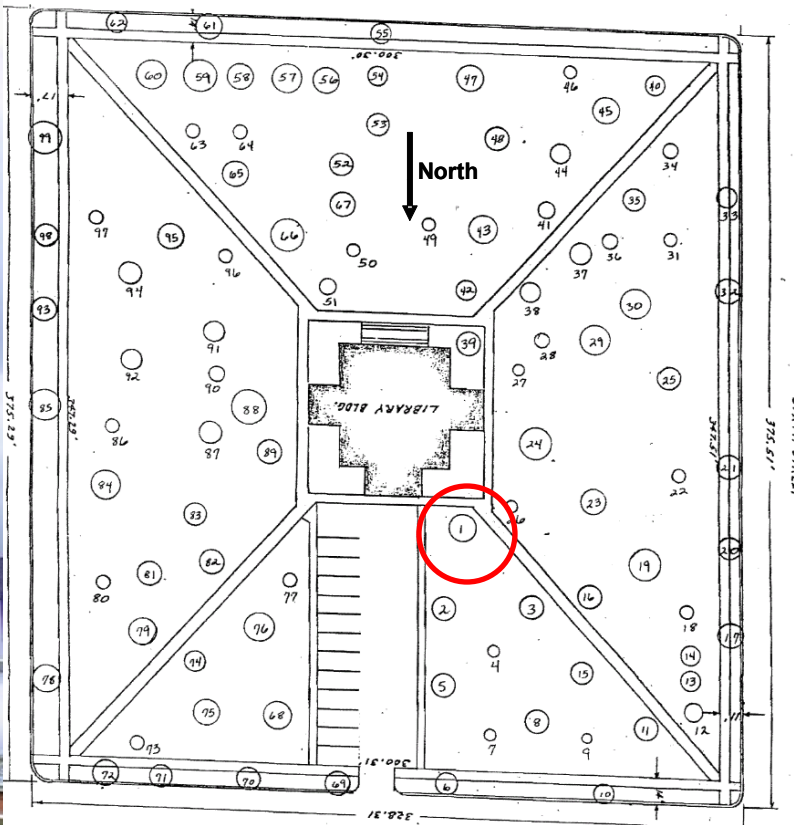
Removal Tree # 14  
Carnegie Park - #1 on diagram  
(red dot paint on trunk)

- Comments:
- Elm, ~ 30' tall.
  - West facing limb presents risk of failure.
  - Main stem has been damaged (topped or broken); insufficient to sustain tree.

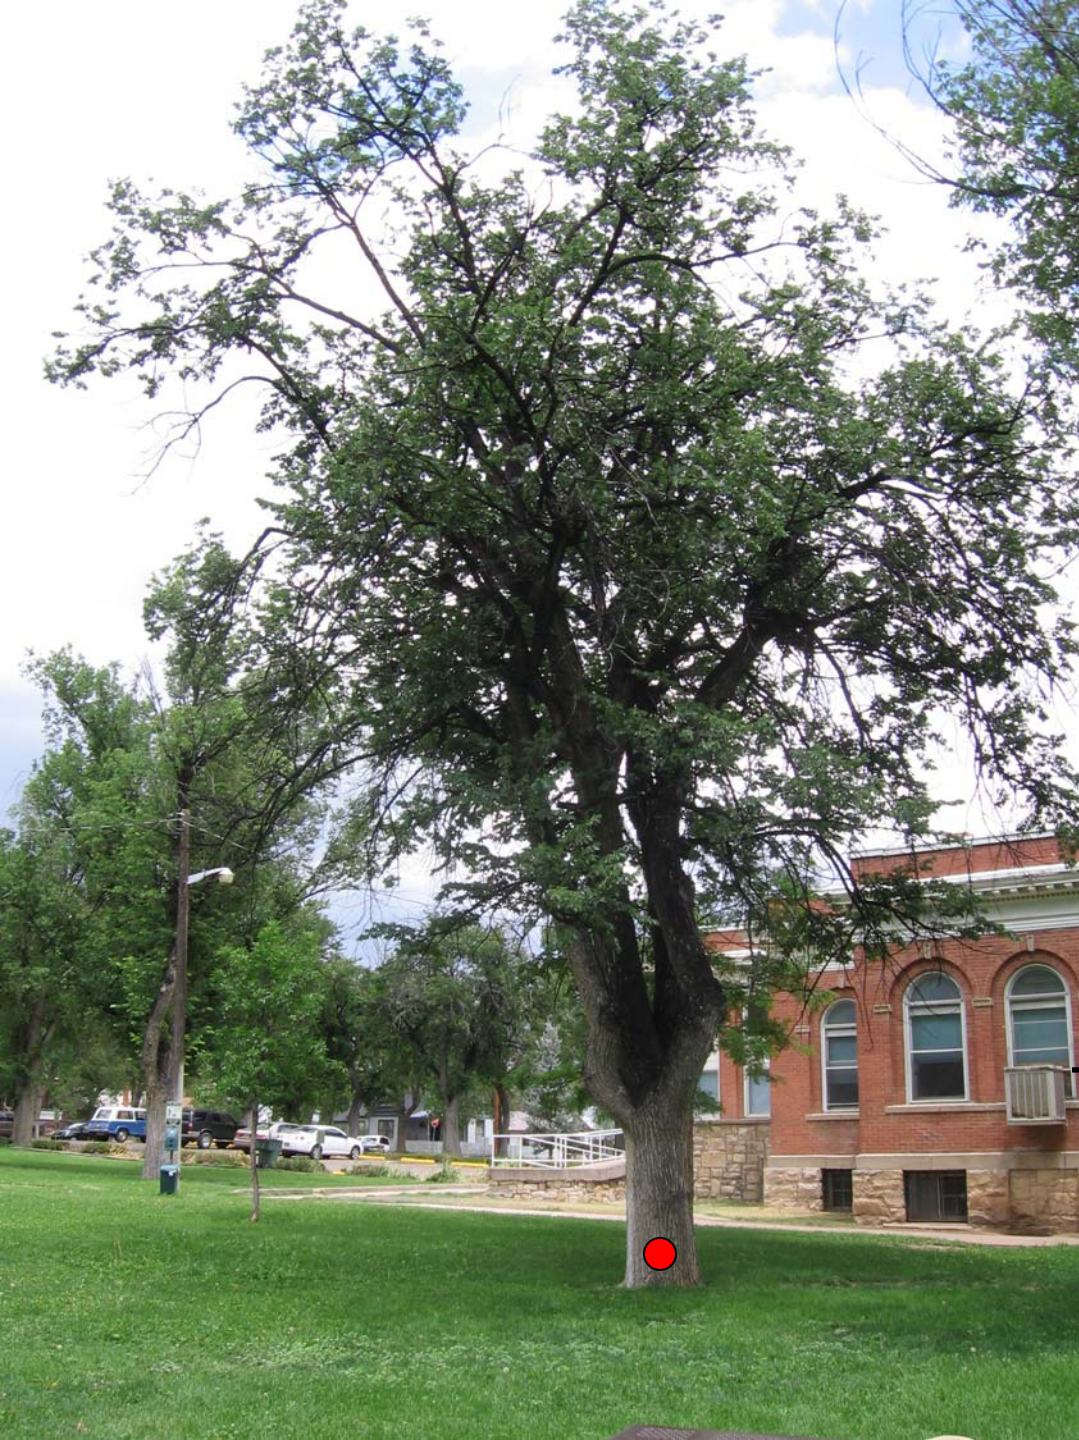
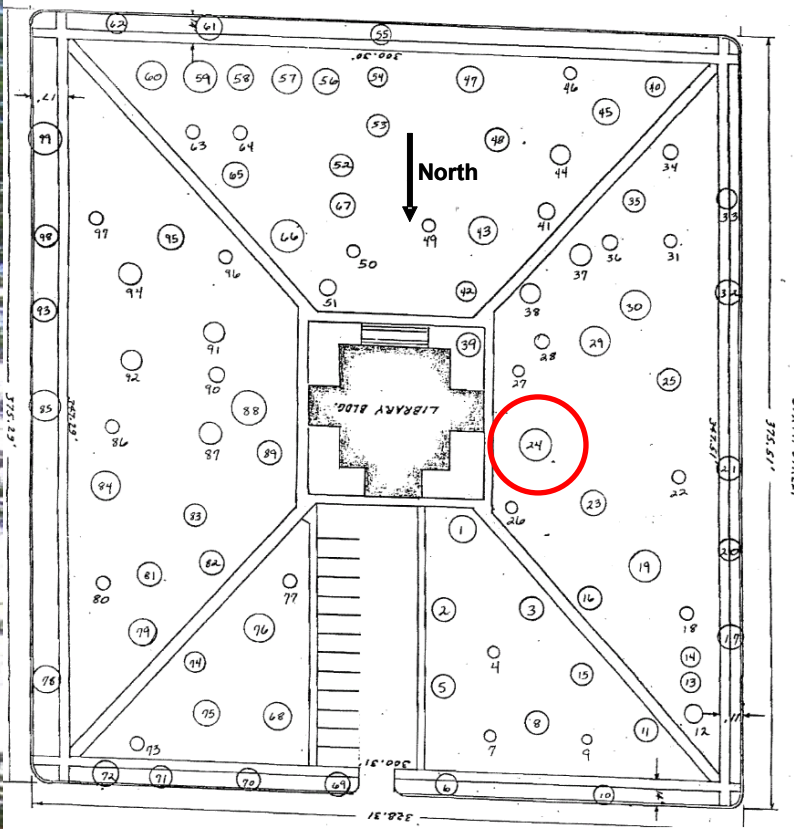
Removal Tree # 15  
Carnegie Park - #24 on diagram  
(red dot paint on trunk)

- Elm, ~ 30'tall.
- Extremely poor structure, with too many large limbs radiating from the same area of stem.
- Signs of weak attachment on one or more limb.

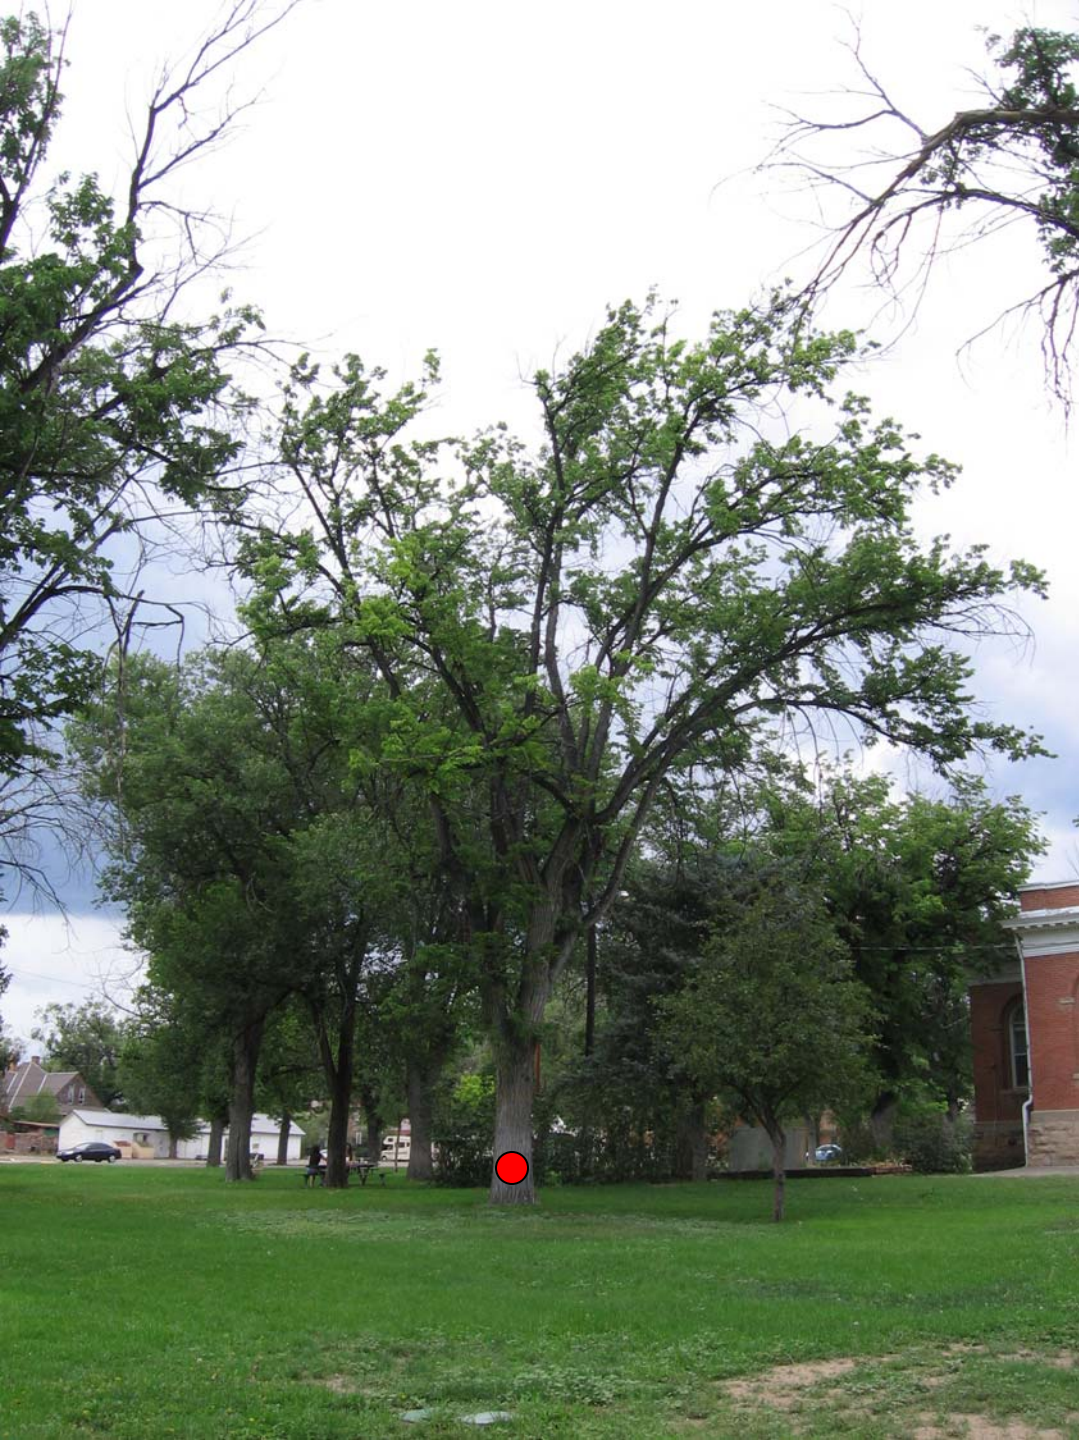
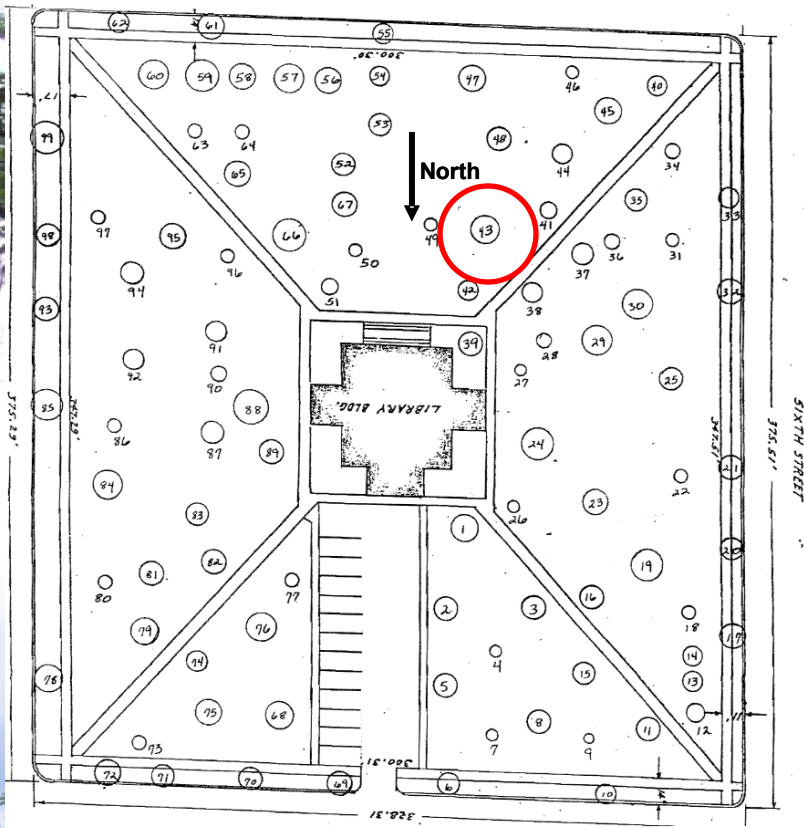
Removal Tree # 16  
Carnegie Park - #43 on diagram  
(red dot paint on trunk)

- Elm, ~ 40'tall.
- Lack of vigor and poor color indicate a tree in distress.
- Decay present.

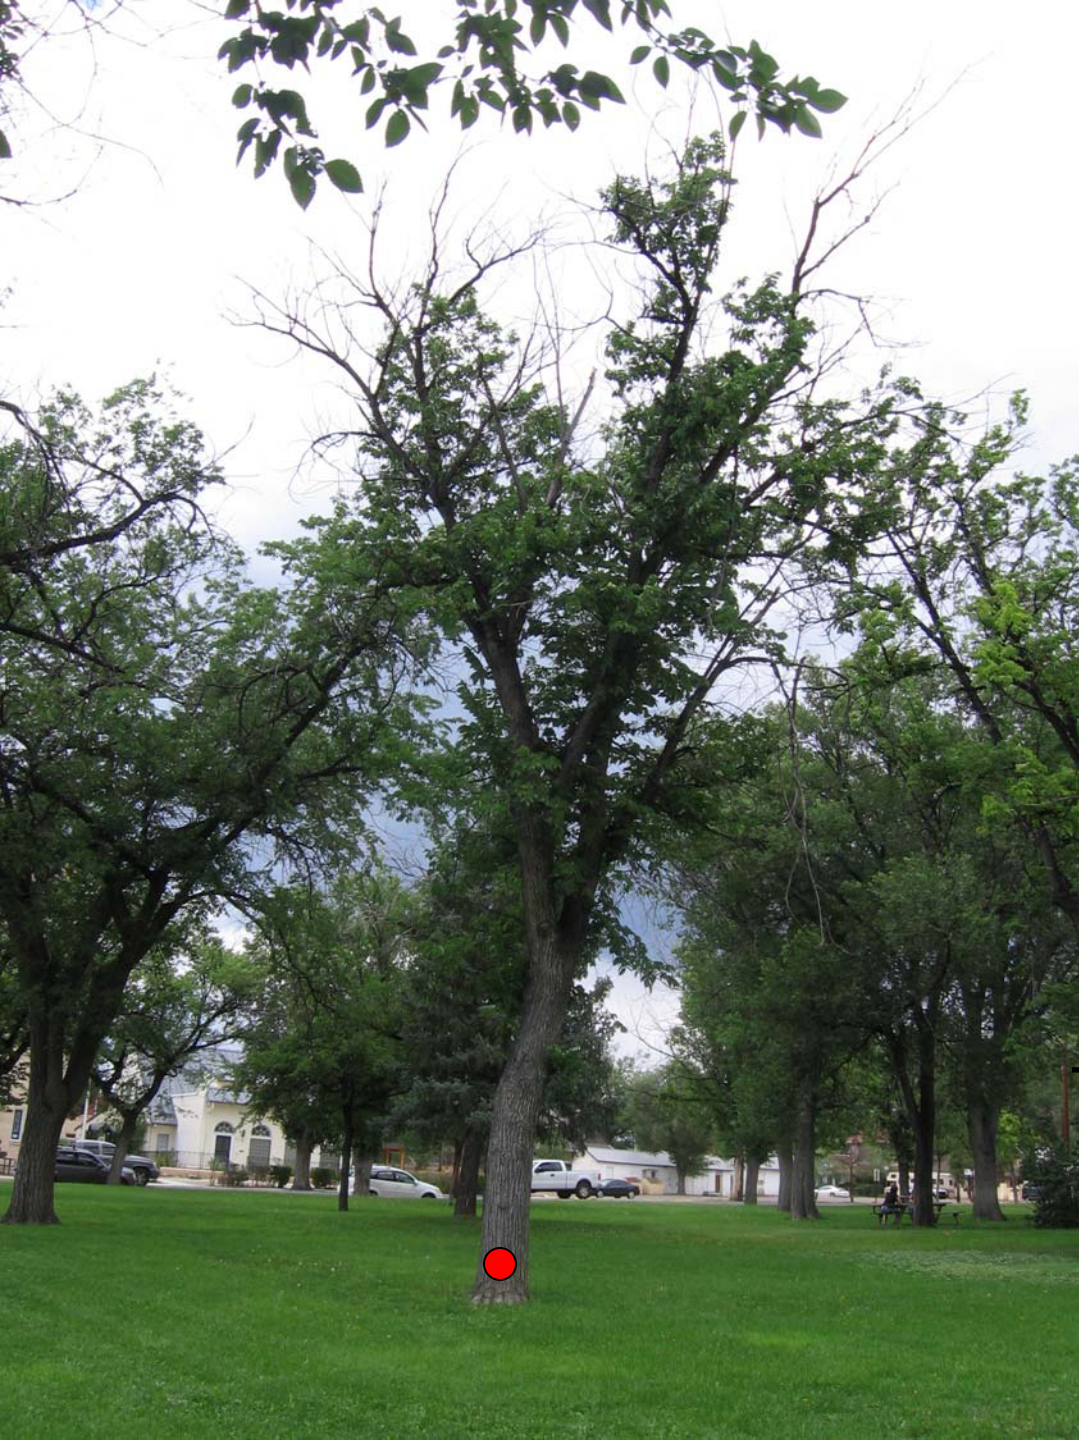
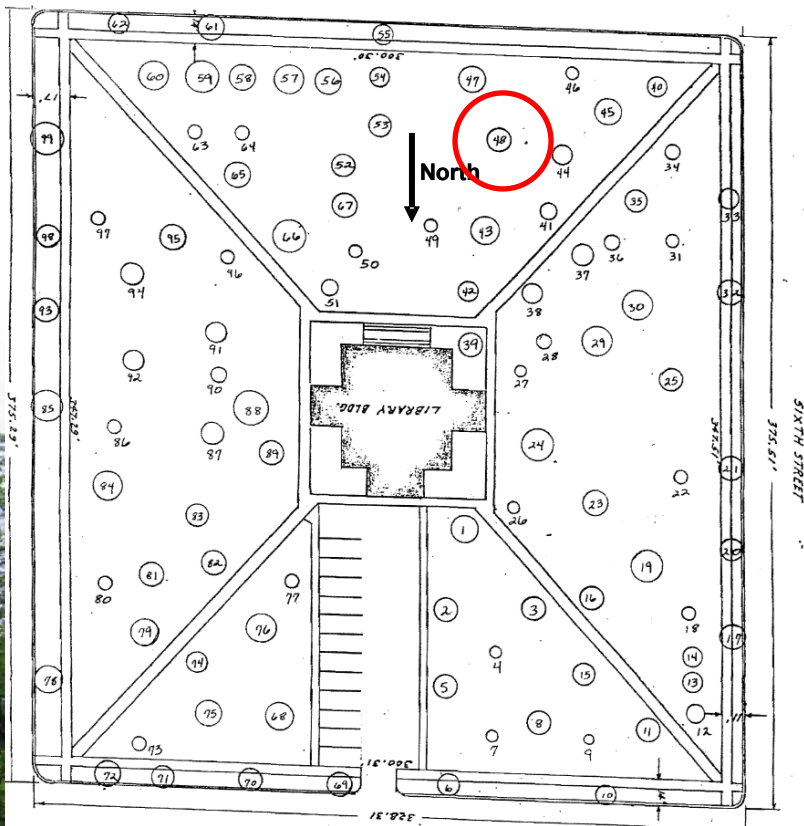
Removal Tree # 17  
Carnegie Park - #48 on diagram  
(red dot paint on trunk)

- 
- Elm, 25 – 30'tall.
- Significant deadwood, lack of vigor.
- Lean may indicate further problems.

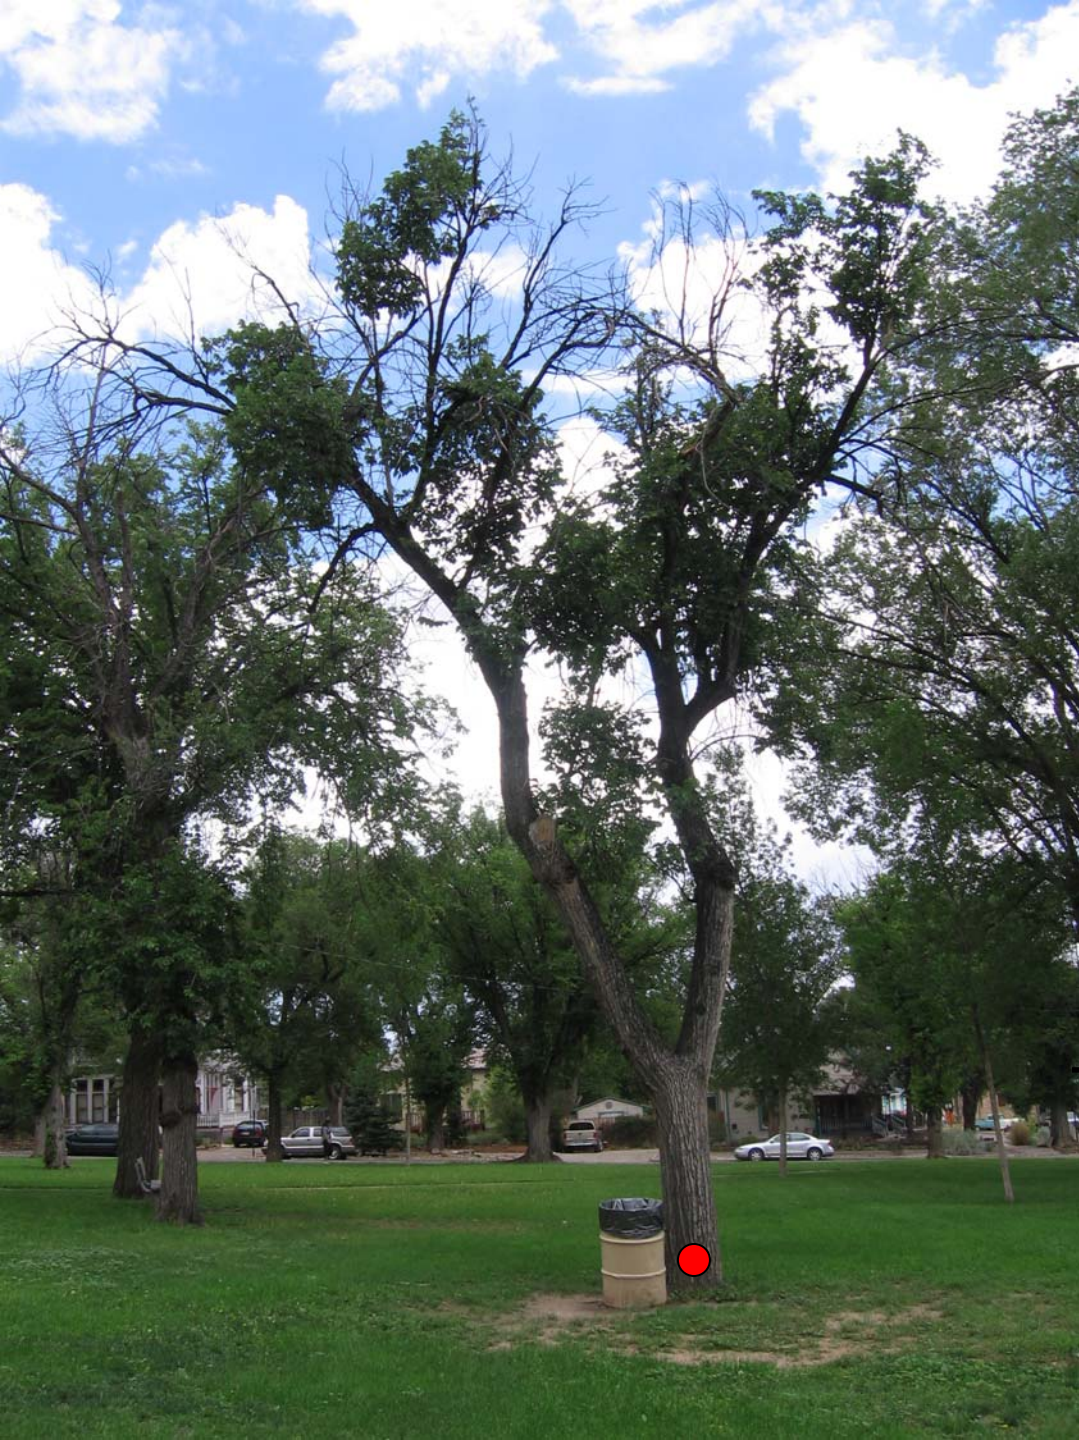
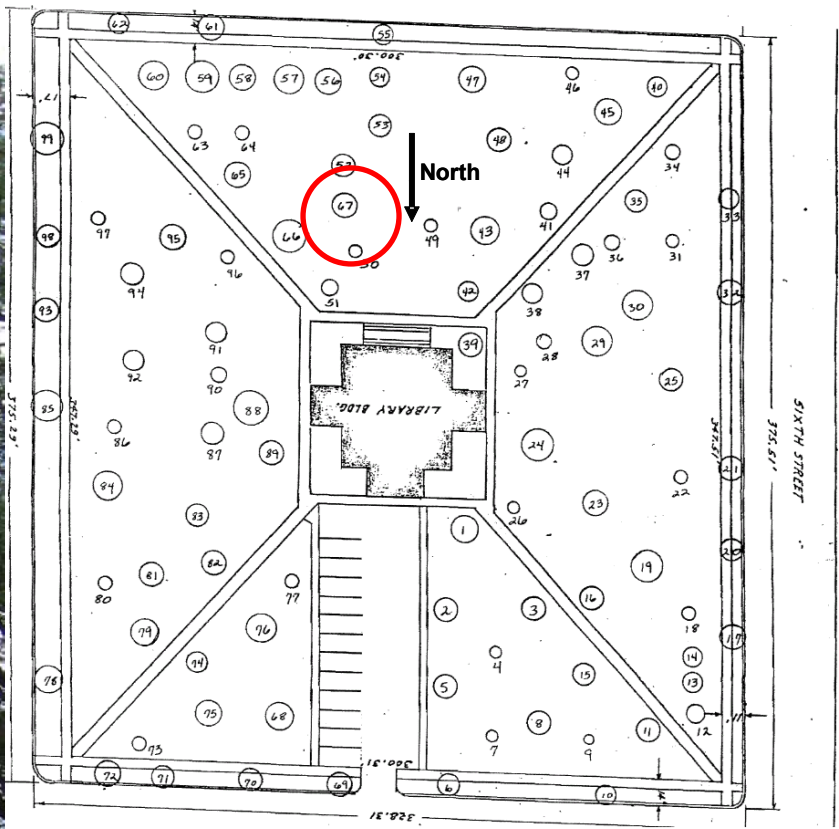
Removal Tree # 18  
Carnegie Park - #67 on diagram  
(red dot paint on trunk)

- Elm, ~ 25 – 30' tall.
- Lack of canopy and vigor.
- Wound at ~ 12' in one major limb.

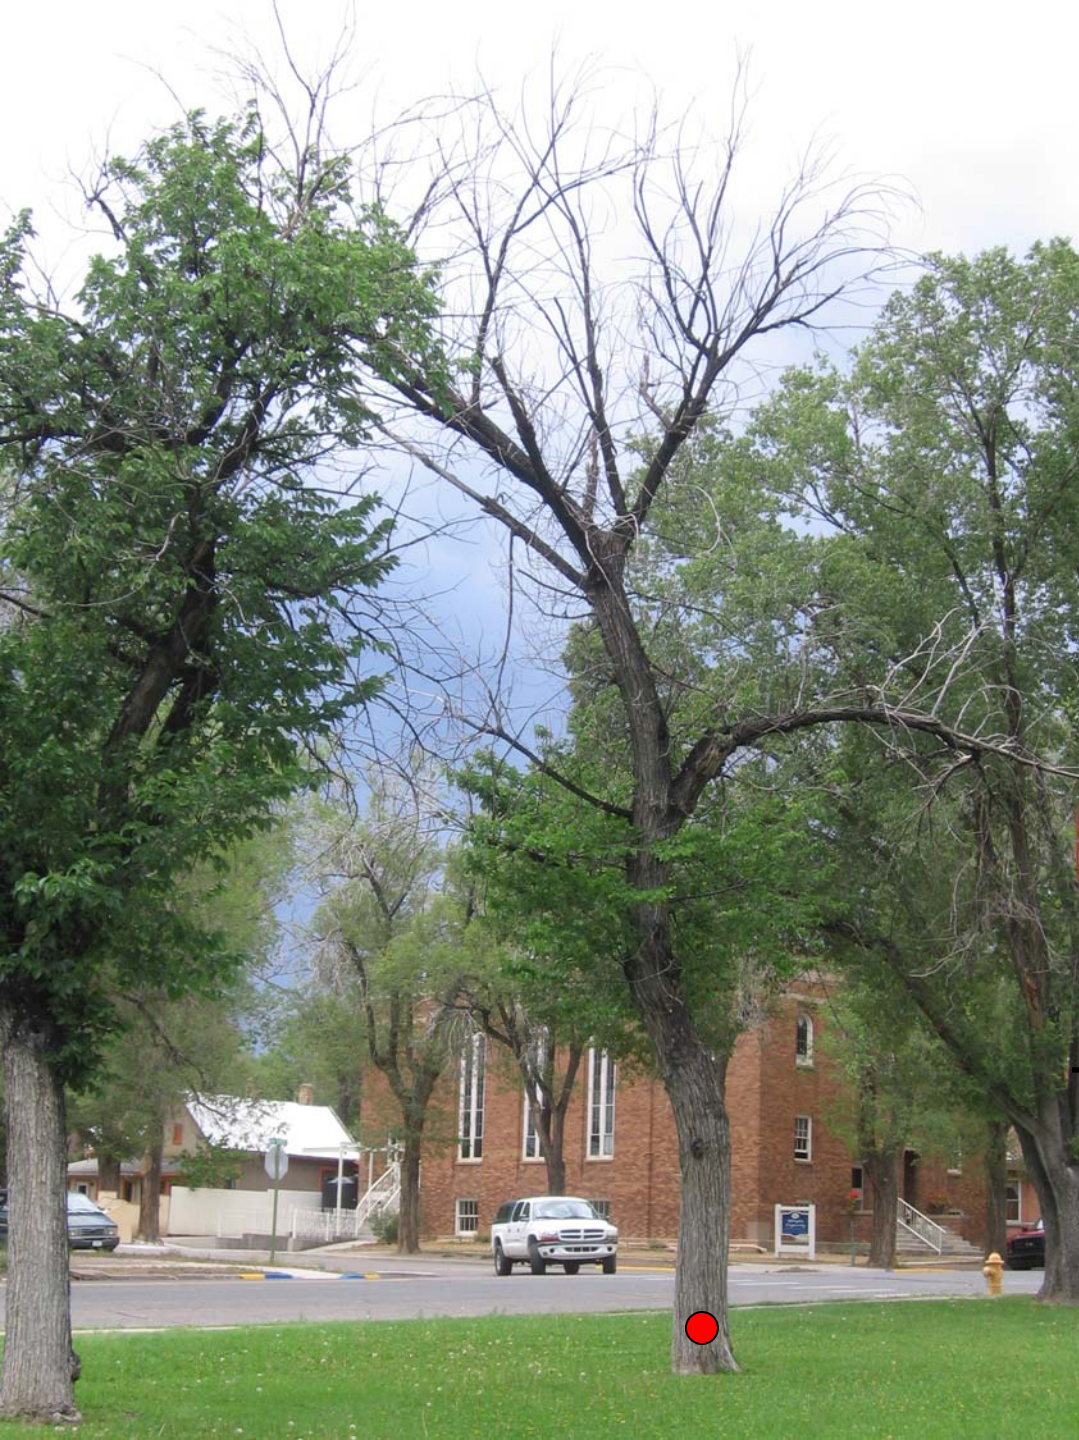
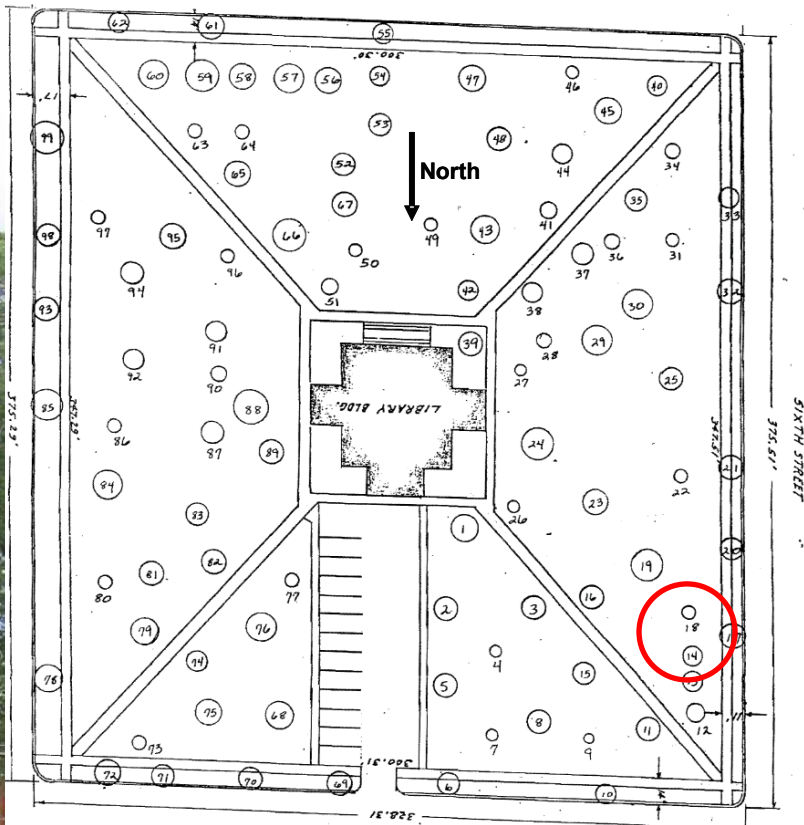
Removal Tree # 19  
Carnegie Park - #14 on diagram  
(red dot paint on trunk)

- Probable elm, ~ 30' tall.
- Dead top 20', with a fringe of epicormic shoots only at ~ 10'.

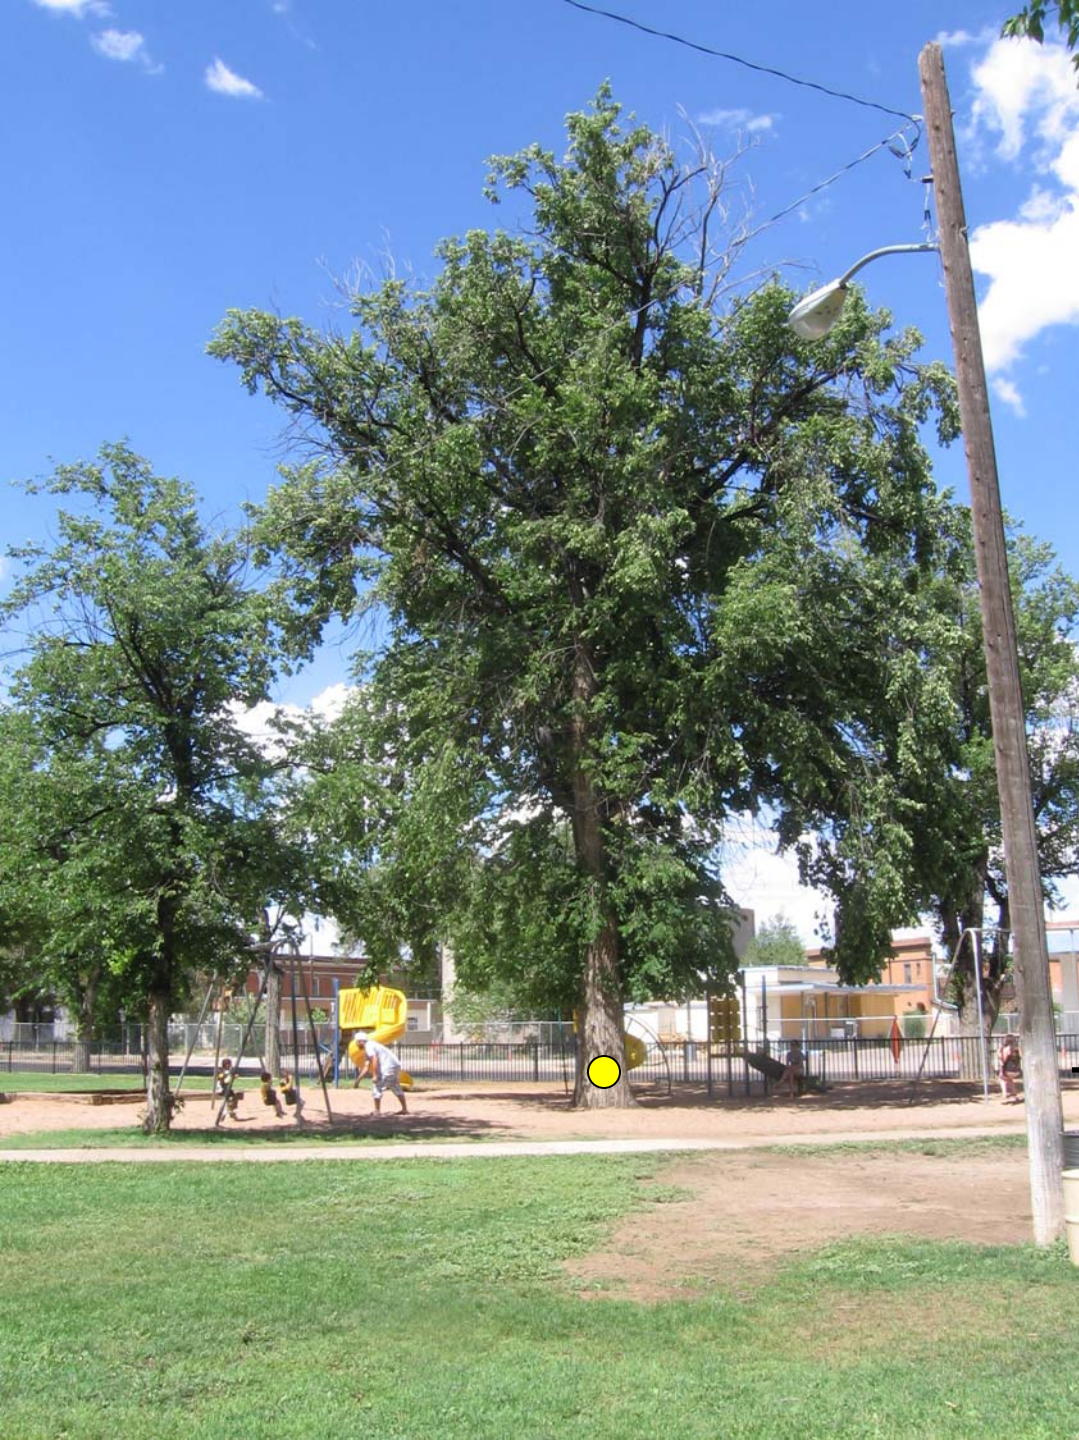
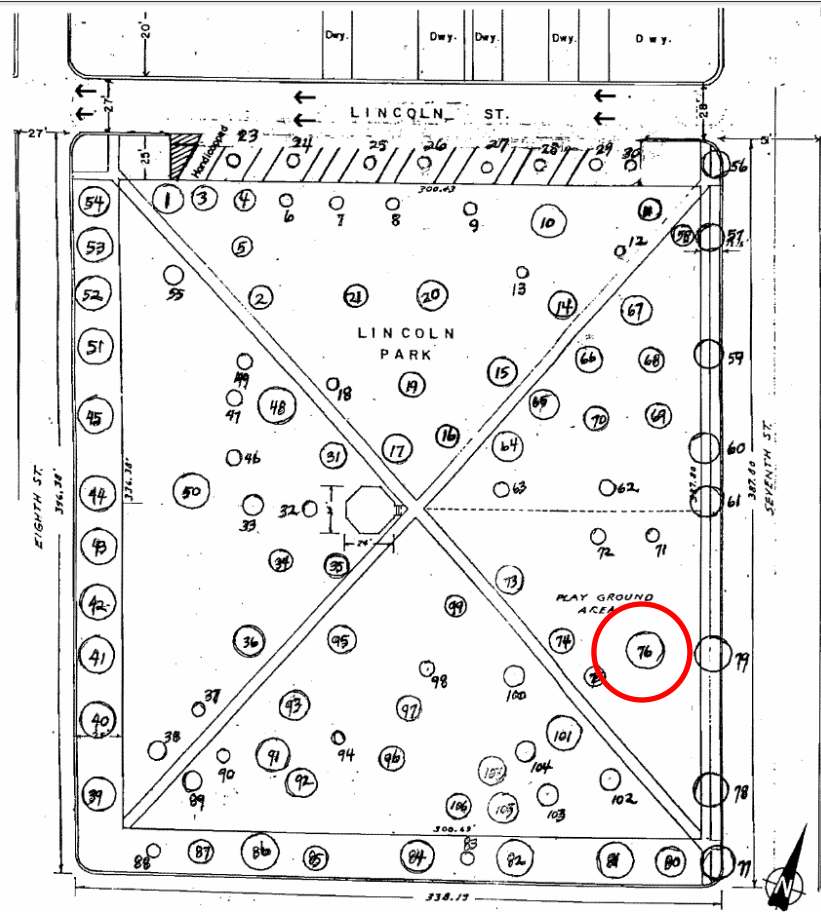
Pruning Tree # 1  
Lincoln Park - #76 on diagram  
(yellow dot paint on trunk)

- Elm, ~50' tall, provides significant playground shade
- Needs crown cleaning, crown thinning, selective structural pruning
- Goal is to improve safety and retention
