# Appendix A

## Las Vegas, NM Urban Forest Project

### Candidate Trees for Removal

# Appendix B

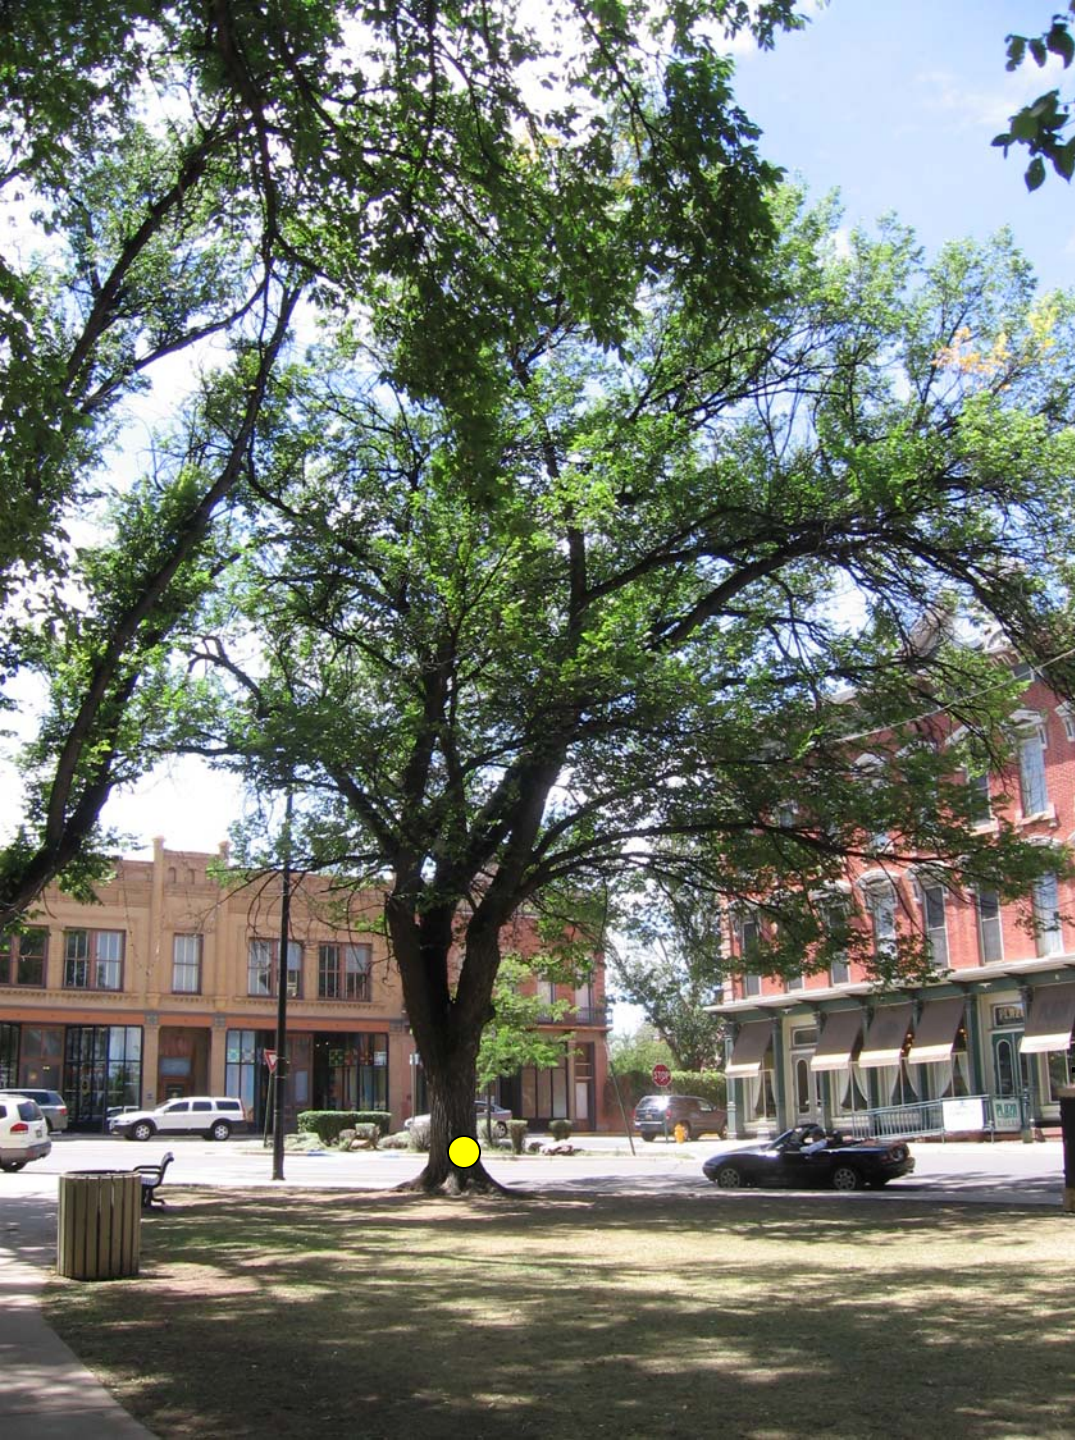
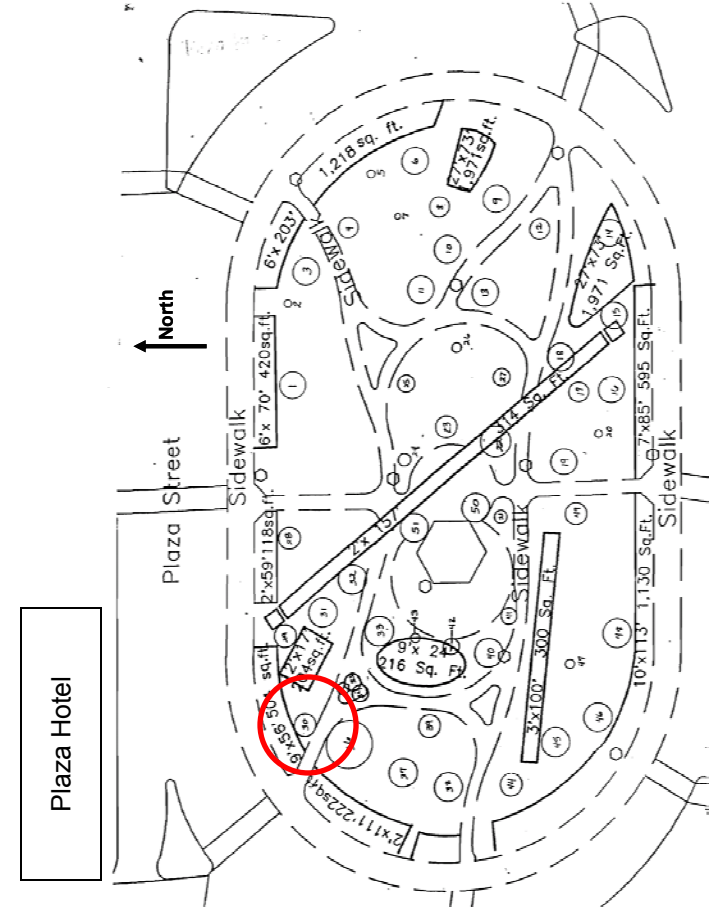
Pruning Tree # 2  
 Plaza Park - #30 on diagram  
 (yellow dot paint on trunk)

- Elm, 40-50' tall
- Street tree, anchors Plaza Park corner
- Needs crown cleaning and reduction of weight on limbs overhanging street, parked cars, pedestrian walkways and next to street lamp.
- Goal is to reduce street side limb failure risk in target-rich environment.

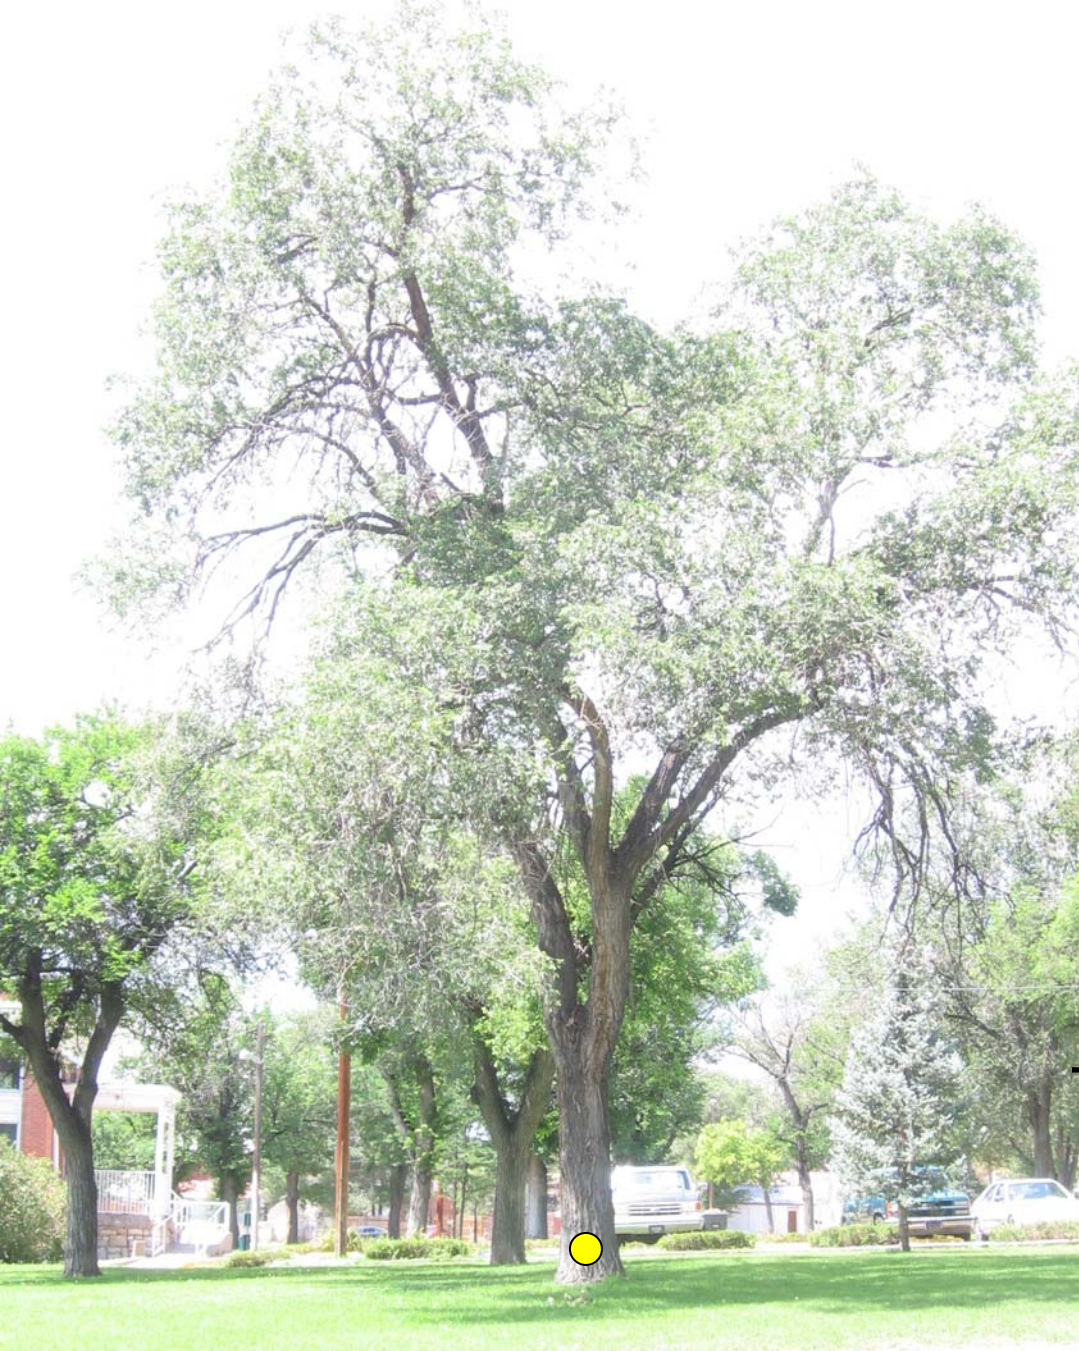
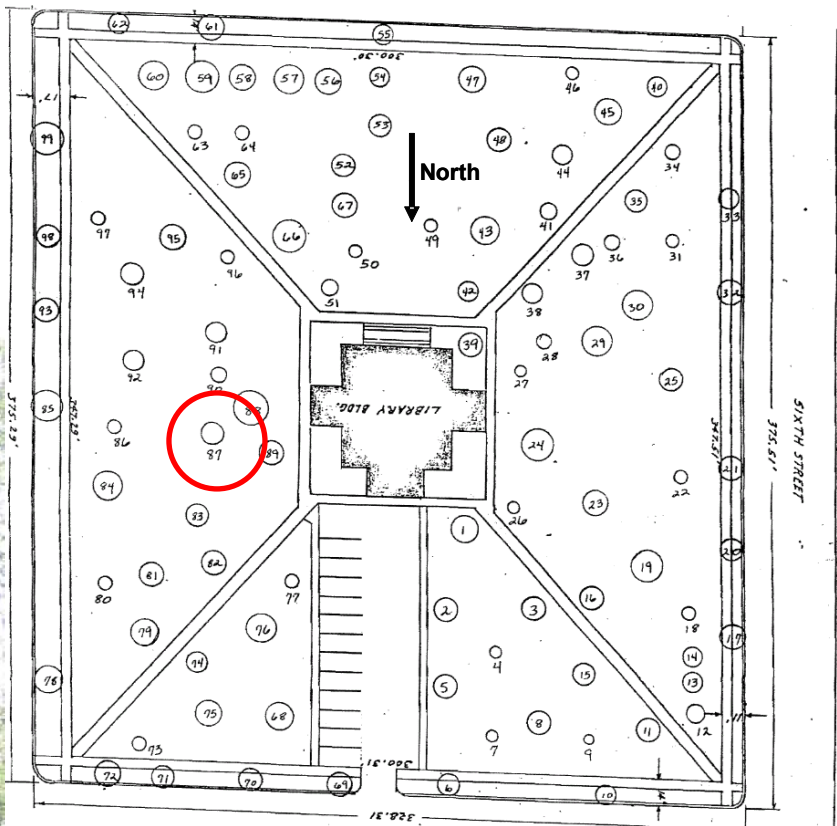
**Pruning Tree # 3**  
**Carnegie Park - #87 on diagram**  
**(yellow dot paint on trunk)**

- Elm, 55-60' tall
- Significant park tree
- Needs crown cleaning and aerial inspection to identify and remediate any significant problems detected.
- Goal is to improve retention of tree

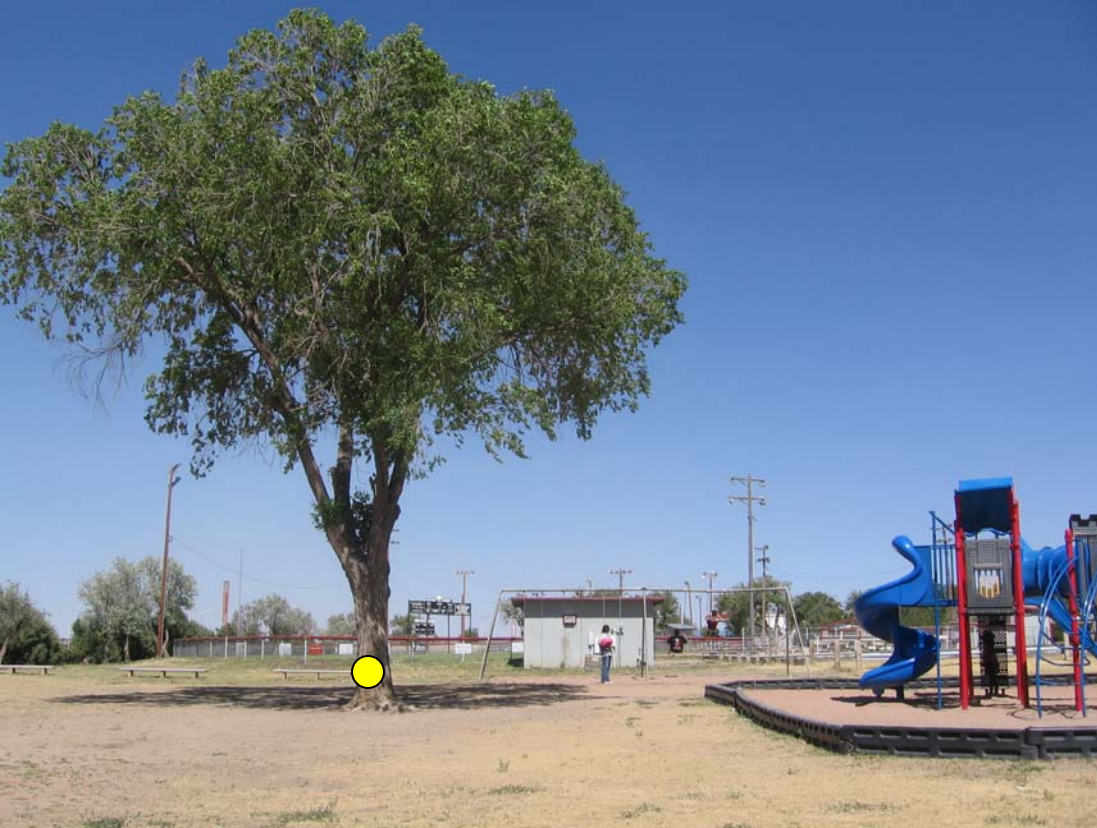
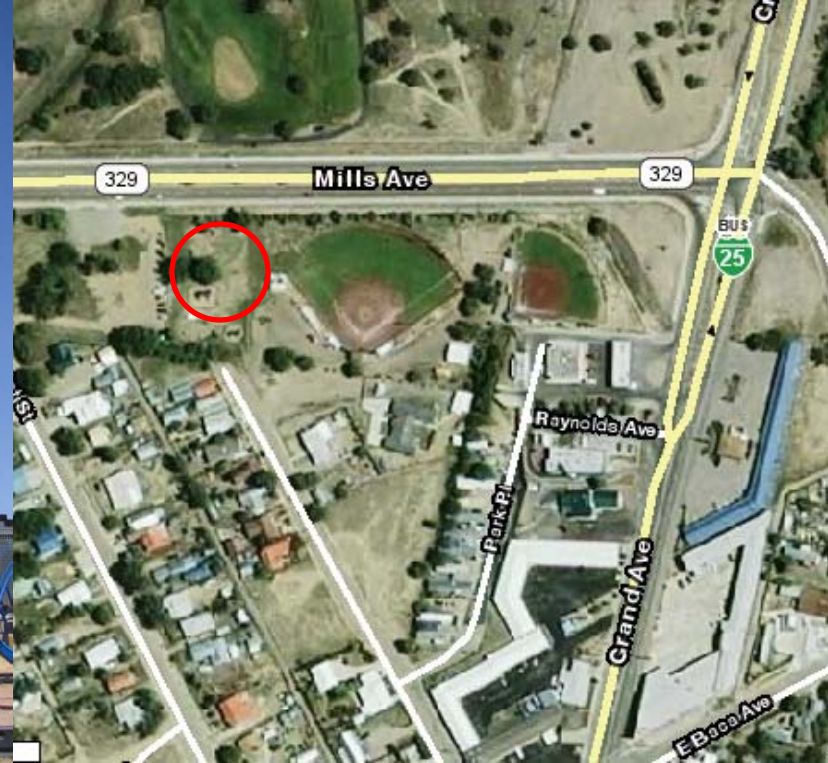
**Pruning Tree # 4**  
Keys Park - #NN on diagram  
(yellow dot paint on trunk)

- Elm, ~40' tall
- Significant tree; the only shade in playground area.
- Needs crown thinning and restoration (from bad cuts).
- Remove lower stem of codominant limb, on NE side, ~ 25' up.
- Goal is to improve safety and retention of tree.

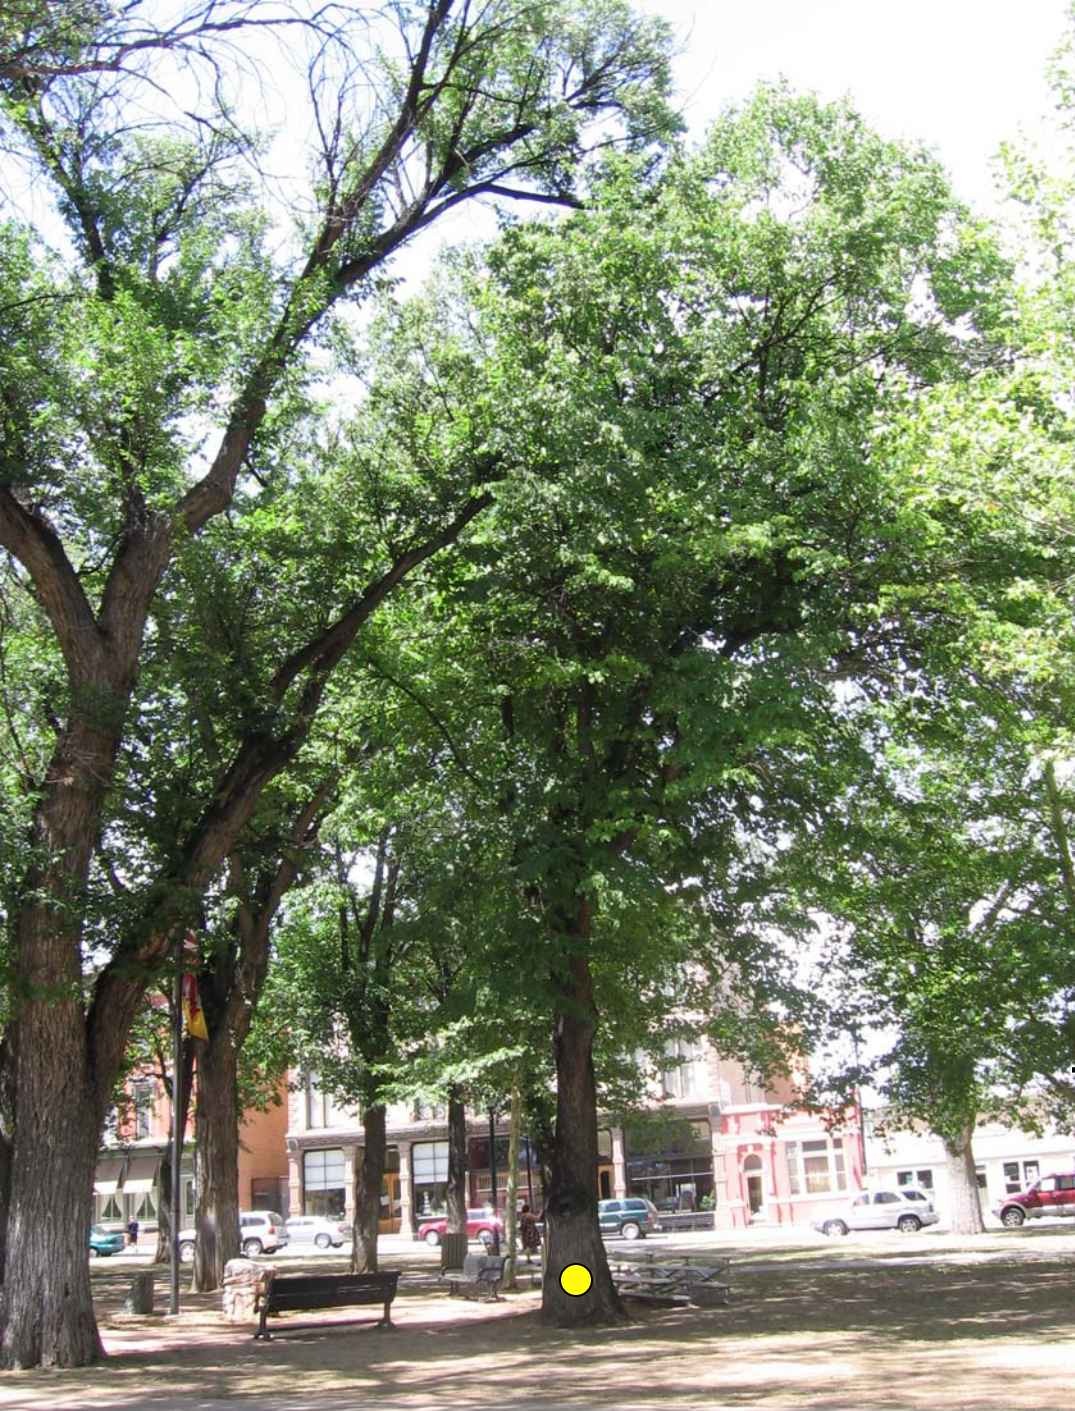
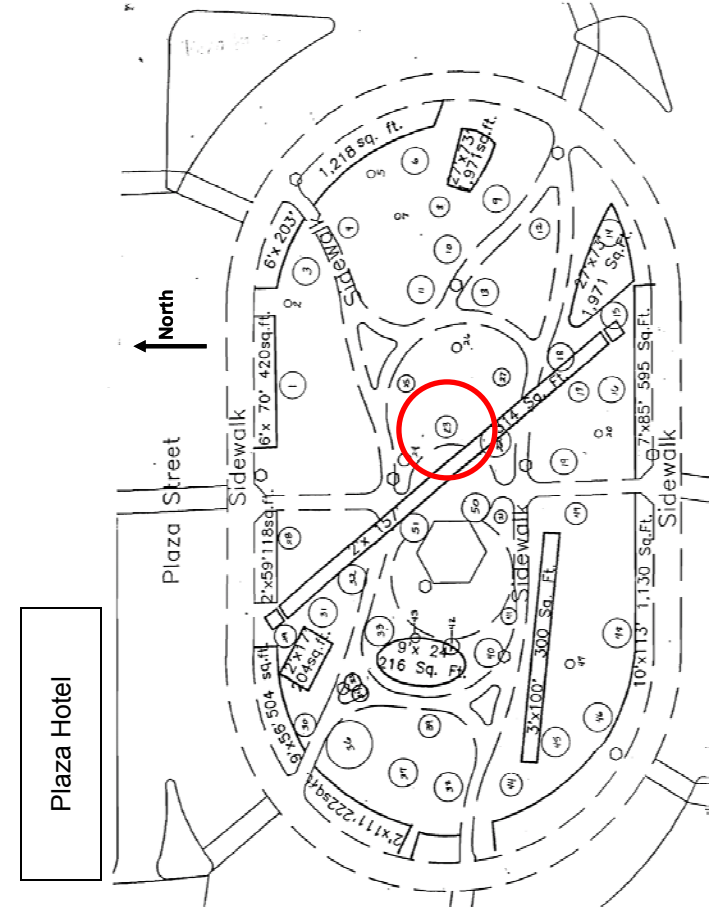
Pruning Tree # 5  
Plaza Park - #23 on diagram  
(yellow dot paint on trunk)

- Elm, ~ 30 – 40' tall
- Thin canopy to reduce wind drag through tree.
- Despite evidence of some decay, an otherwise healthy appearing tree of value to park.

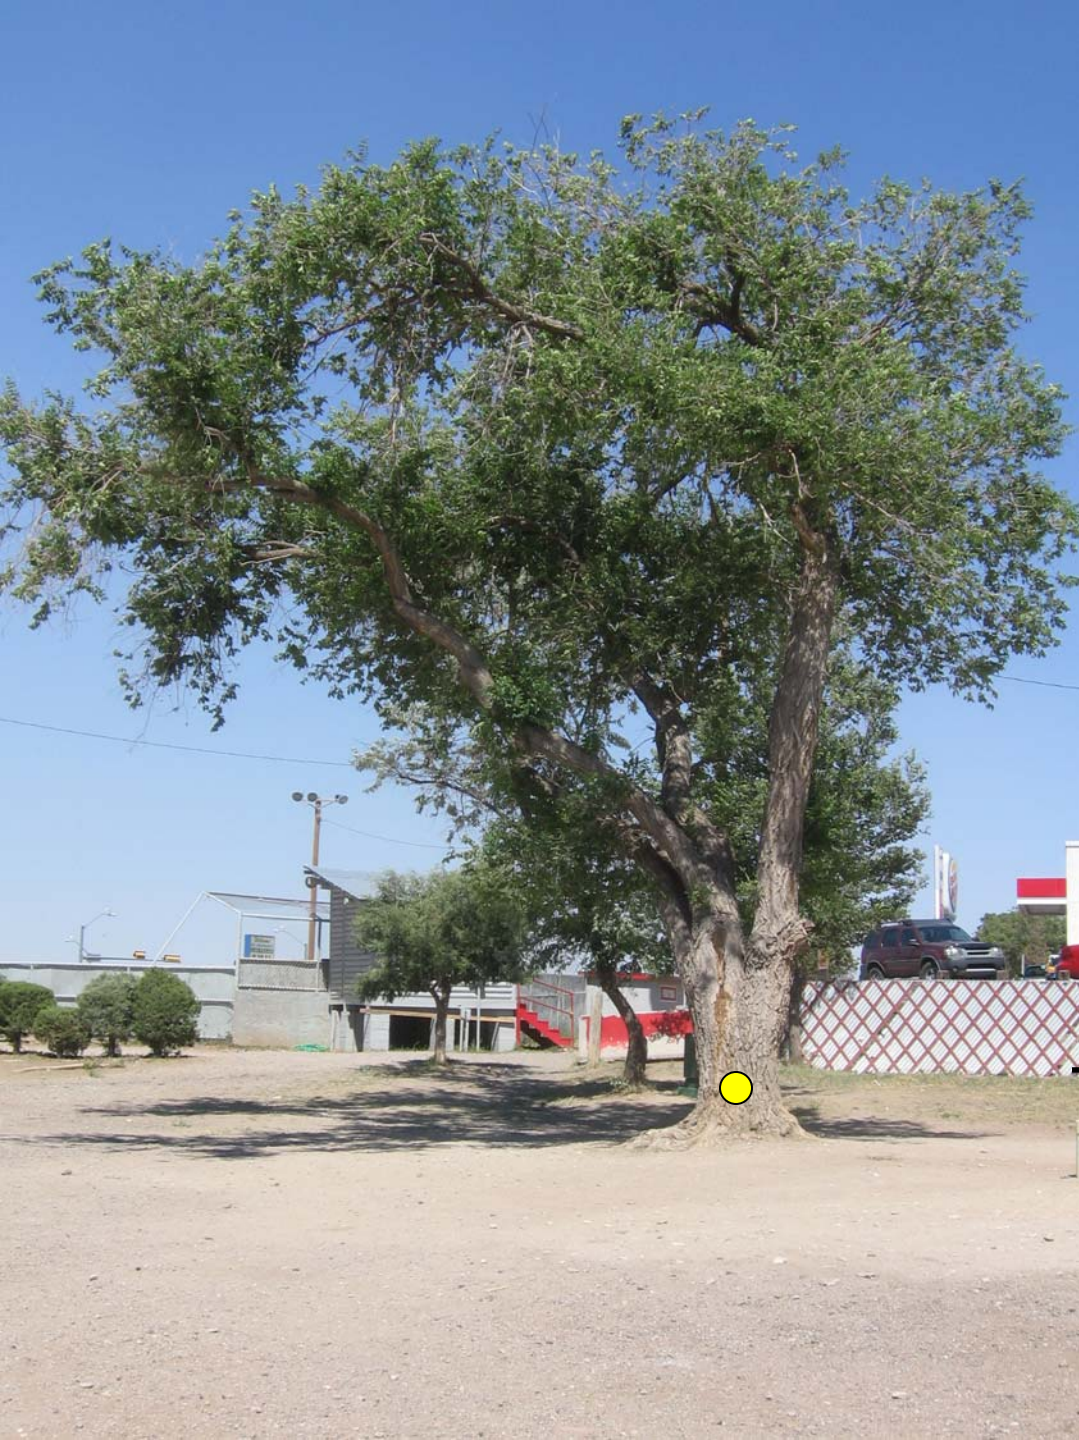
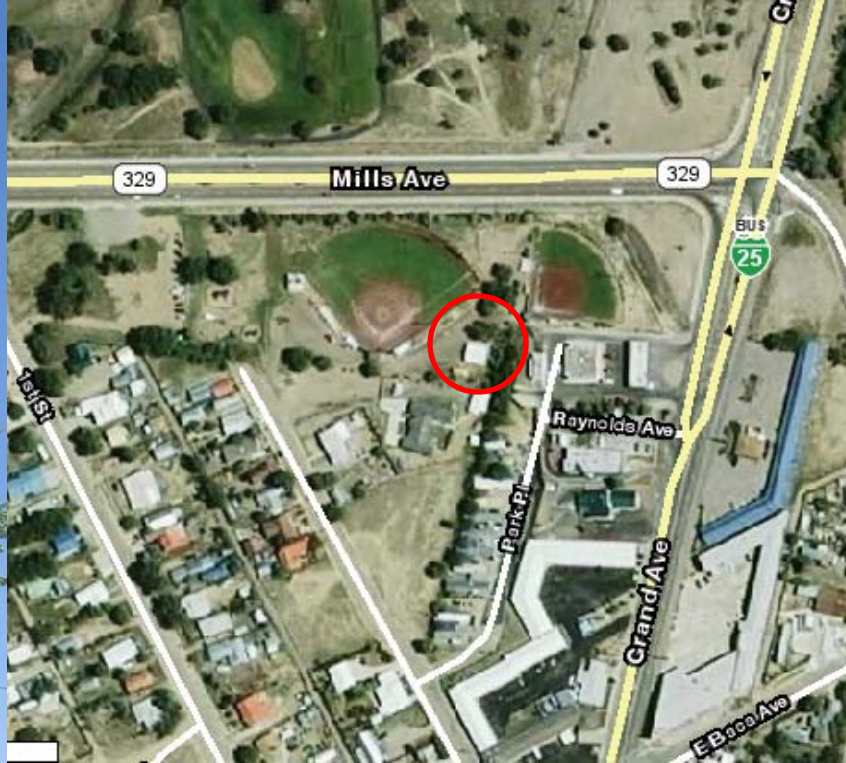
Pruning Tree # 6  
Keyes Park - #129 on diagram  
(yellow dot paint on trunk)

- Elm, ~ 30' tall.
- Structural pruning reduce weight of limbs on west side of tree.
- Clean and restore crown (prune damage and poor pruning cuts).
- Goal is to reduce risk of poor weight distribution and retain tree. This tree has flaws but is deemed important to the site..

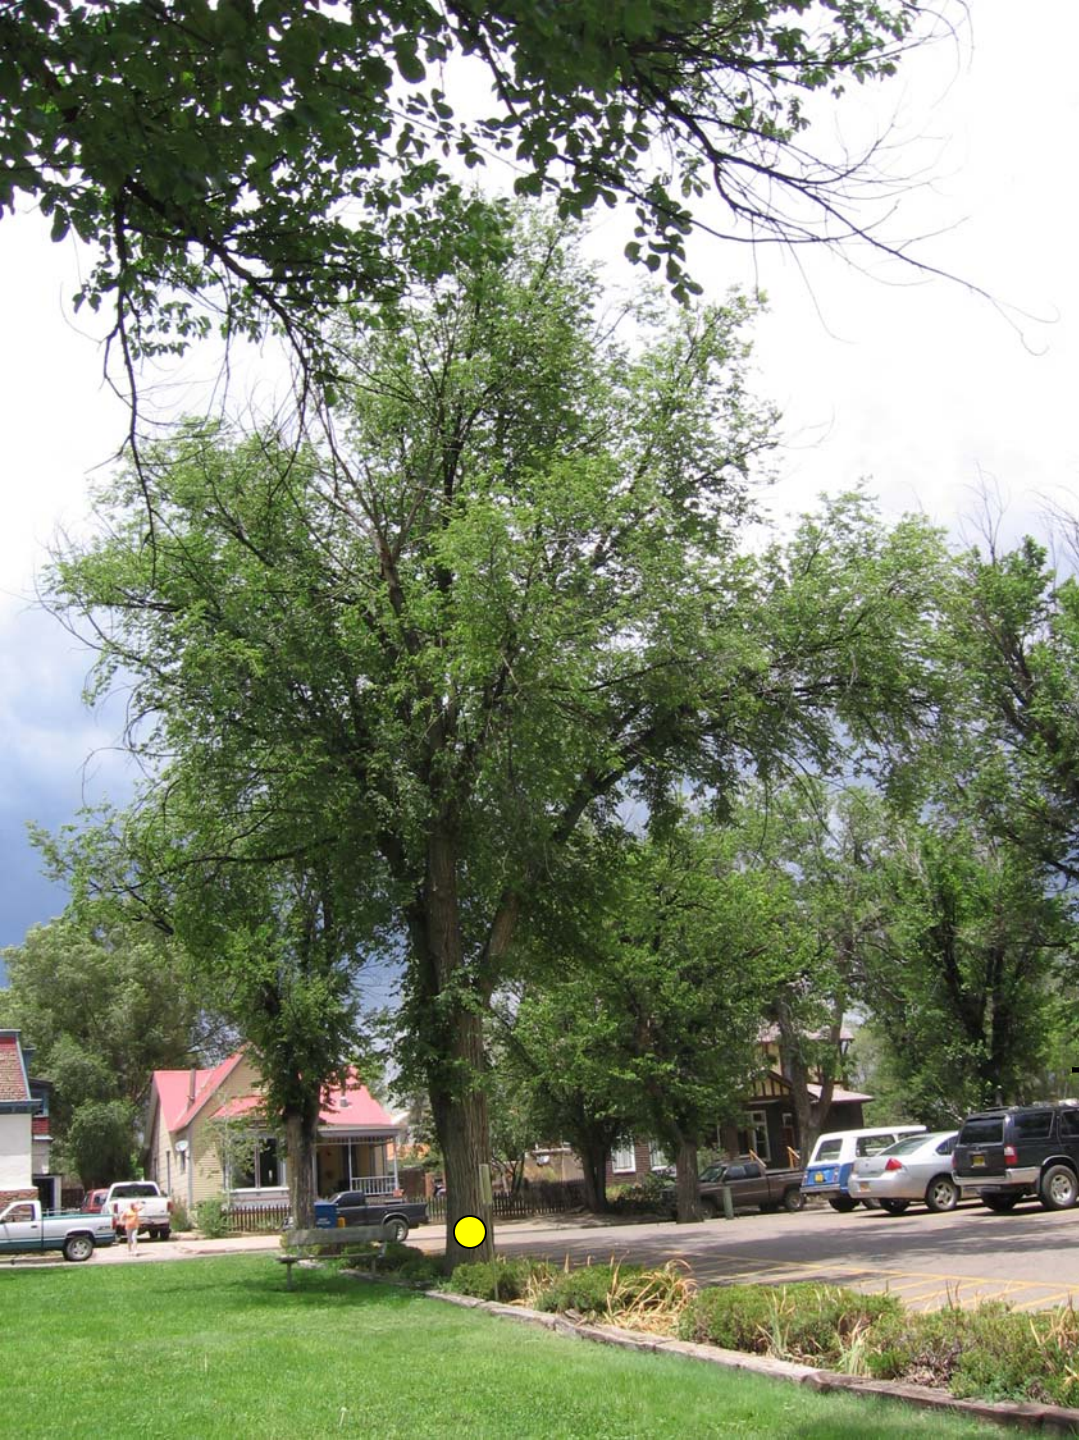
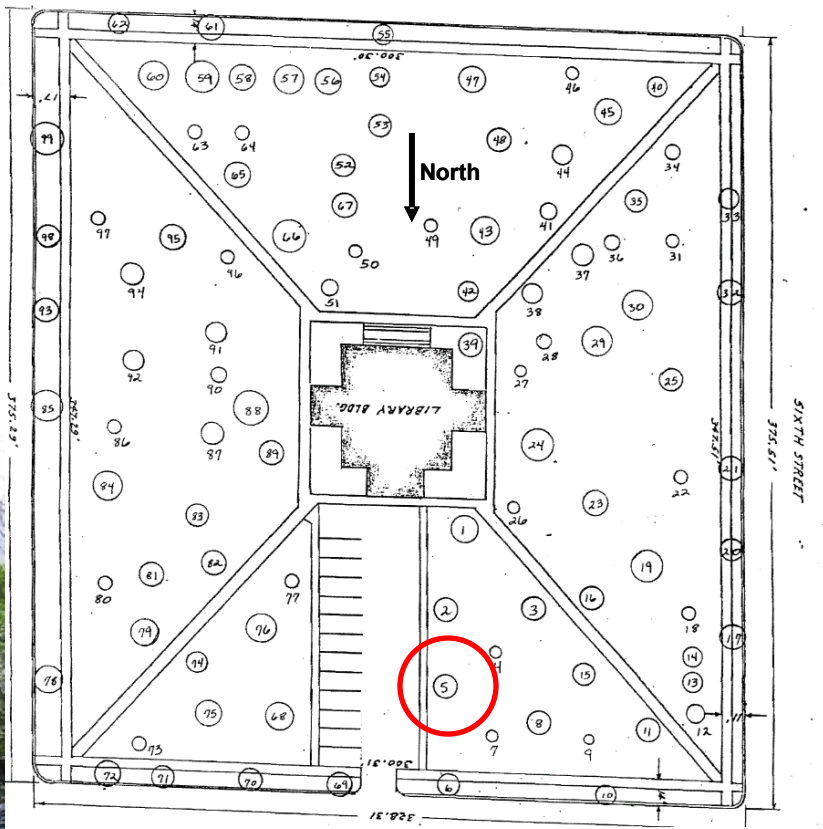
Pruning Tree # 7  
Carnegie Park - #5 on diagram  
(yellow dot paint on trunk)

- Elm, ~ 30' tall
- Clean and thin crown, prune west side of tree over parking lot.
- Goal is to reduce risk to cars and pedestrians in parking lot.

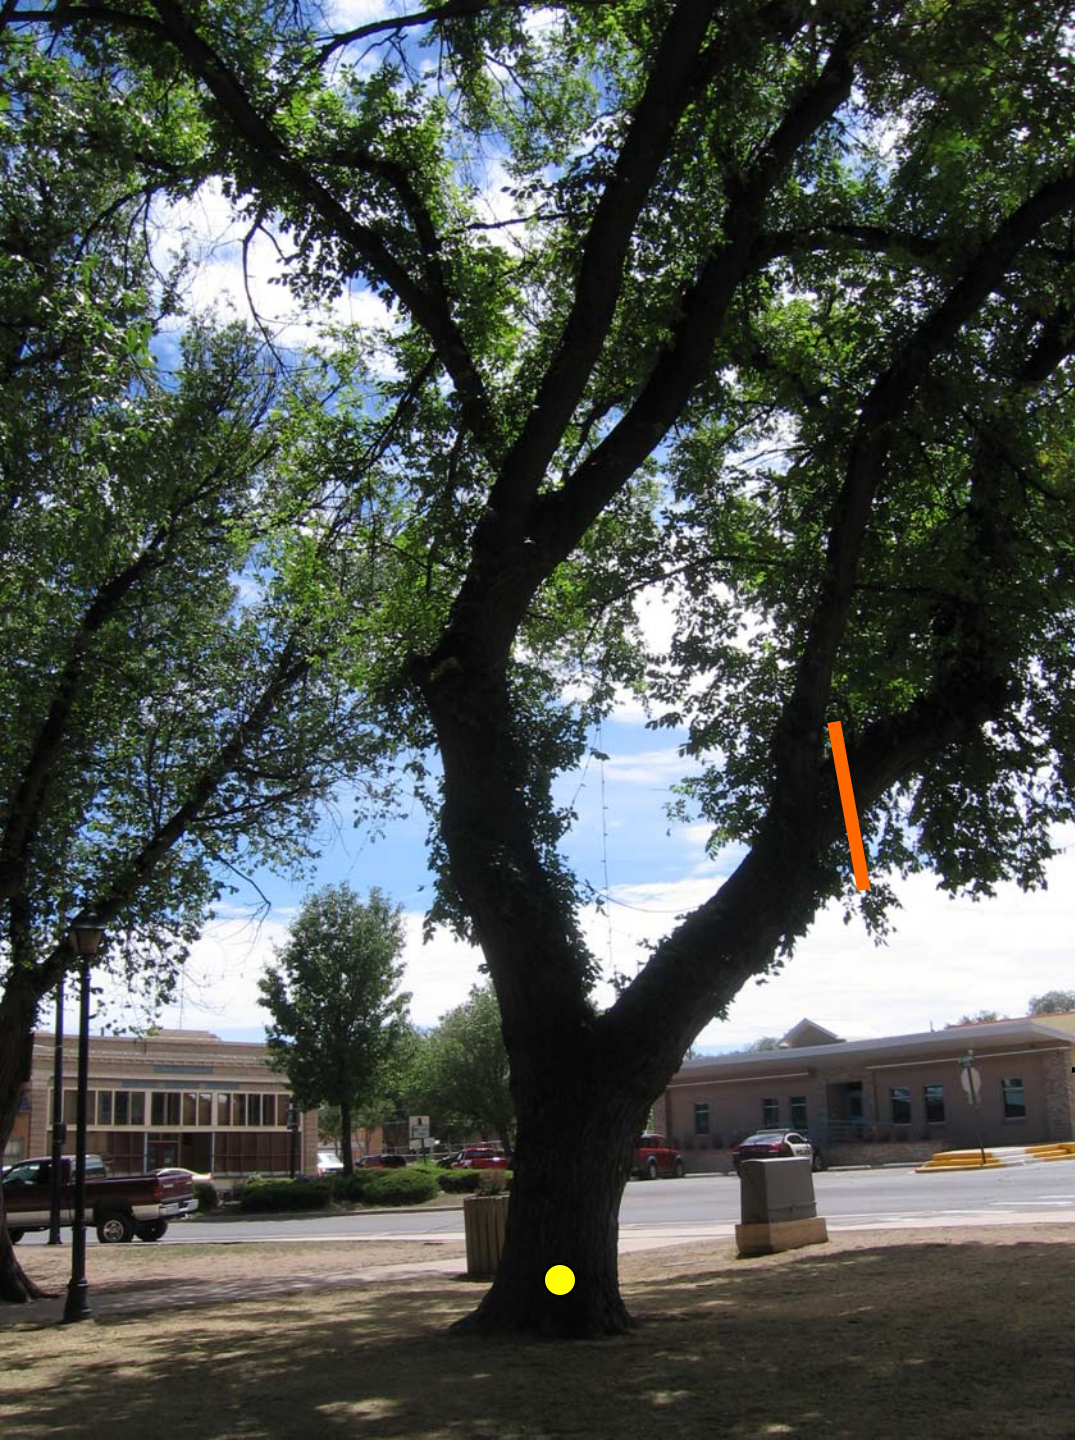
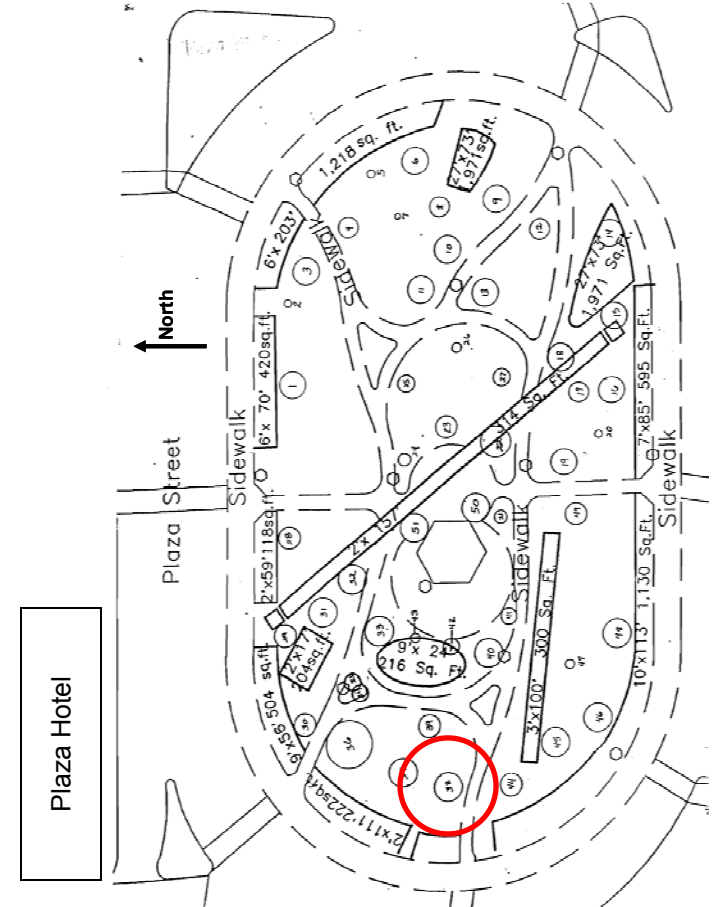
Pruning Tree # 10  
 Plaza Park - #38 on diagram  
 (yellow dot paint on trunk)

- Elm, ~ 30' tall
- Prune limb where indicated to reduce weight on limb.
- Clean and thin crown, as needed.
- Goal is to remediate a poor weight distribution (due to poor structure ) and reduce risk to park users and pedestrians.

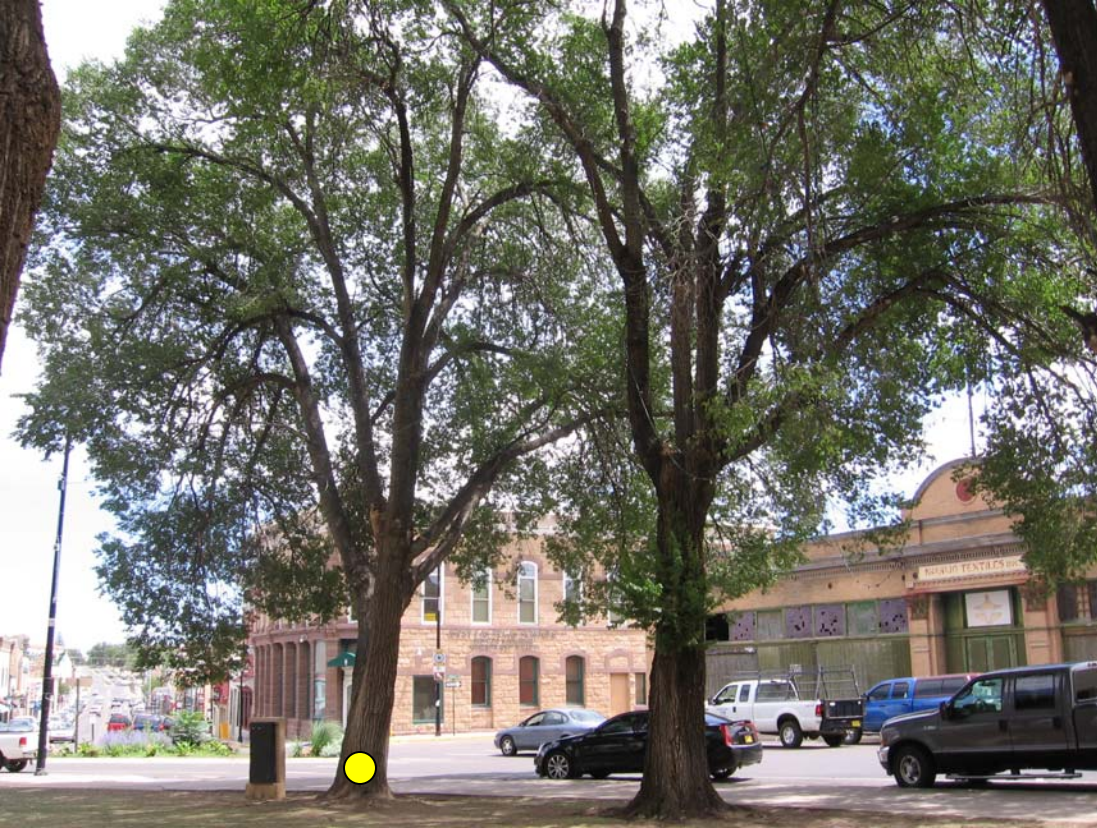
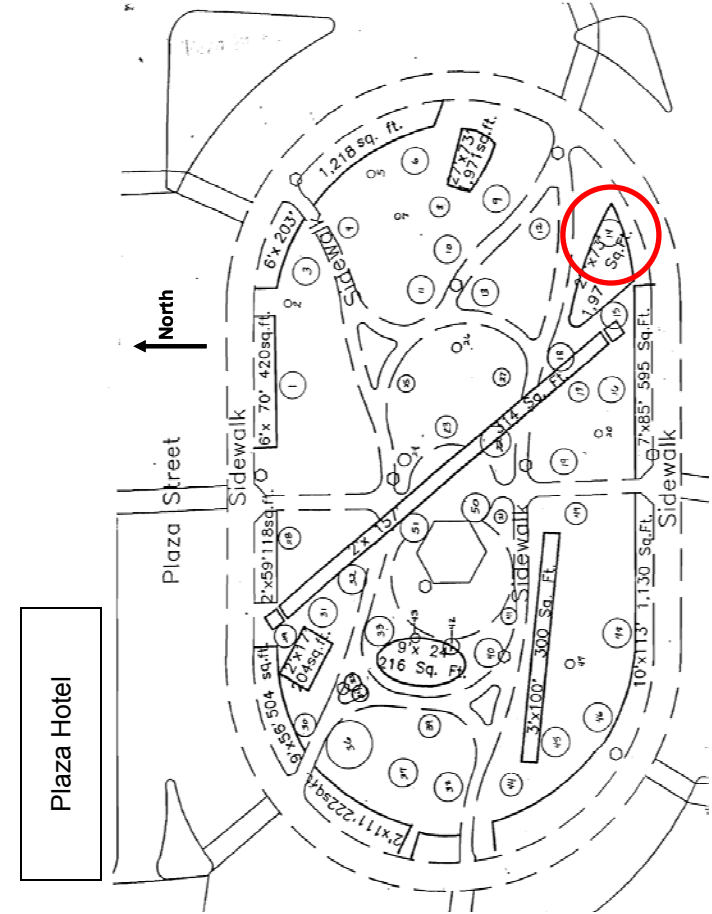
Pruning Tree # 12  
 Plaza Park - #14 on diagram  
 (yellow dot paint on trunk)

- Elm, 30 to 40' tall
- Prune to reduce overhang on south side.
- Goal is to reduce risk of limb failure on target-rich side (cars and pedestrians)

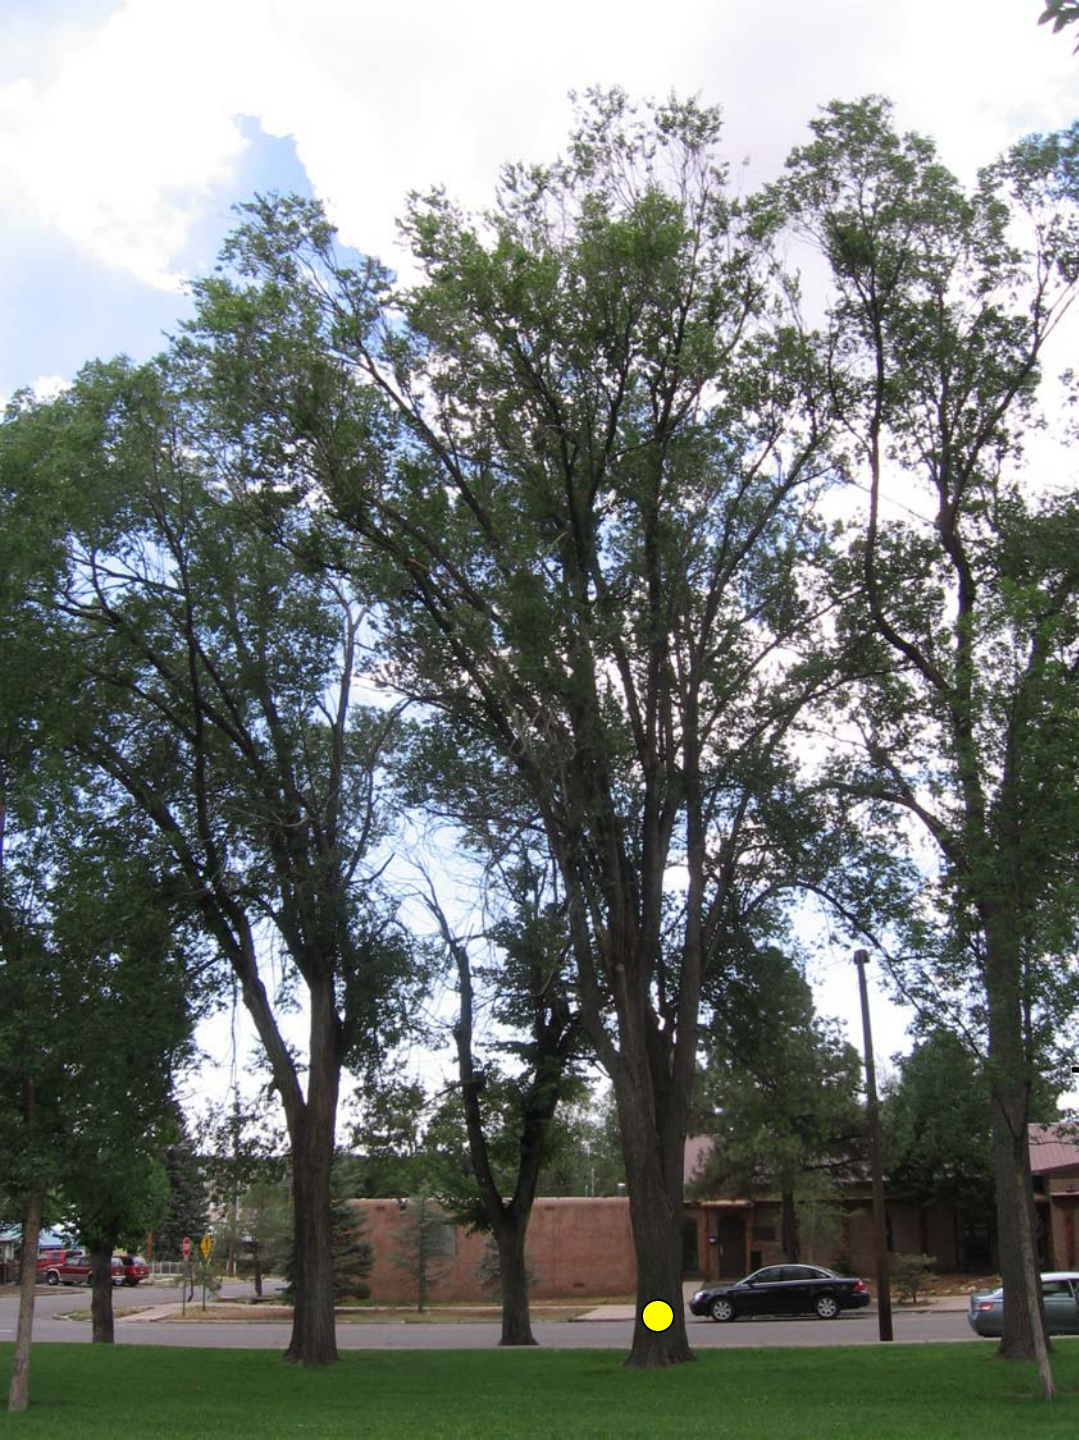
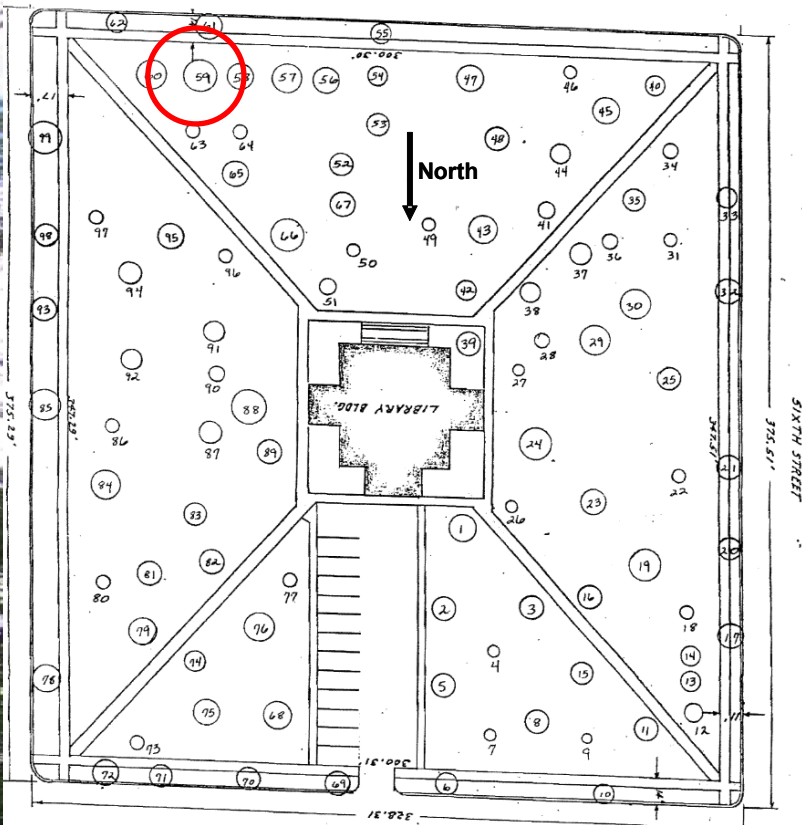
Pruning Tree # 13  
Carnegie Park - #59 on diagram  
(yellow dot paint on trunk)

- Elm, ~ 40 to 50' tall
- Structural prune – subordinate or thin multiple main branches.
- Goal is retention of a significant and otherwise reasonably healthy tree.

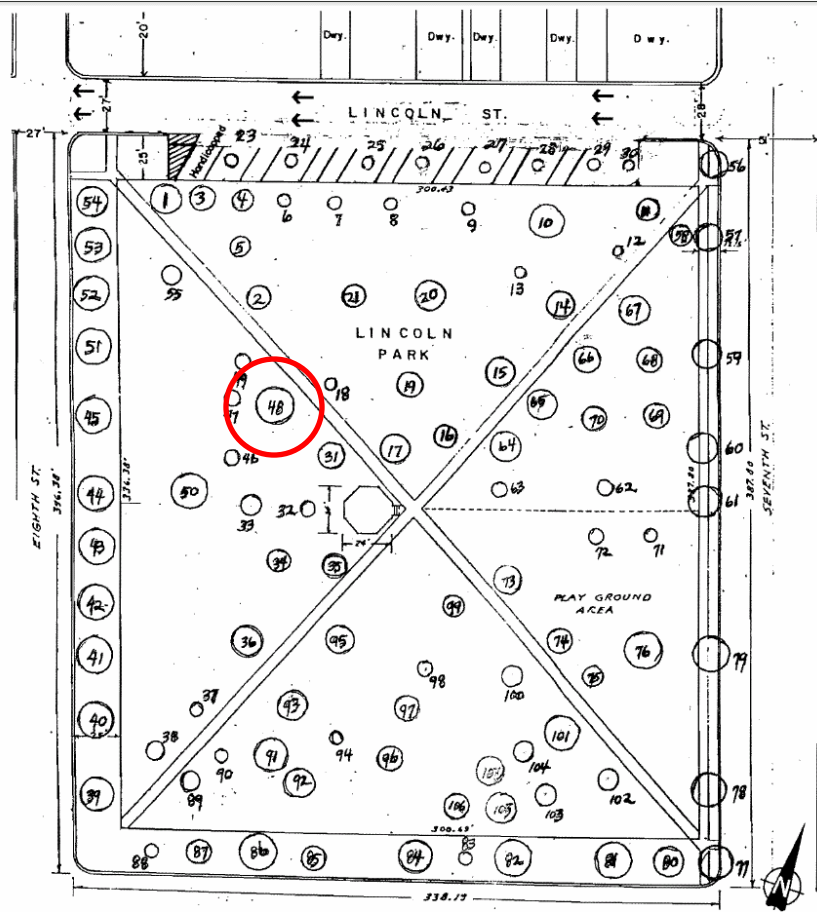
Pruning Tree # 14  
Lincoln Park - #48 on diagram  
(yellow dot paint on trunk)

- Elm, ~ 30 to 35' tall
- Restore damaged tree - remove significant dead limb
- Clean and thin crown, as warranted.
- Goal is to clean and re-shape for retention.

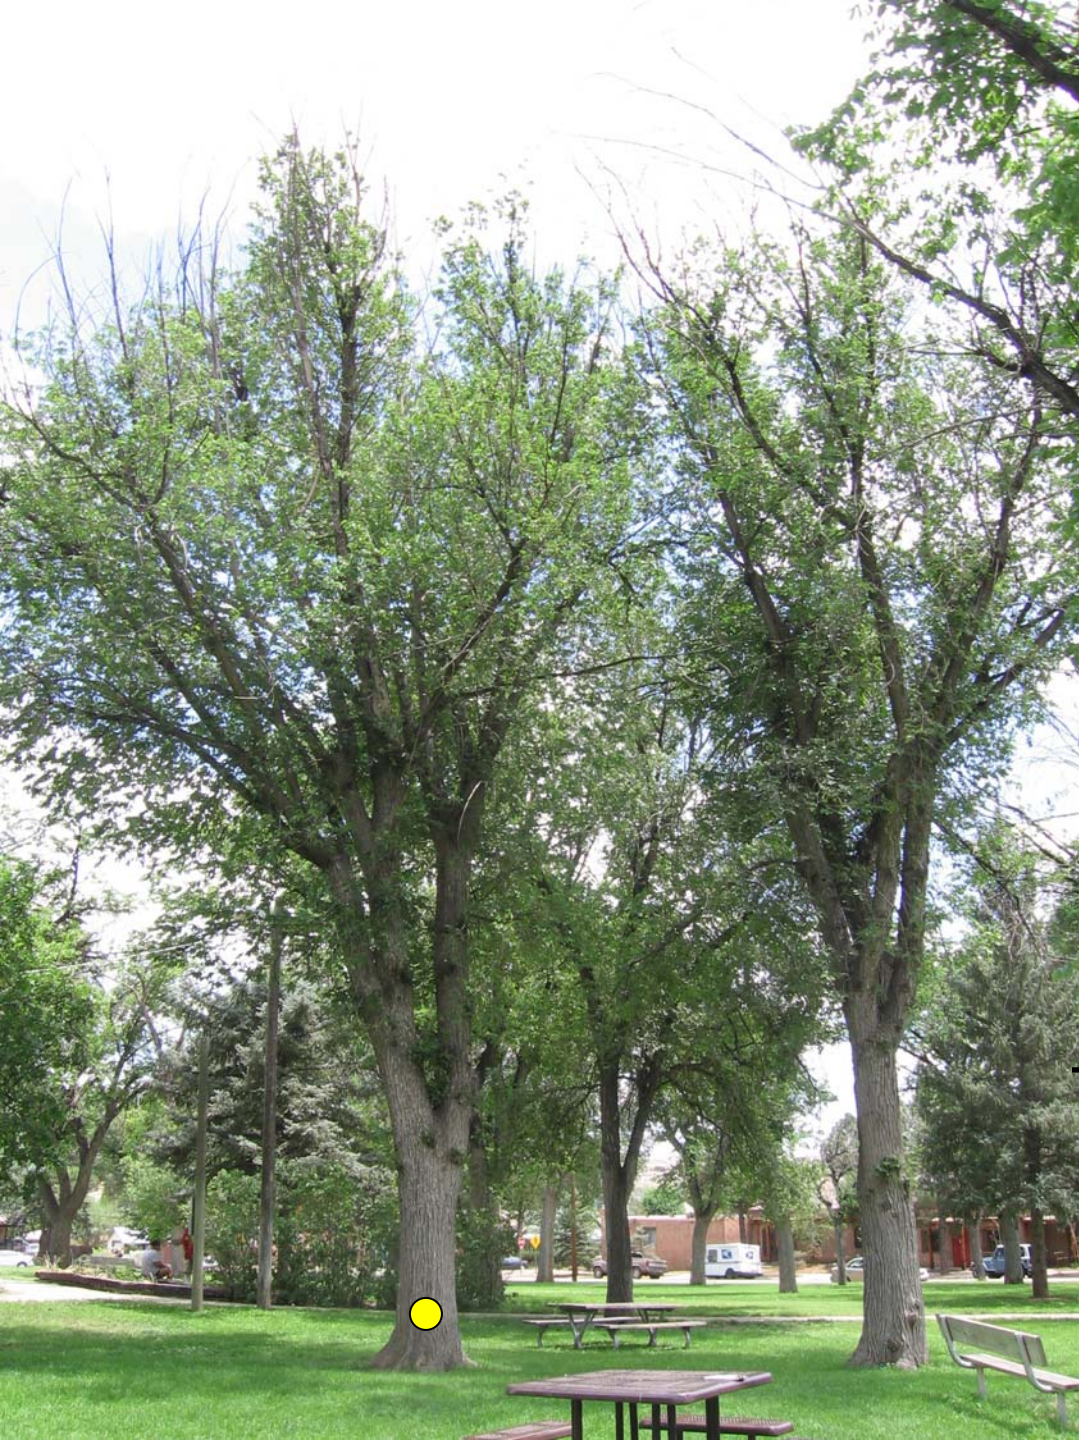
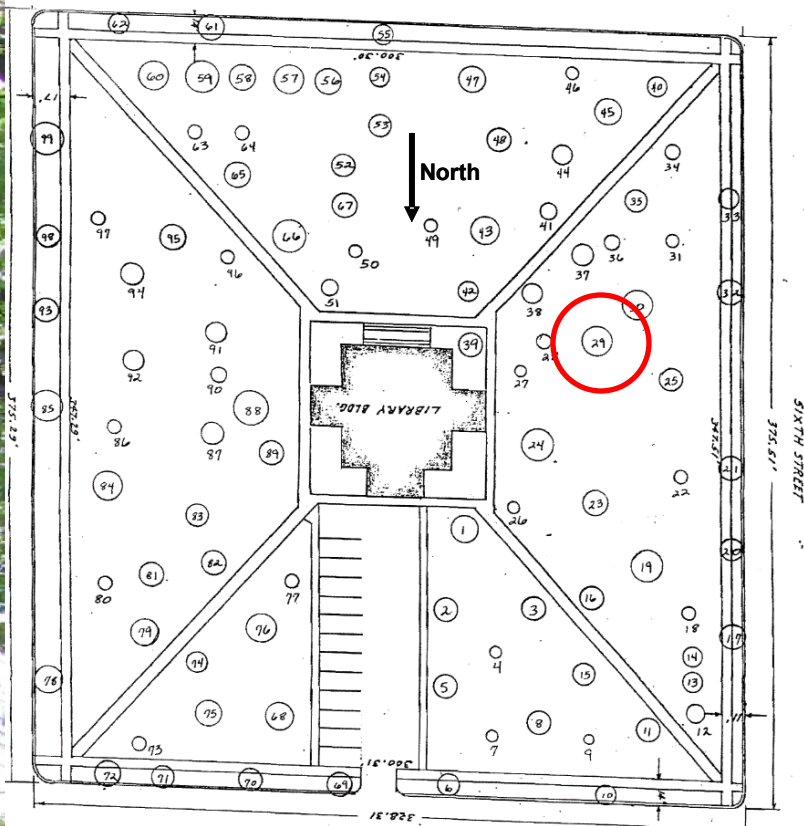
Pruning Tree # 16  
Carnegie Park - #29 on diagram  
(yellow dot paint on trunk)

- Elm, ~ 30 to 40' tall
- Clean, thin, and structurally prune.
- Goal is to reduce risk and prolong life of tree until replacement trees are viable.
