# Appendix A

## Las Vegas, NM Urban Forest Project

### Candidate Trees for Removal

# Appendix B

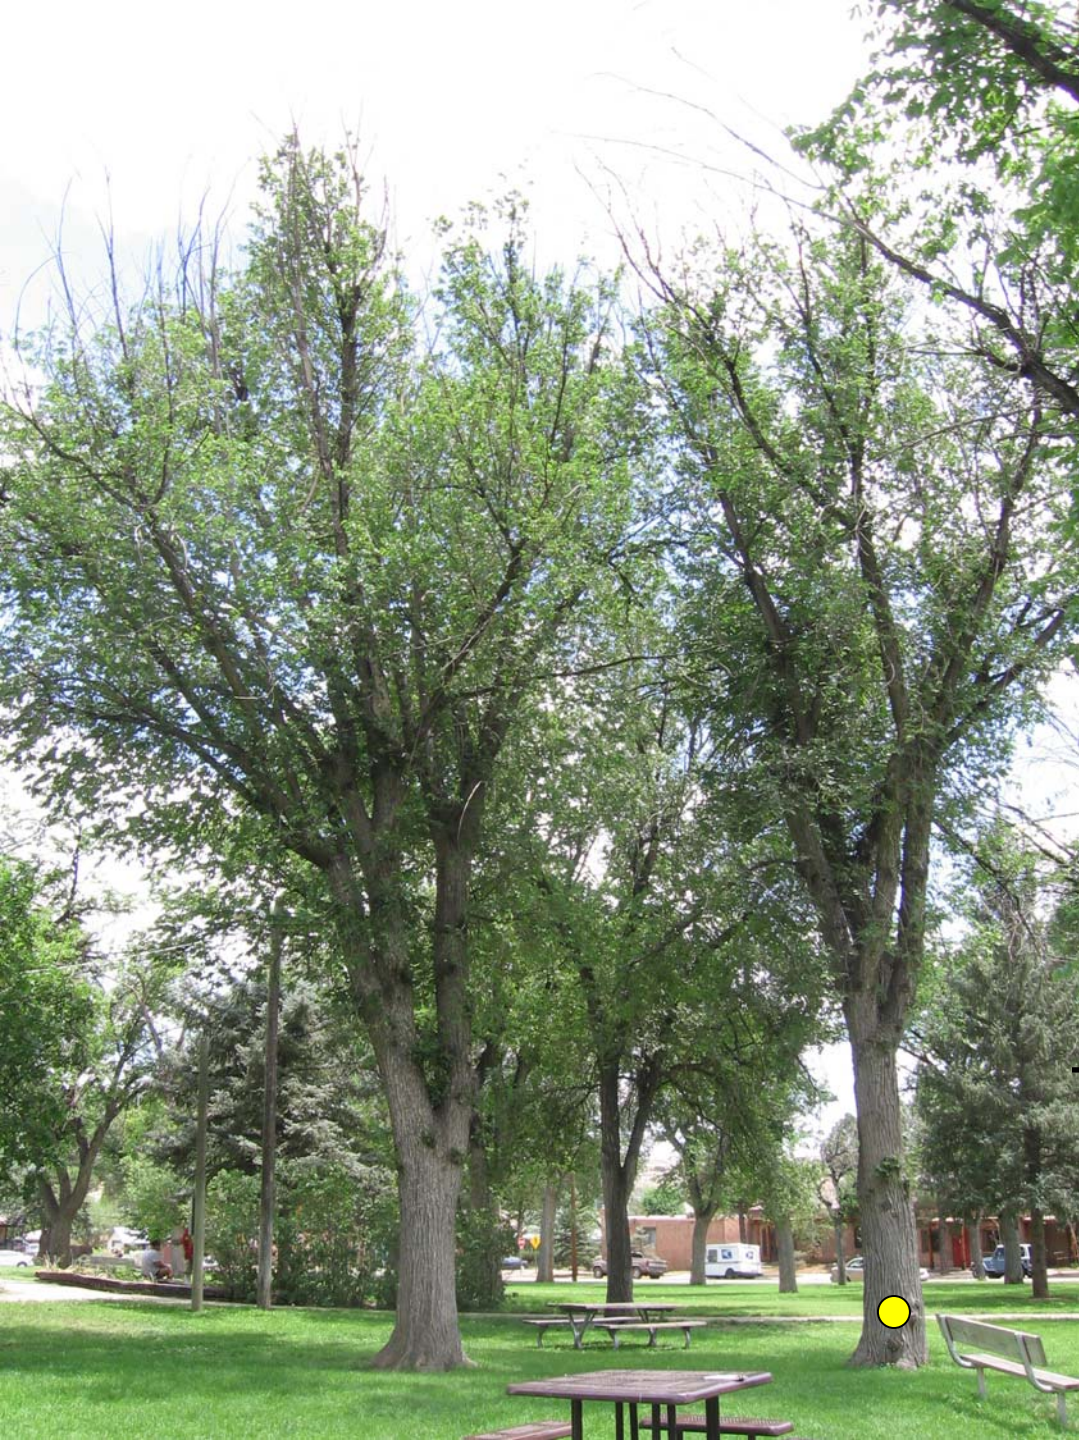
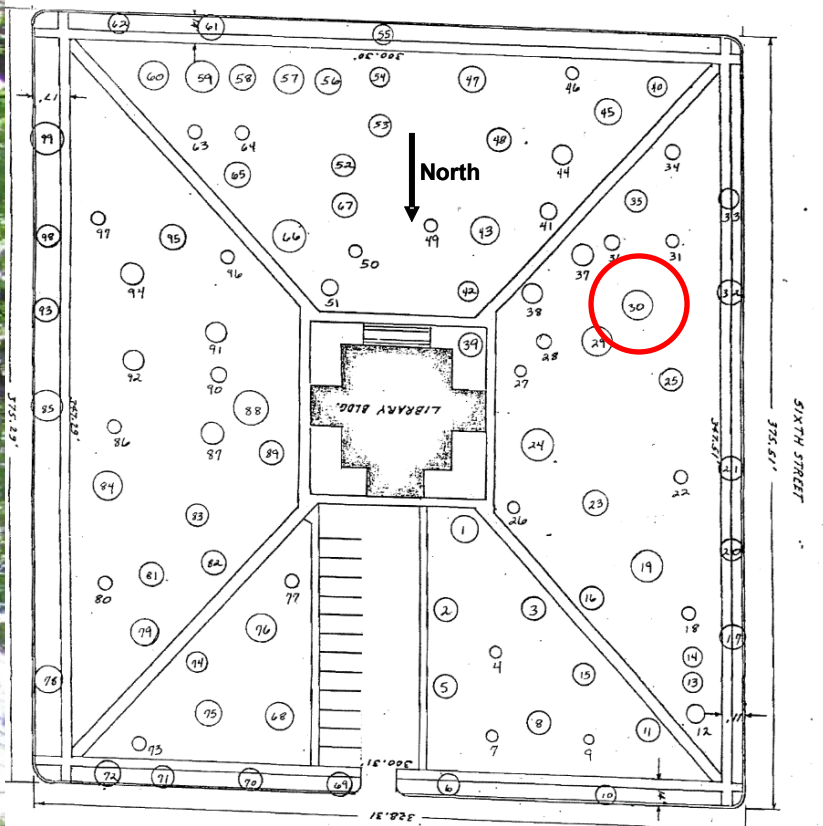
Pruning Tree # 17  
Carnegie Park - #30 on diagram  
(yellow dot paint on trunk)

- Elm, ~ 30 to 40' tall
- Clean, thin, and structurally prune.
- Goal is to reduce risk and prolong life of tree until replacement trees are viable.

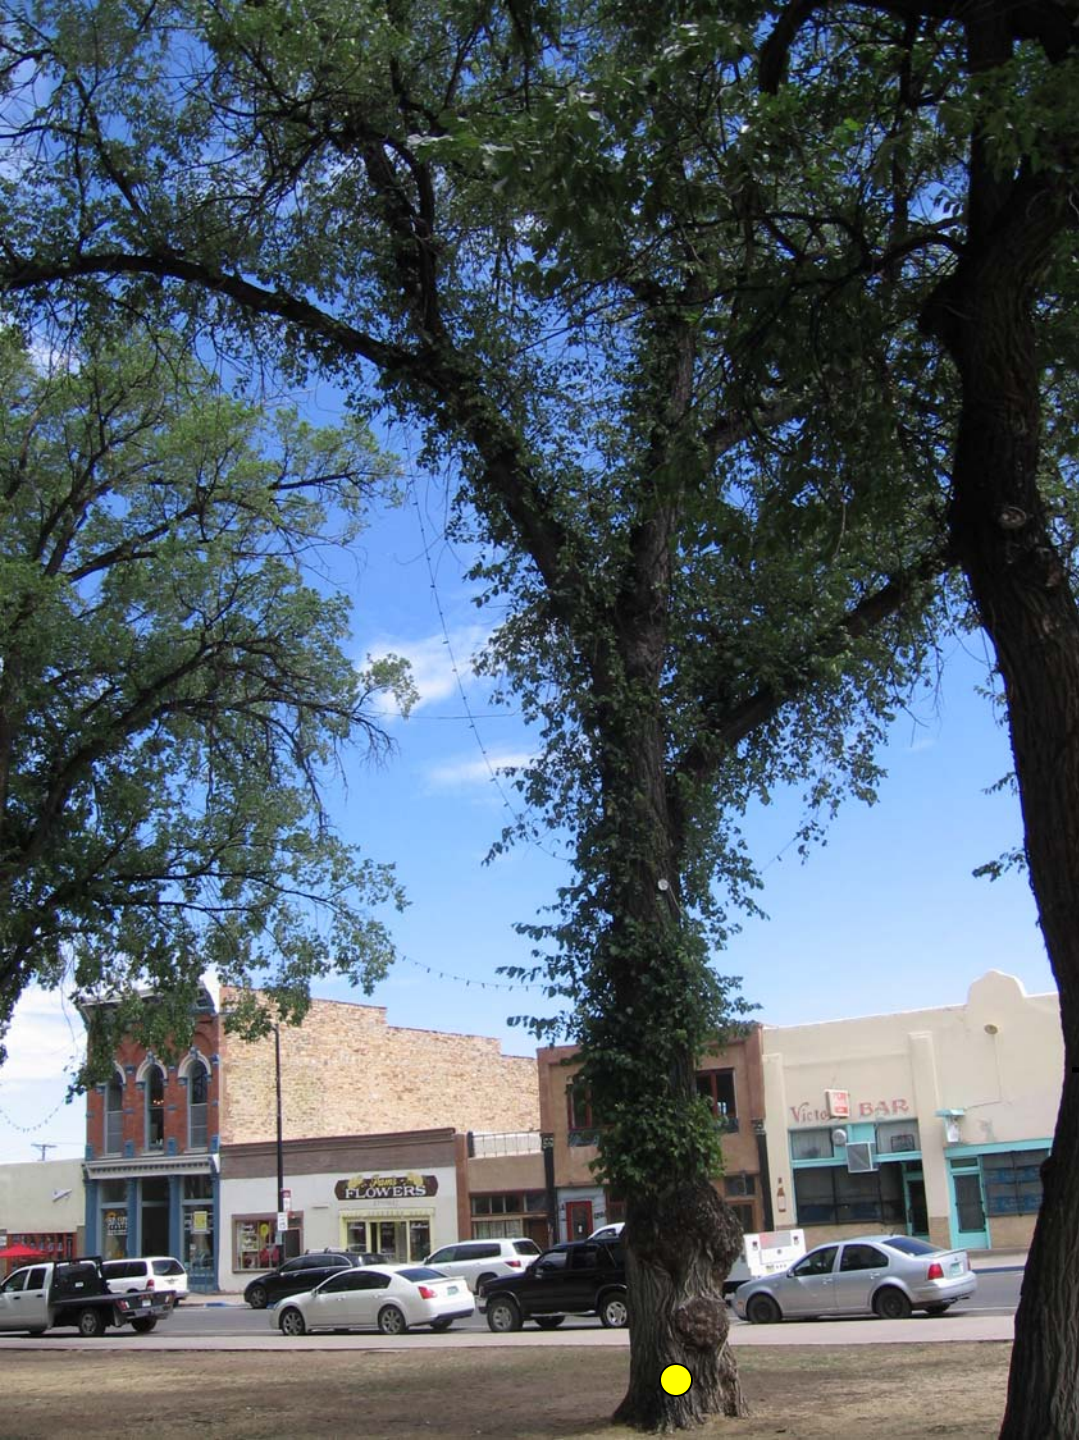
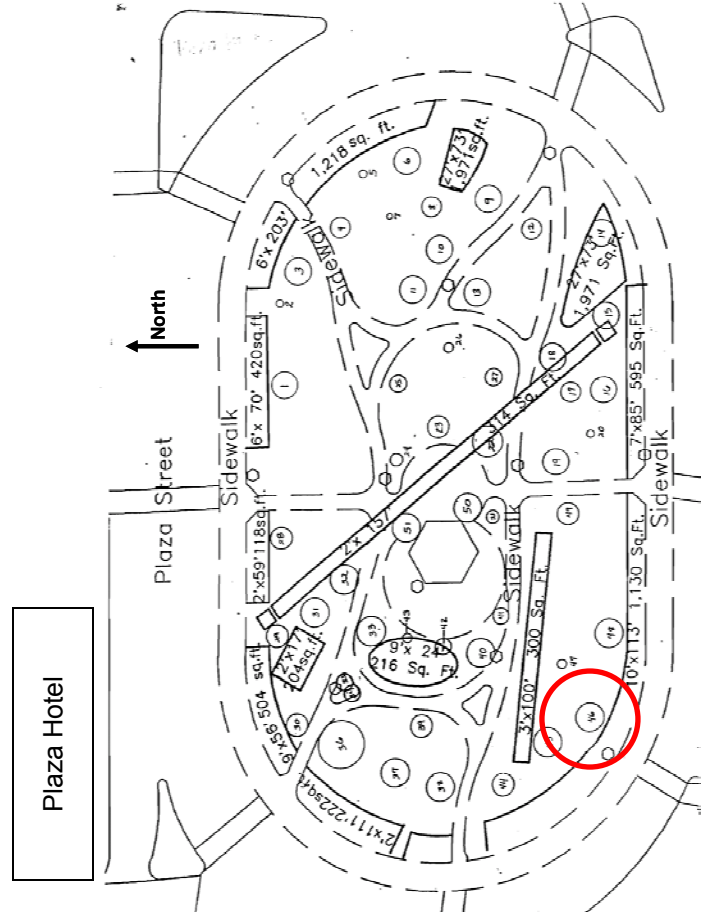
Pruning Tree # 18  
 Plaza Park - #46 on diagram  
 (yellow dot paint on trunk)

- Elm, ~ 30 to 40' tall
- Clean and thin crown. Prune overhanging limbs.
- Tree has major faults (galls, epicormic shoots, reduced vigor) but its removal would leave a significant hole in the park canopy.
- Goal is to plant replacement tree(s) while maintaining existing tree for 3 to 5 years before its removal.

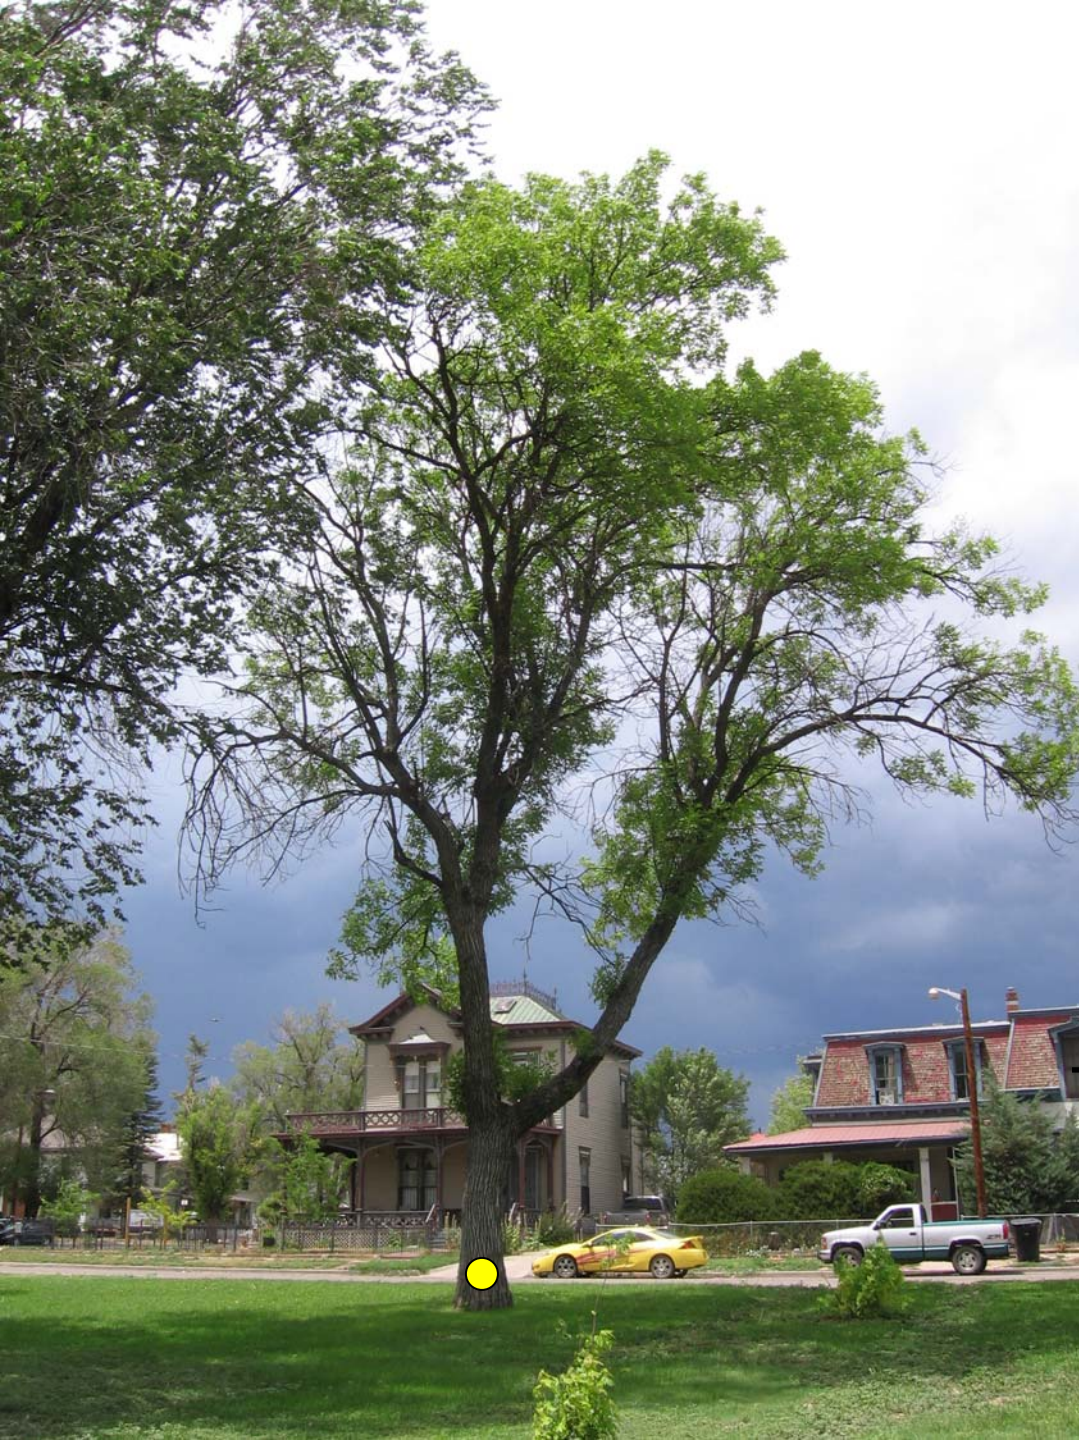
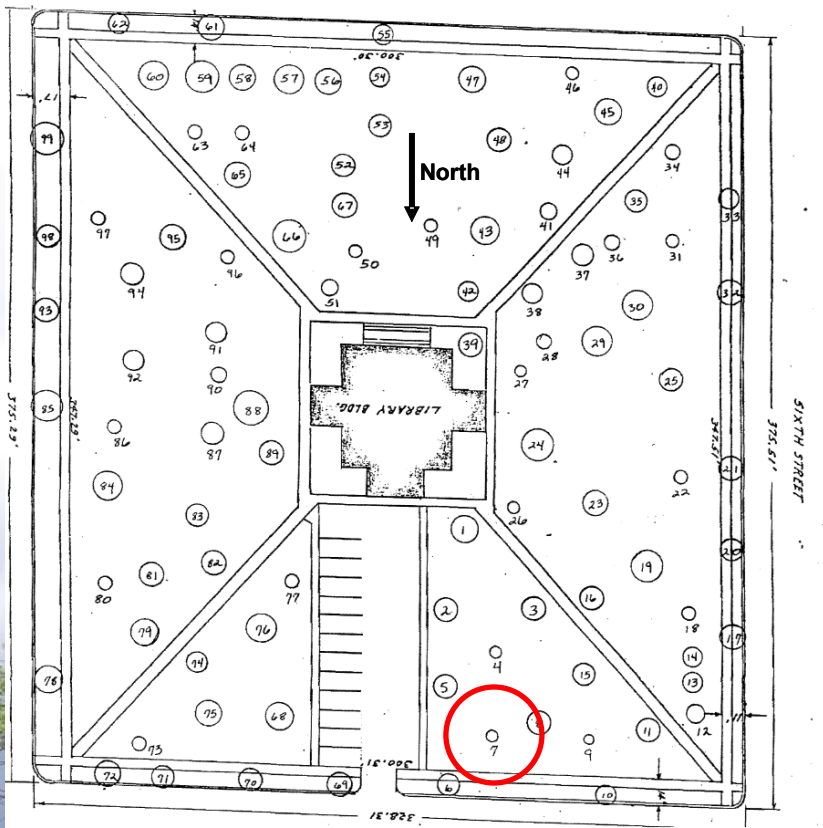
Pruning Tree # 19  
Carnegie Park - #7 on diagram  
(yellow dot paint on trunk)

- Ash, ~ 30 to 40' tall
- Reduce weight on NE facing limb by thinning.
- Clean crown.
- Tree has poor structure and vigor; it bears watching in subsequent years.
- Goal is to reduce risk to pedestrians and cars.

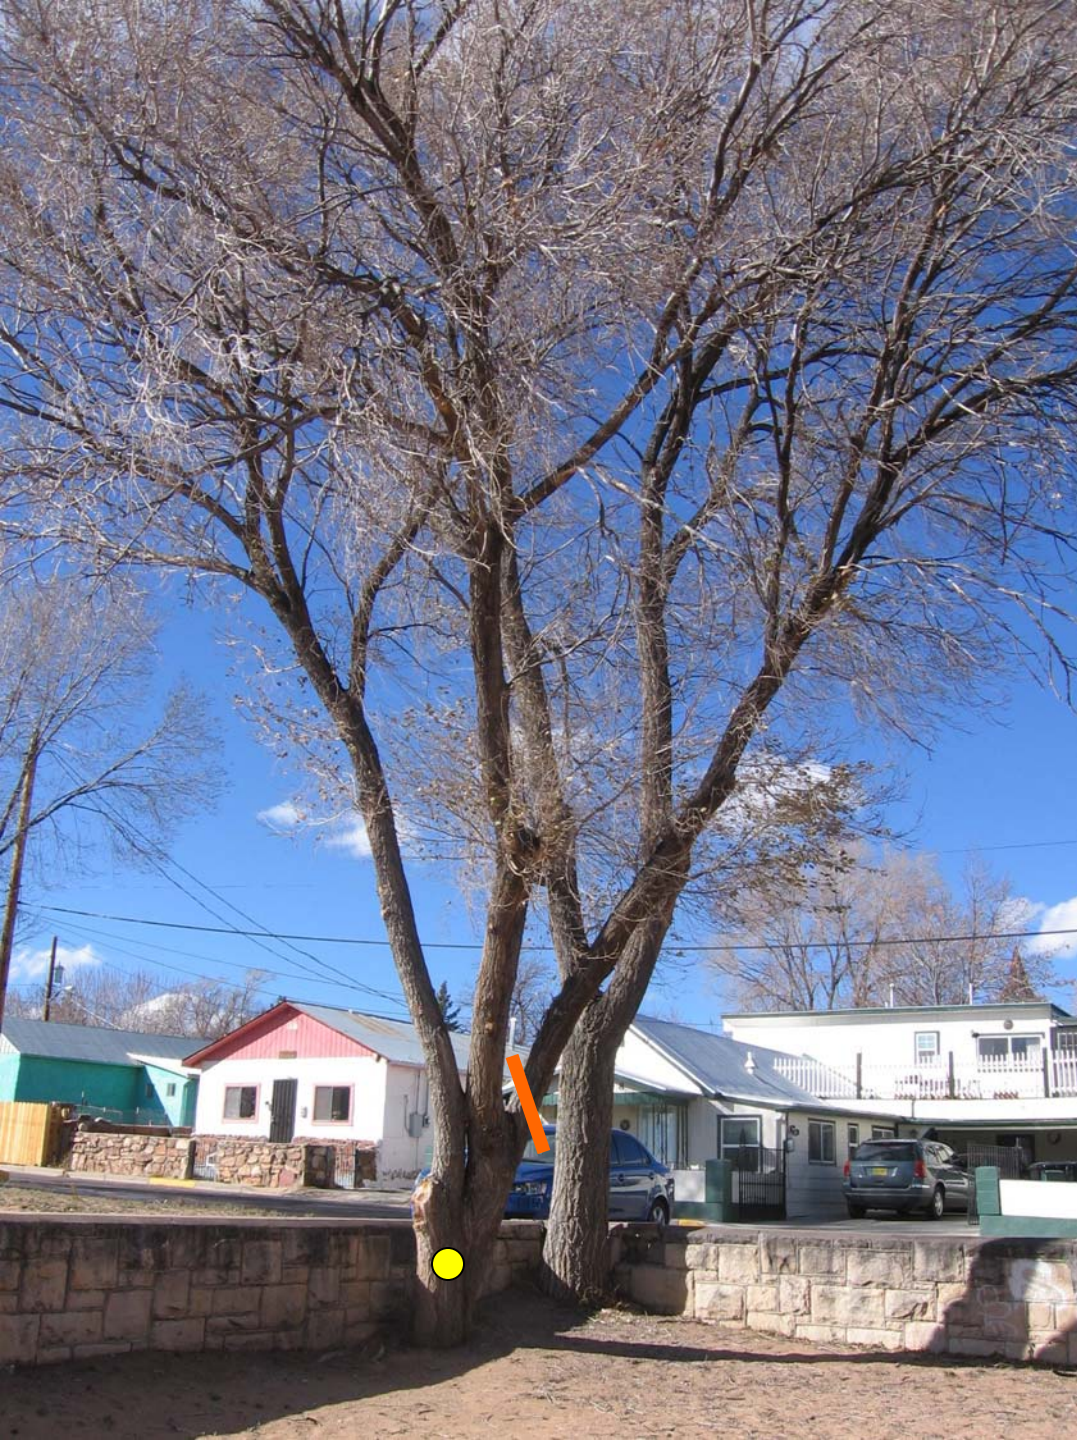
Pruning Tree # 20  
S. Pacific Park - #17/18 on diagram  
(yellow dot paint on trunk)

- Elm, ~ 25 to 30' tall
- Multi-stem tree. Prune one stem where indicated
- Thin and reduce overhang on opposite stem, closest to playground equipment.
- Goal is to improve poor structure and reduce risk to playground in a park that has few trees. This tree bears watching in future years.
