CLEARING THE WATERS

Volume 15, No.4

Winter 2010/11

Vacas Asphalt Spill Cleaned Up

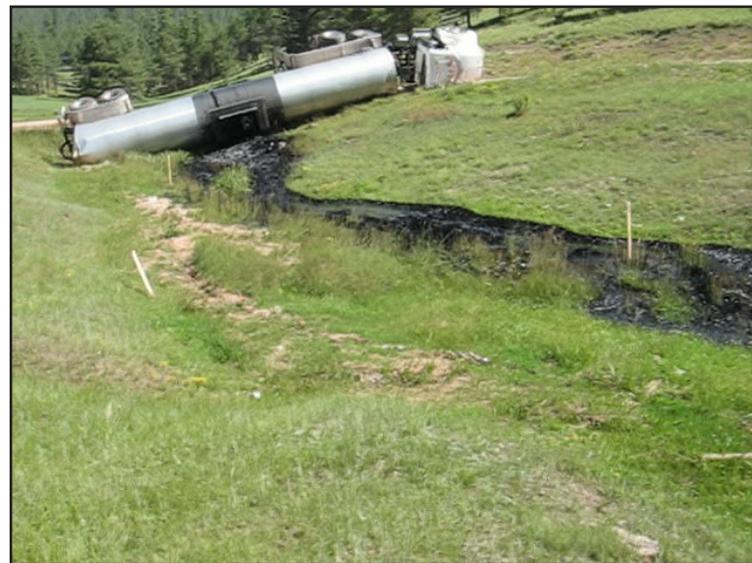
Asphalt Spill. Photo courtesy of Rudy Rios.

On August 10th, 2010 an accident occurred on NM Highway 126 about 12 miles east of Cuba, New Mexico. The highway was undergoing a chip seal procedure, and one of the ingredients used was a "hot oil asphalt slurry." Rudy Rios, President of NM Trout, was working in the area and observed an overturned tanker truck spilling an unknown quantity of asphalt slurry from a 5,000 gallon capacity tanker into a side drainage that flowed to a beaver pond on the Rio de las Vacas. The Rio de las Vacas is in the headwaters of the Jemez watershed, and is a popular recreational area and fishery. The driver had been attempting to turn around when the truck flipped over, and the material spilled out an unsecured top door/valve. The driver was not seriously injured, and the Department of Public Safety was contacted. Cactus Transport Inc., the owner of the tanker truck, took responsibility for the incident.

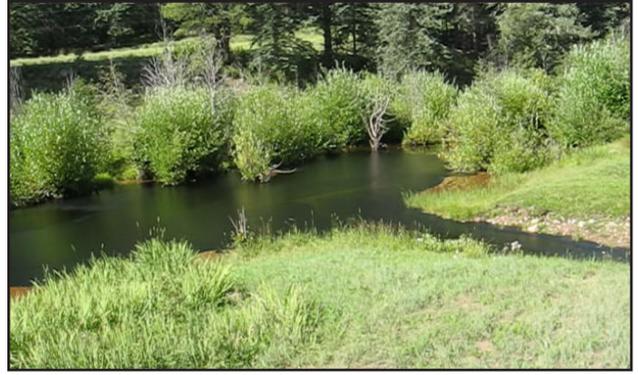
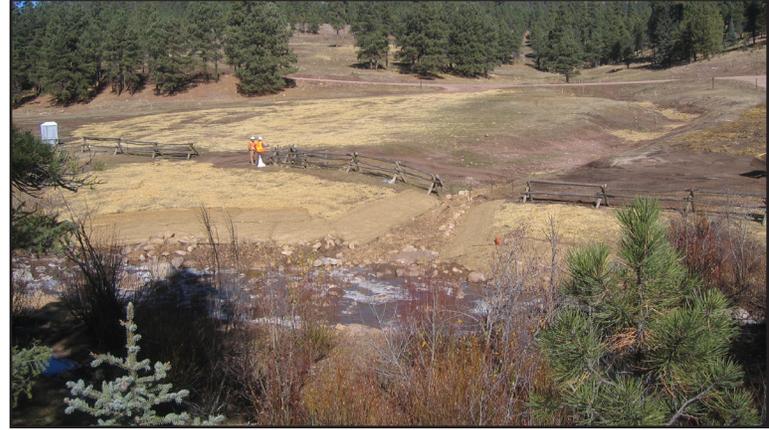
Beaver Pond immediately after spill (above).

Beaver Pond and drainage after remediation (below).

The asphalt slurry cooled as it reached the stream and became less mobile. Most of the heavier hydrocarbons were contained in the beaver pond. There was no evidence that the beavers were active in this pond, and there was minimal fish mortality observed. It took approximately 12 weeks for the post-spill remediation to be completed. Cactus Transport Inc. worked diligently and stayed on site until the site was cleared by a multi-agency group that provided guidance. Although initial work is complete, the responsible party will continue to monitor the site.

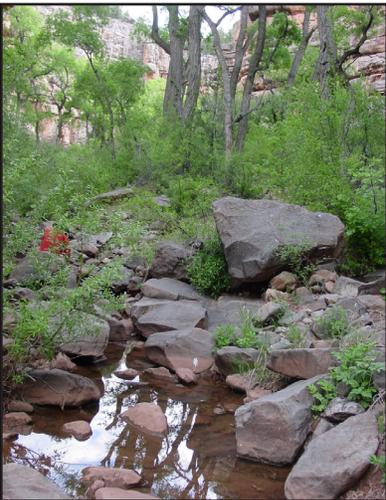
Perennial example - Rio Nutria
Zuni Watershed

SWQB has released a revised version of the Hydrology Protocol, a technical document developed to distinguish between ephemeral, intermittent and perennial streams and rivers in New Mexico. Such determinations are often key to applying the appropriate water quality standards to a waterbody. The protocol relies on hydrological, geomorphic, and biological indicators of the persistence of water. These characteristics are then ranked using a weighted, four-tiered scoring system for an objective, practical scoring mechanism. The protocol can be used to provide technical support for a use attainability analysis (UAA), or to identify unclassified waters within an otherwise classified segment. However, the protocol is designed solely to aid in water quality standards determination and the resulting determinations have no bearing on water rights or other non-SWQB programs.

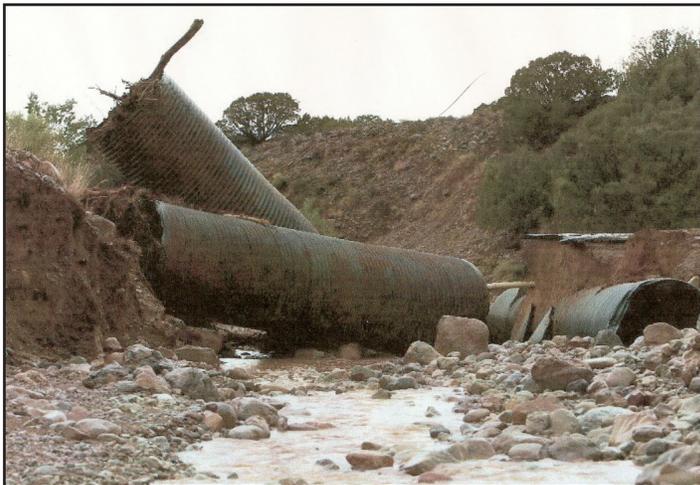
Flood damage on Las Huertas Creek, July 2006

During the summer rainstorms, extreme events can lead to downcutting of the river bed - without accessing its floodplain it has nowhere to release its energy except downwards. Such was the case determined by the Las Placitas Watershed Association when in 2006 they applied for and were awarded a Clean Water Act (CWA) Section 319 (h) “on-the-ground” watershed restoration project.

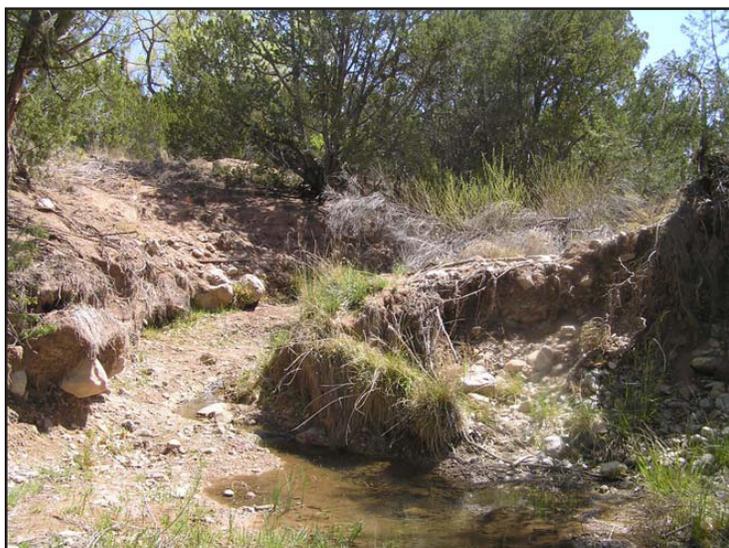
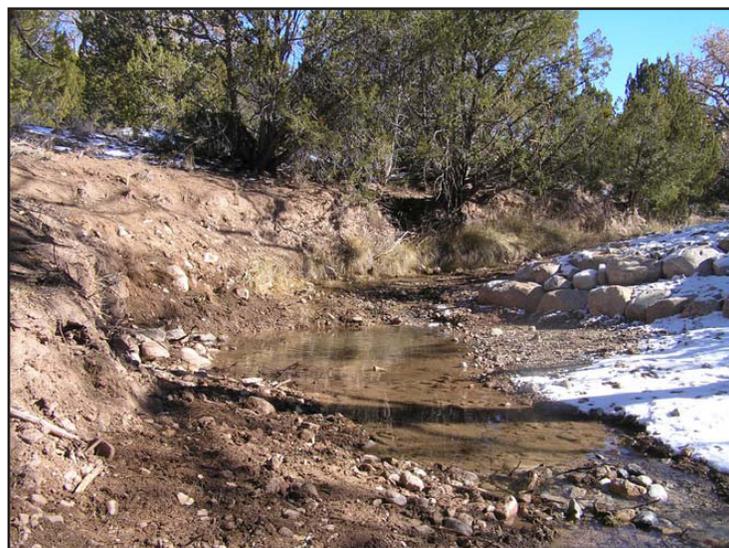
Restoration of deep downcut gully and back-eddy area at Van Driessche/Bladergroen property boundary – (view upstream). Note baffle installation on right and restoration of floodplain. Photos courtesy of R. Bandeen

For the Las Huertas Watershed Project, a sediment load reduction was estimated based on implementation of three types of best management practices (BMPs). Each type of BMP was either in-stream or in the riparian area; permitting an assumption that erosion rates are roughly equivalent to sediment loading to the stream. Fencing of riparian areas (mainly to exclude wild horses) was applied on eight percent of the “pastureland” land use category. The BMP was assumed to be effective at reducing sediment and nutrient loading by 60% from the area where it was applied. A separate wetland restoration was applied to 0.005% of a user defined rangeland land use category. That BMP was assumed to reduce sediment loading by 50%, nitrogen loading by 20%, and phosphorus loading by 40%. Approximately 4,000 feet of streambank, with an average height of approximately ten feet, were stabilized with vanes, weirs, baffles, and cross vanes installed following a natural channel design based in fluvial geomorphology. An average lateral erosion rate of 0.03 ft per year was estimated for these 4,000 feet of streambank, and the structures were assumed to reduce the lateral erosion rate by 45%.
