# Appendix A

## Las Vegas, NM Urban Forest Project

### Candidate Trees for Removal

# Appendix B

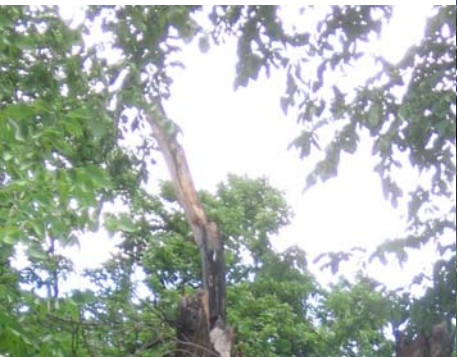
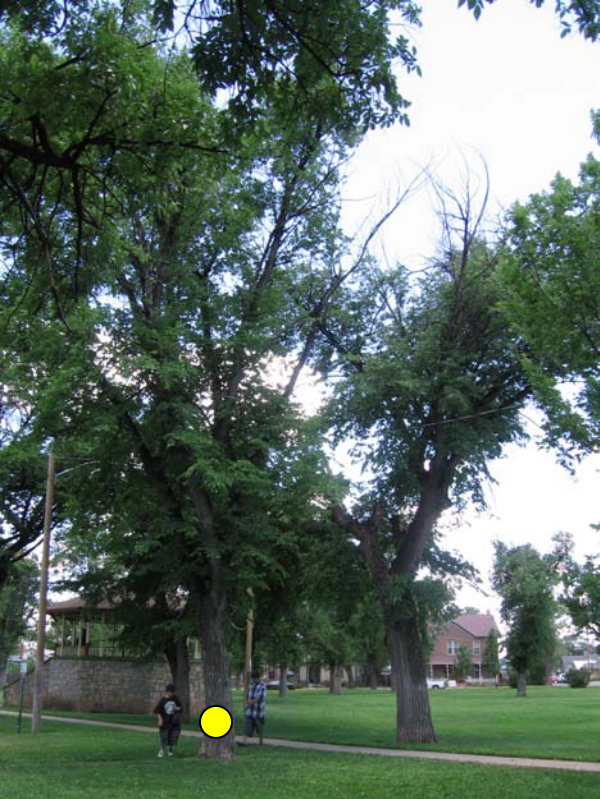
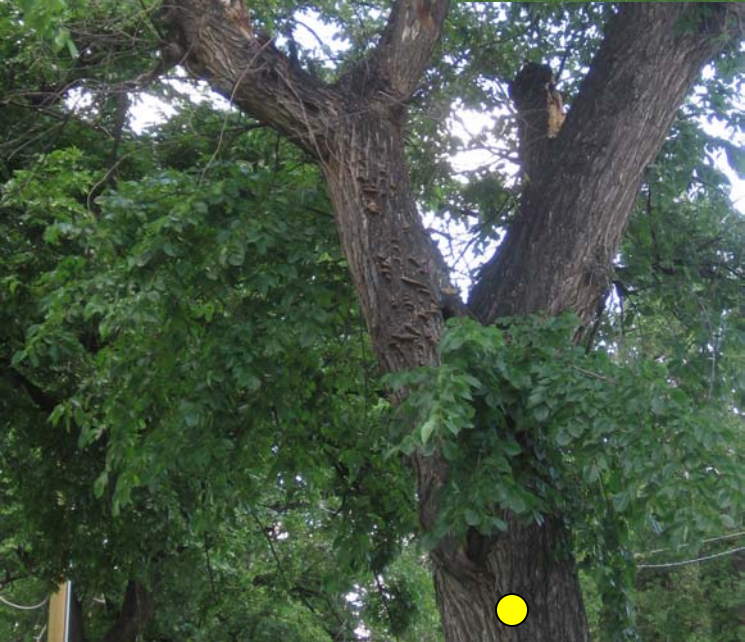
- Elm, ~ 40 to 50' tall
- Structural prune – subordinate or thin multiple main branches.
- Goal is retention of a significant and otherwise reasonably healthy tree.
