Santa Fe River Sampling Sites

Conclusions

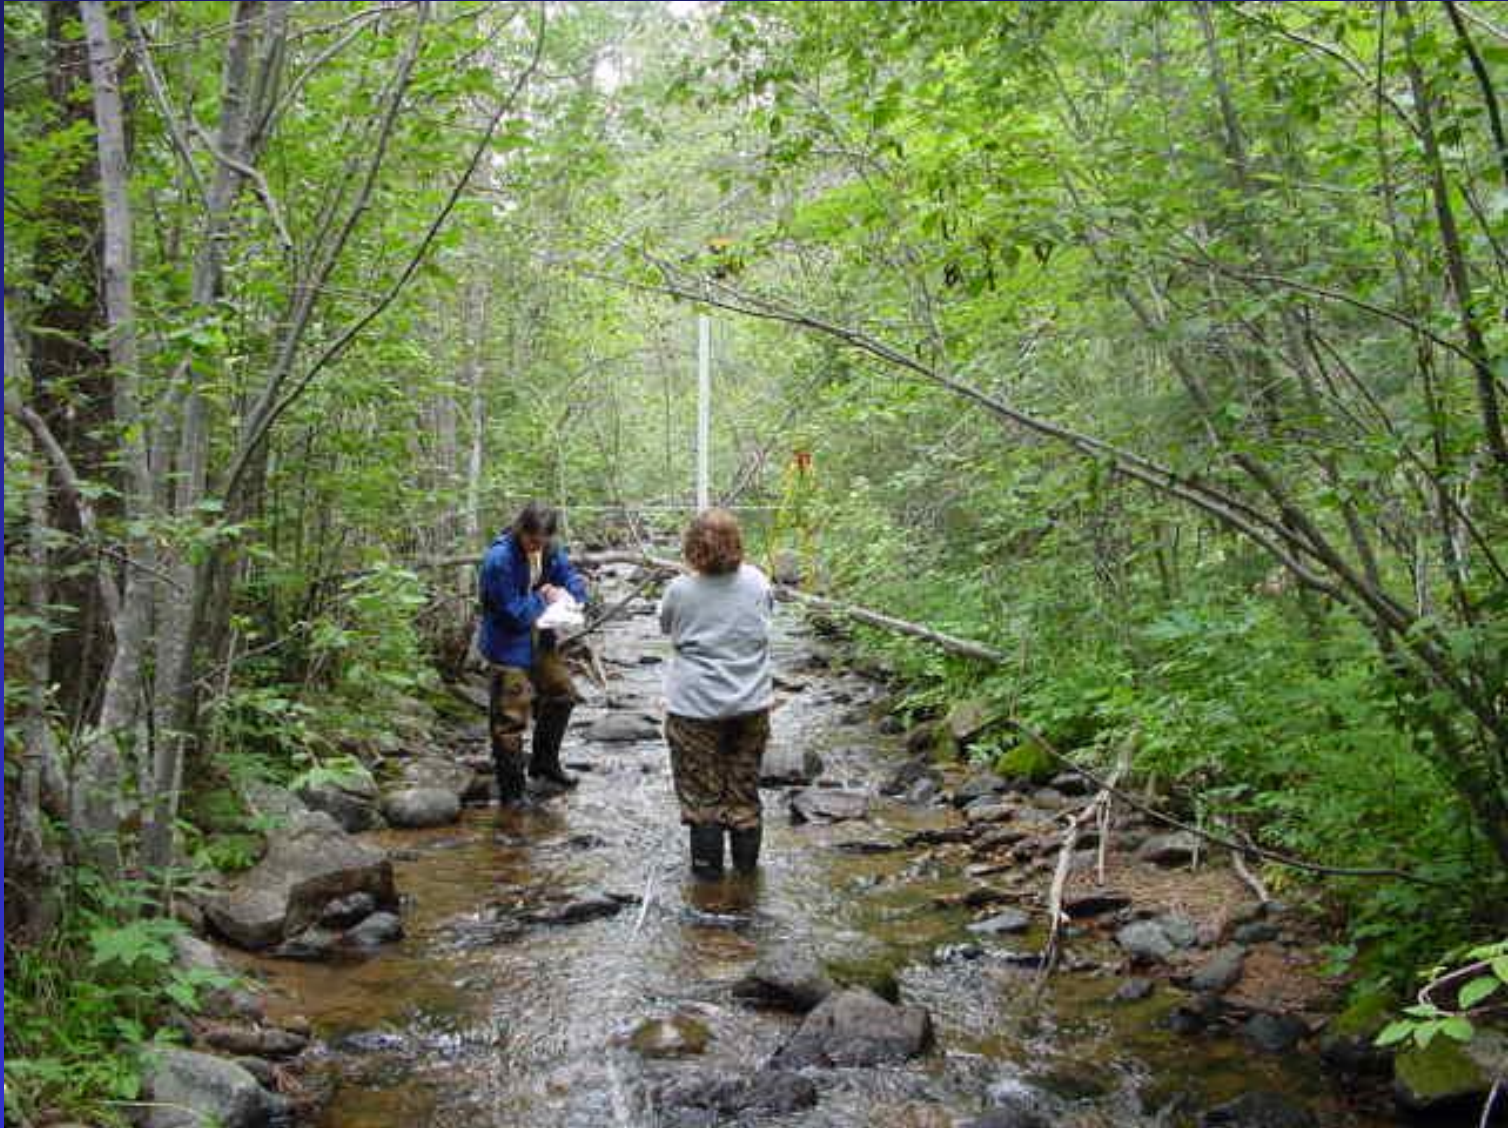
Rosgen Level II geomorphology surveys

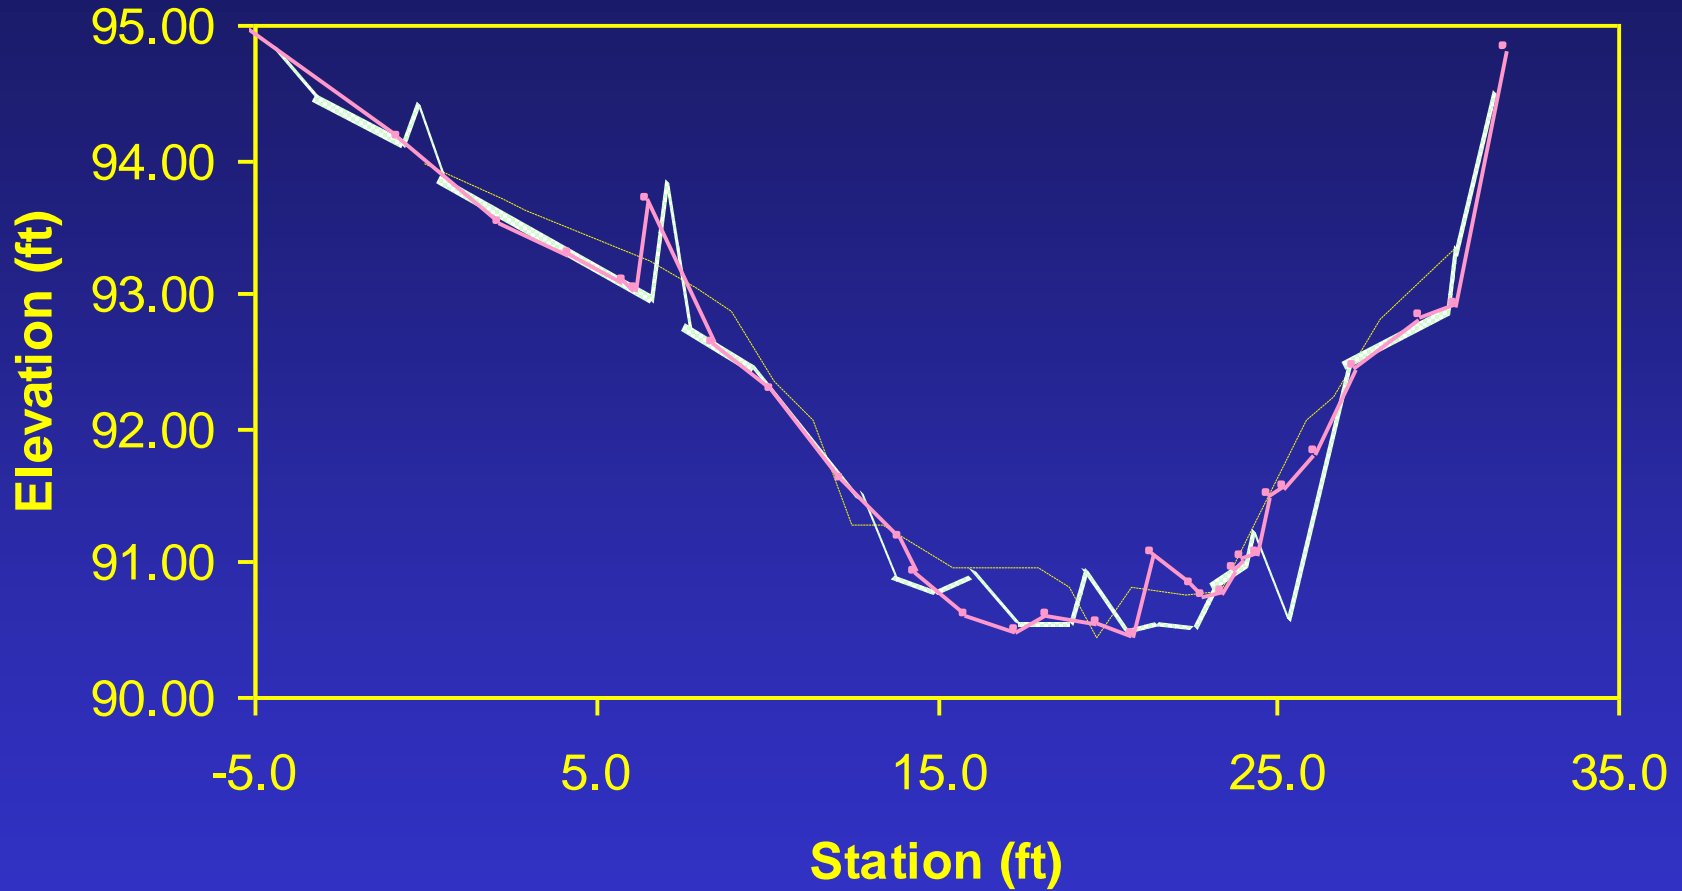
Registered cross sections (above Nichols Reservoir)

— 2002 — 2003 —•— 2007

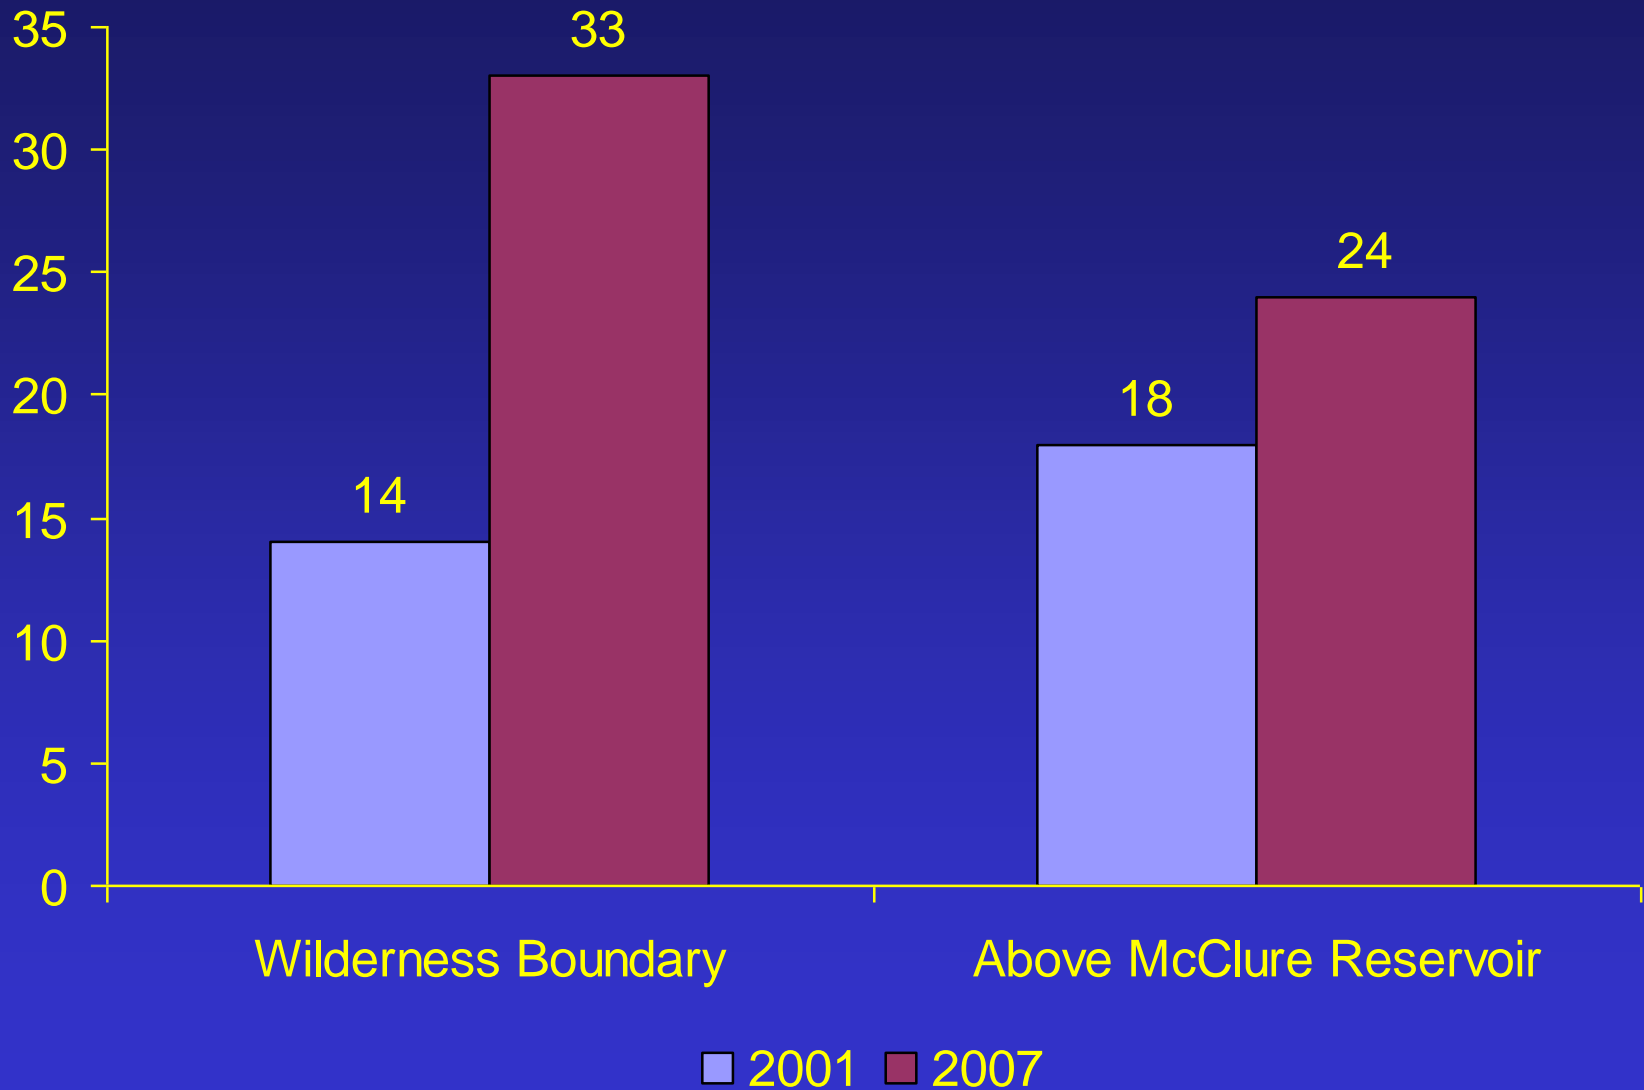
Upstream/downstream, before/after percent fines

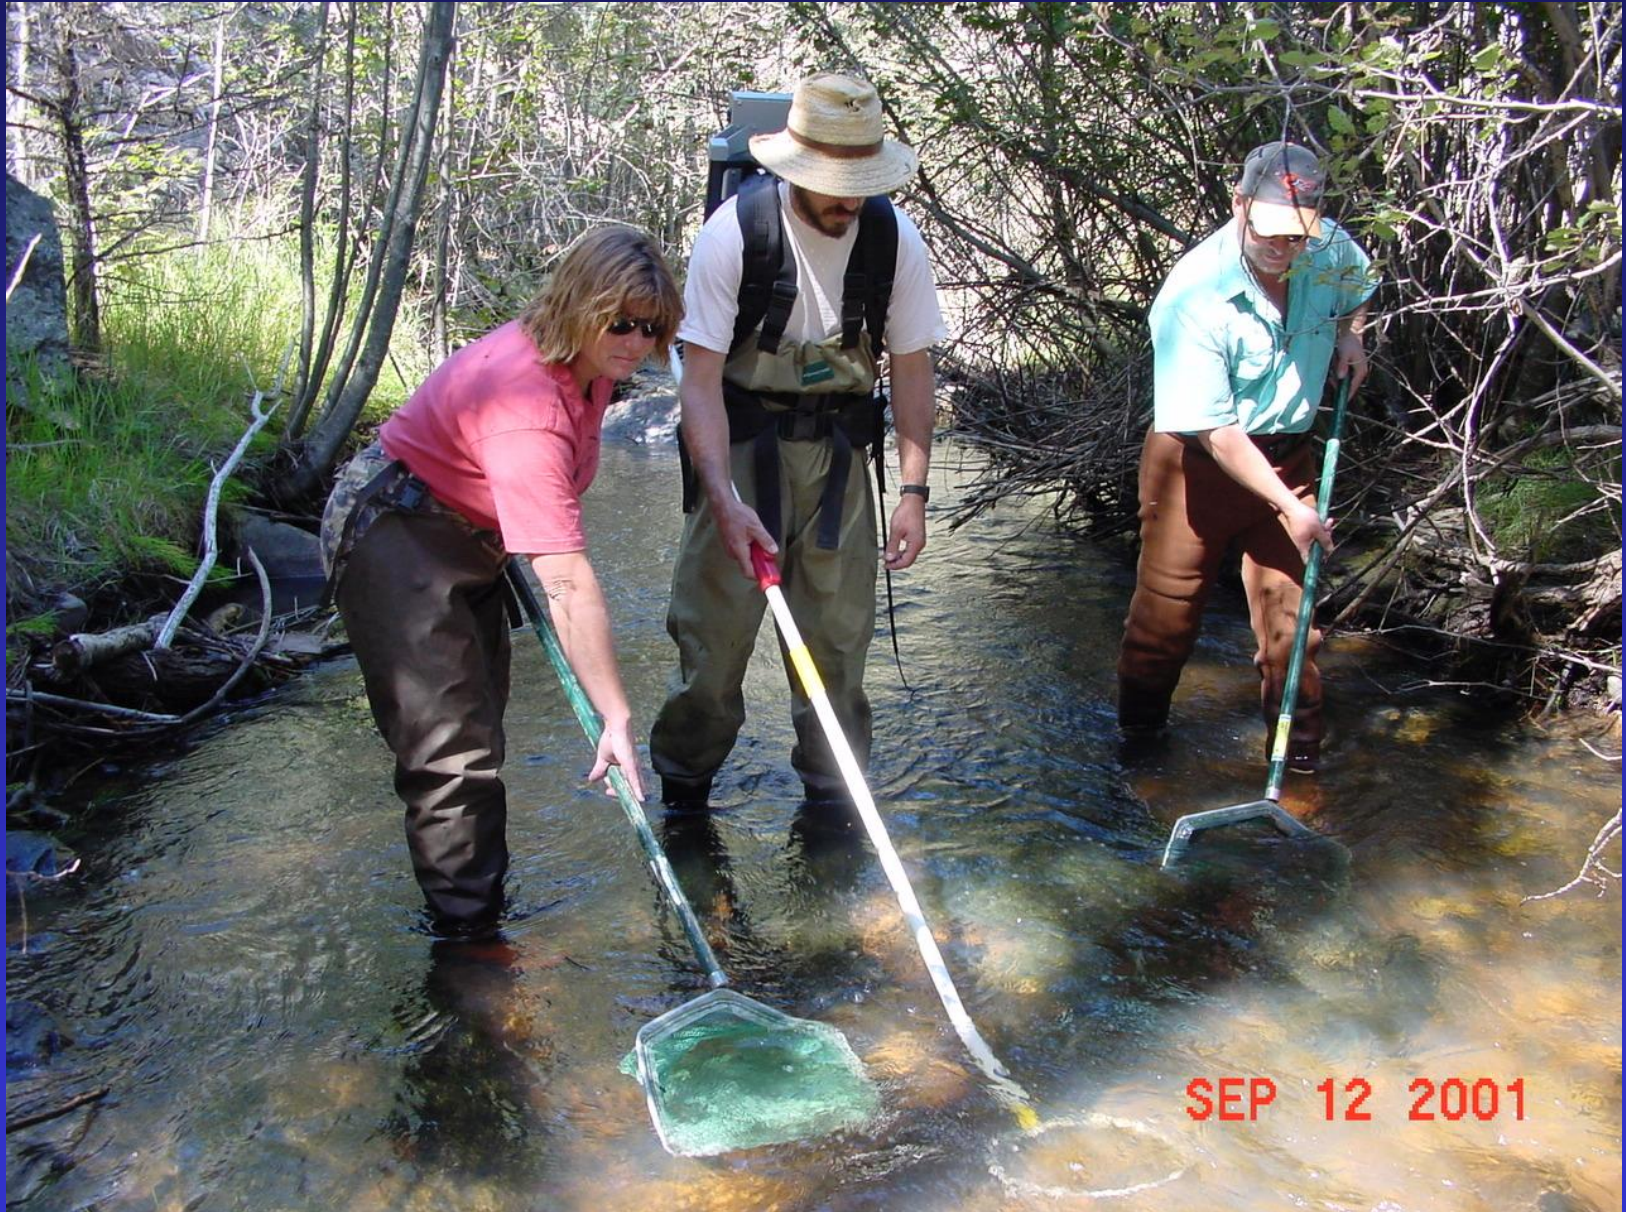
Fish sampling per modified Barbour et al., 1999

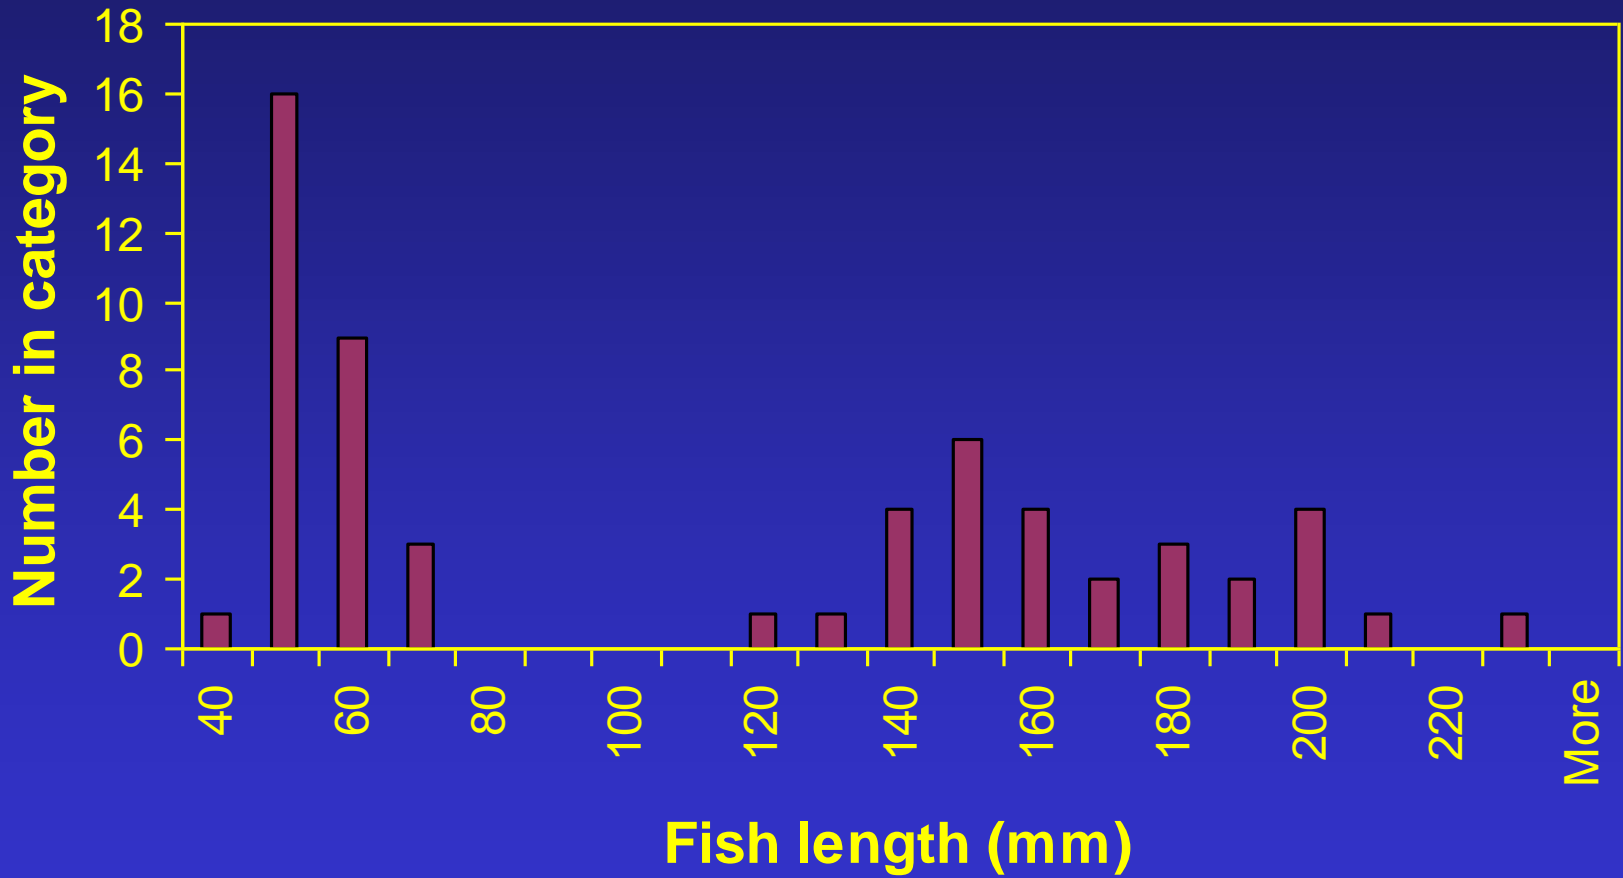
Fish length histogram, 2001, above Nichols Reservoir

CPUE = 0.07

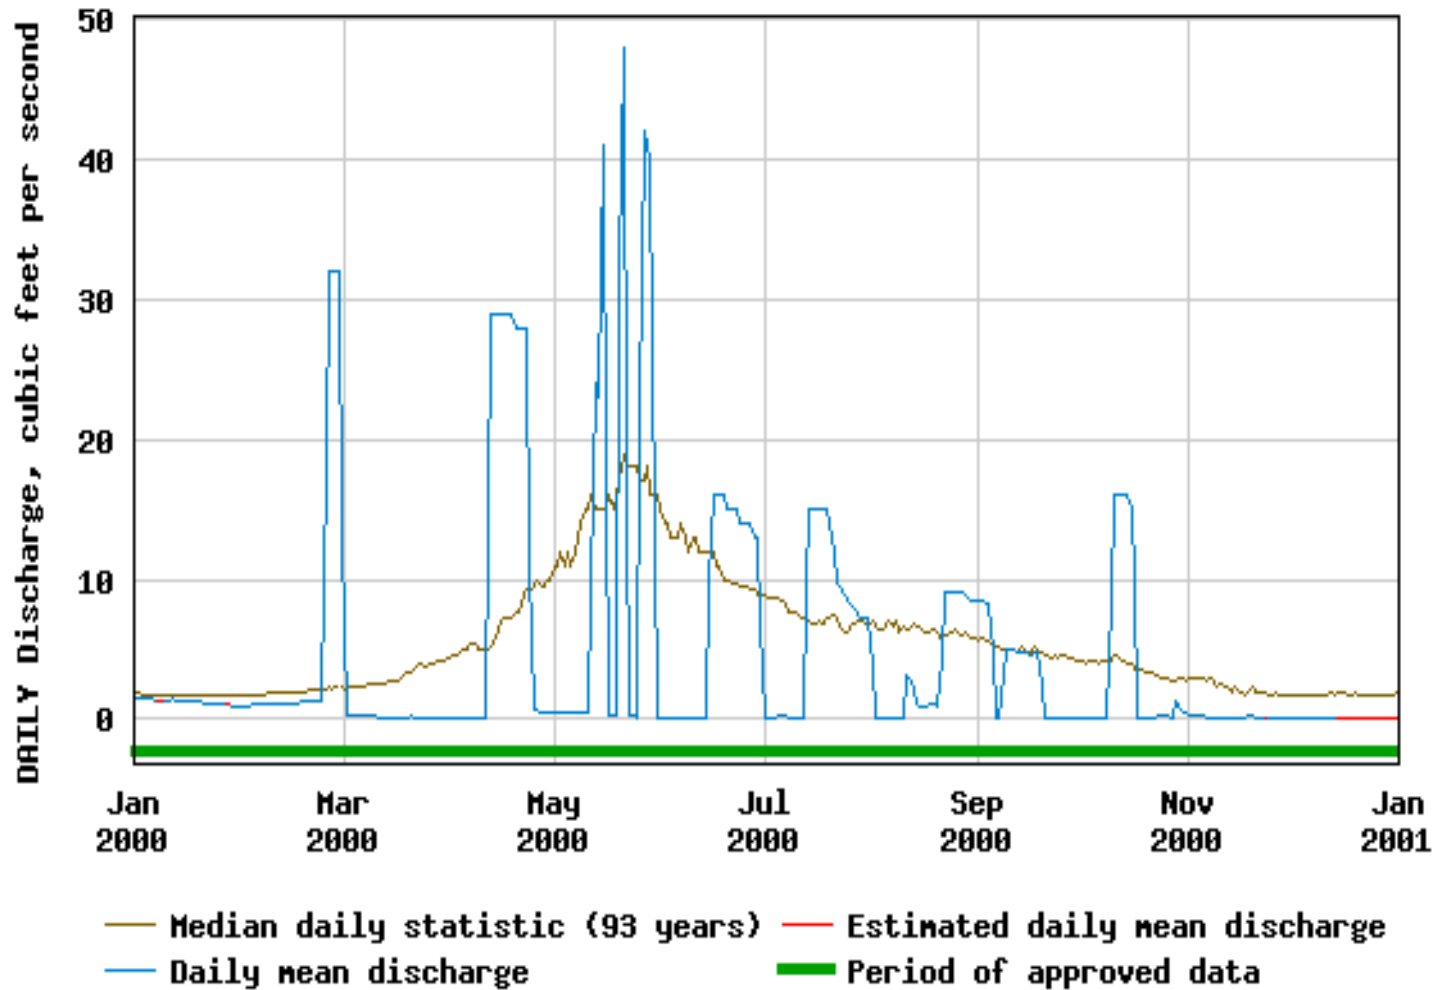
USGS 08316000 SANTA FE RIVER NEAR SANTA FE, NM
